West Main Street Property Condition Assessment Report

811-817 W. Main St.
Louisville, KY 40202

Prepared for:
C&P Real Estate LLC

Building Assessment
811 – 817 W. Main St

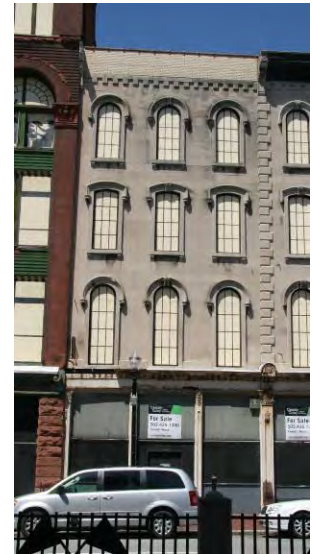
Fig 2 : 813 W Main St

Repairs – based on historic maps and field observations, 813 had an extensive fire at some point. The south interior of the building shows signs of charring on the floor joists and the north ½ of the building is newer construction. A portion of this building was removed at some point on the north end creating a courtyard; this was not present in the maps dating 1906.

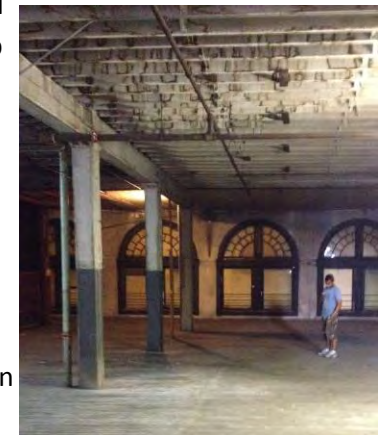
Fig 9 : 815/817 4th floor

The north end of the building had deteriorated due to water damage and was not safe. It was assumed that the structure in these areas requires replacement. The fifth floor is framed with 2x16 joists at 16 inch spacing. This framing is not adequate and requires replacement. The roof at the south end of the building is framed with 2x12 joists at 16 inch spacing and is not adequate.

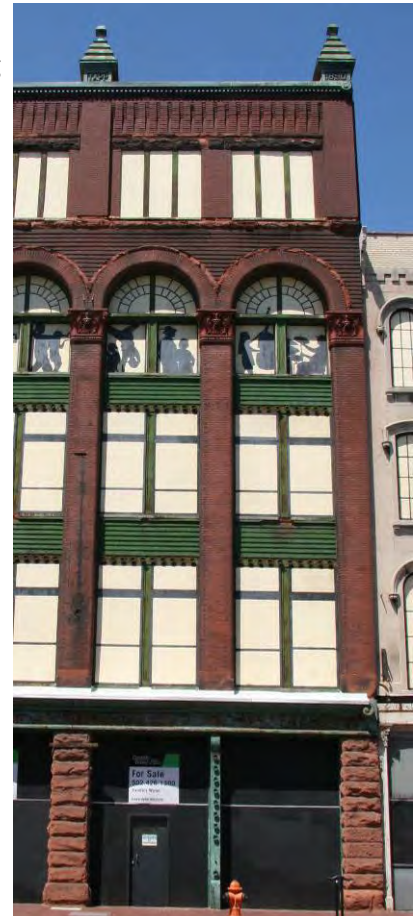
Fig 18: 815/817 building facade

The sandstone, brick and cast-iron façade has areas that need immediate attention and other areas that should be addressed to avoid further deterioration.

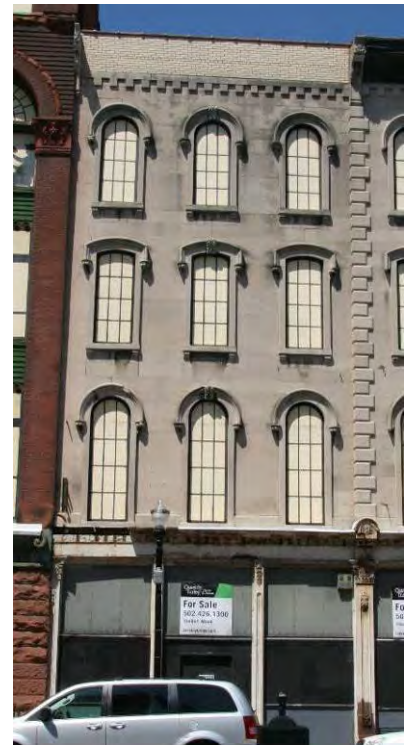
Fig 21: 813, building facade

The windows have extensive damage to frames, sashes and sills. Extensive repair will be required to bring them to working order.
