# Demolition Request

## 2130 New Main Street

# Objective: Urban Greenspace 2130 New Main Street

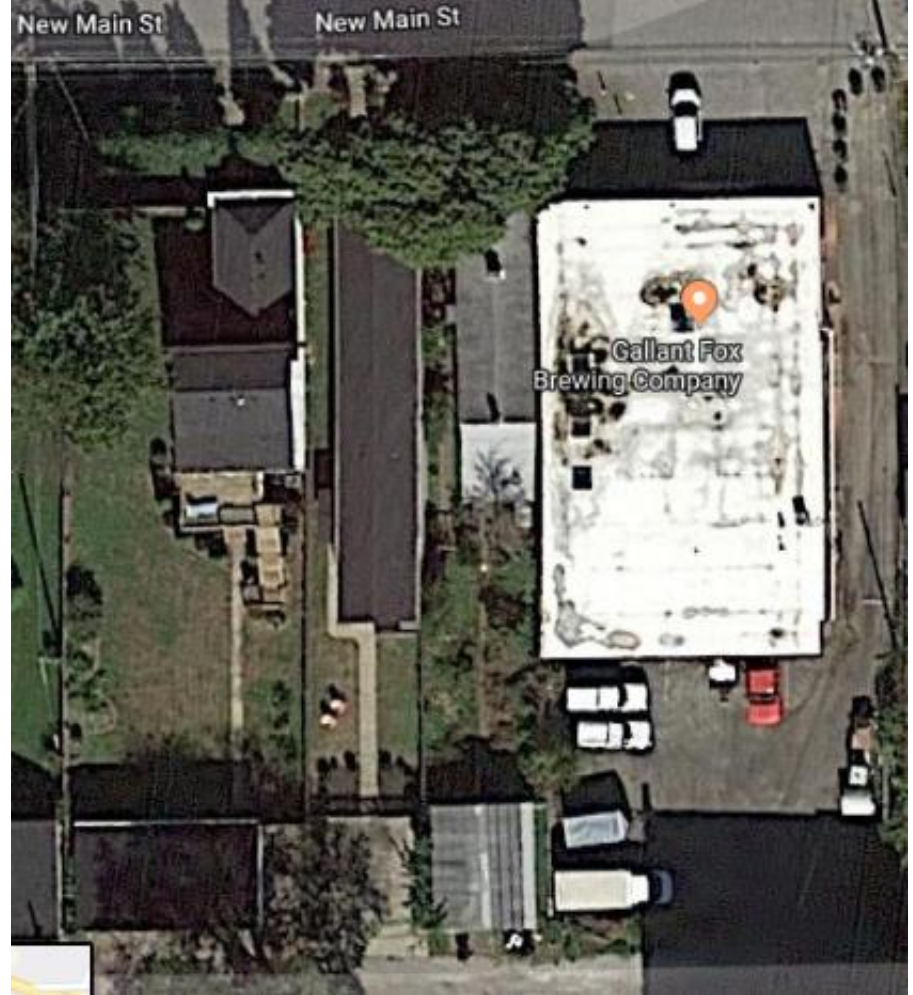
The topography... the lots slope down from north to south / road to alley. There is a 5' drop from the front of the shotgun to the original back brick wall. The flow of water is a significant factor in the damage to masonry and wood walls.

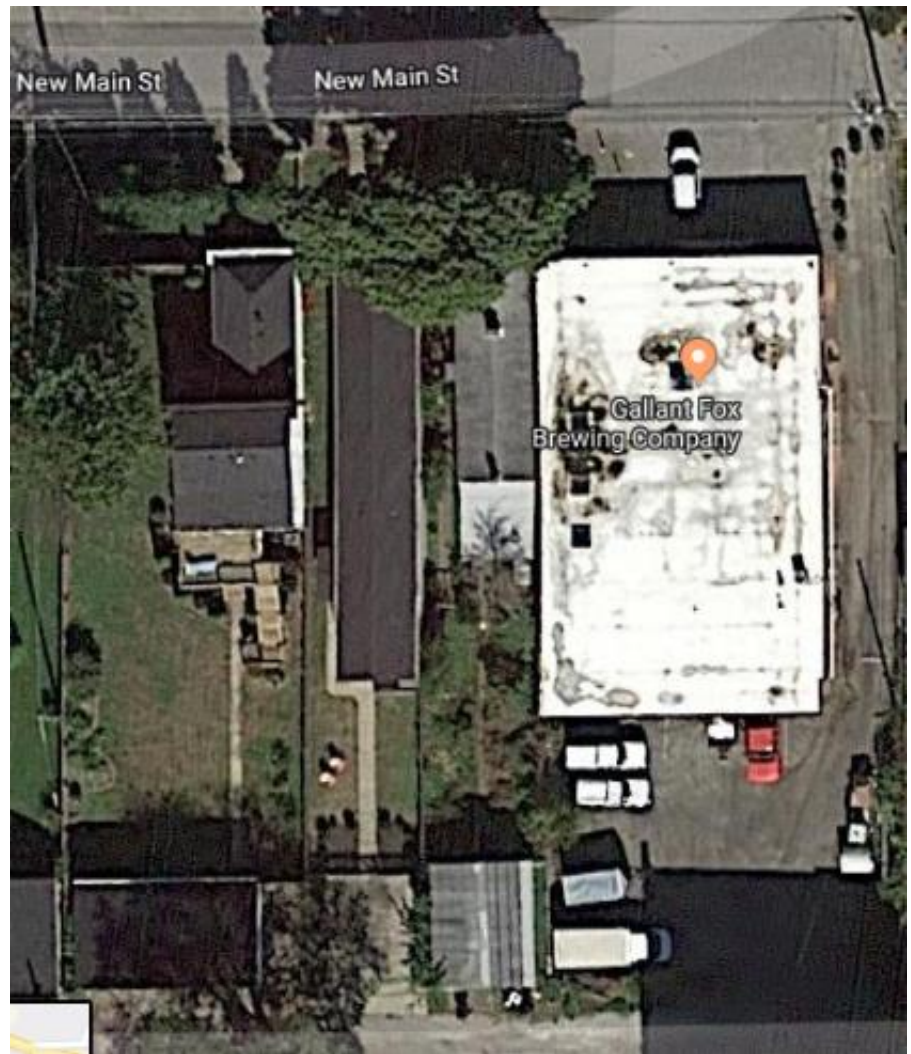
Not only are the sidewalk and road a higher elevation than the 2130 lot, so are the two neighboring lots, and the alley. The lot is a bowl collecting surface and groundwater from all directions.

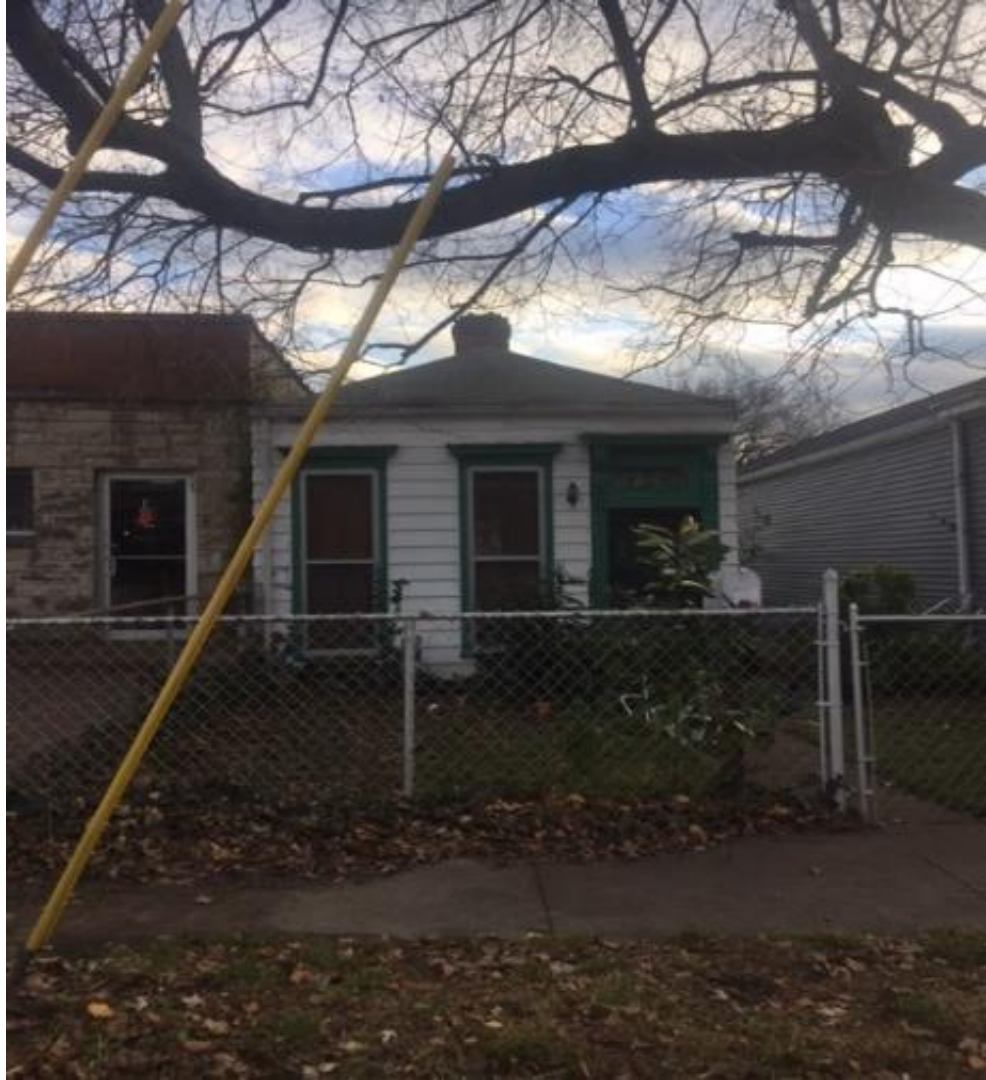
@ 1900 - the clapboard, framed shotgun was constructed on brick foundation walls with no “indication of footings ever having been constructed under any of the foundation walls” (structural engineer’s report - page 3, #4)

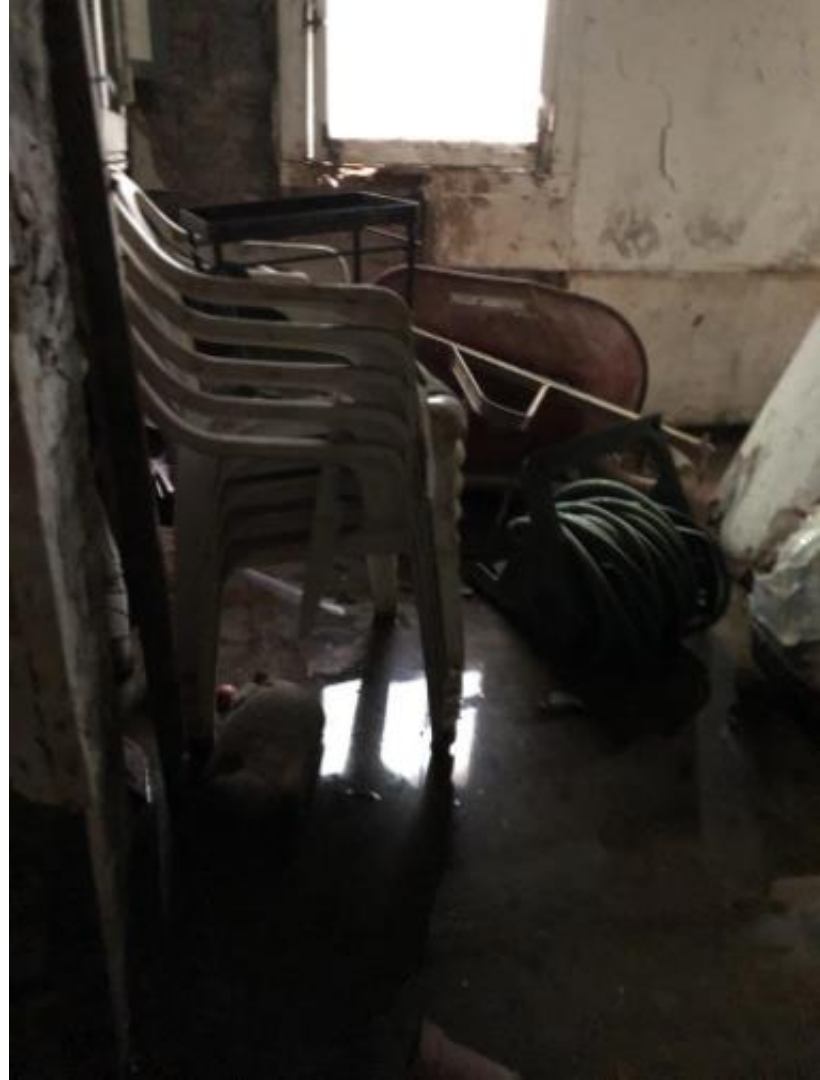
“...water seepage damage/deterioration begins at grade and has progressed to weakening the foundation of the front wall.” (p.2, #1)

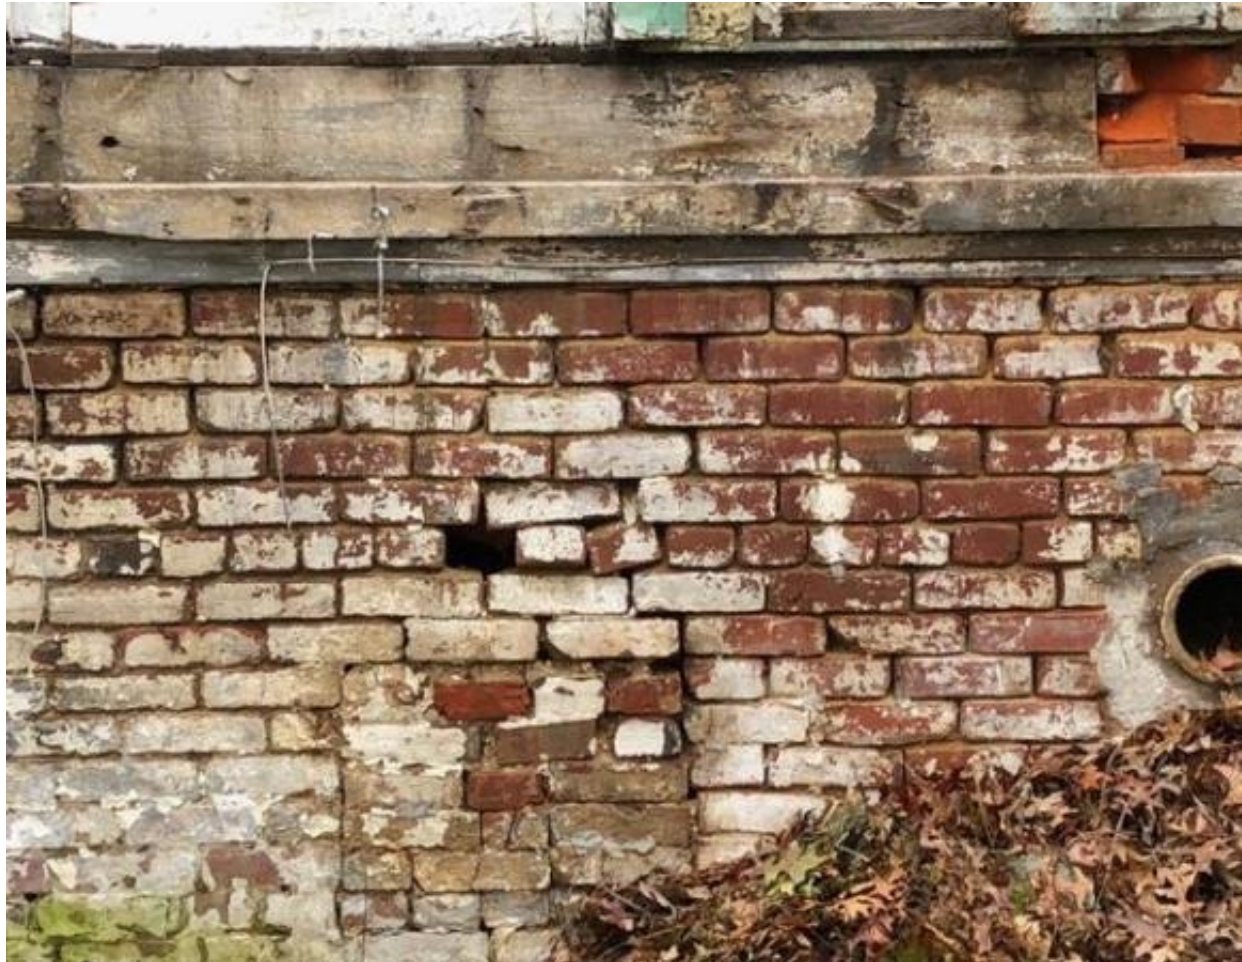
The interior base of that chimney is visible in the top right hand corner above the exterior of the south/back wall. This wall became an interior wall when the addition was built.

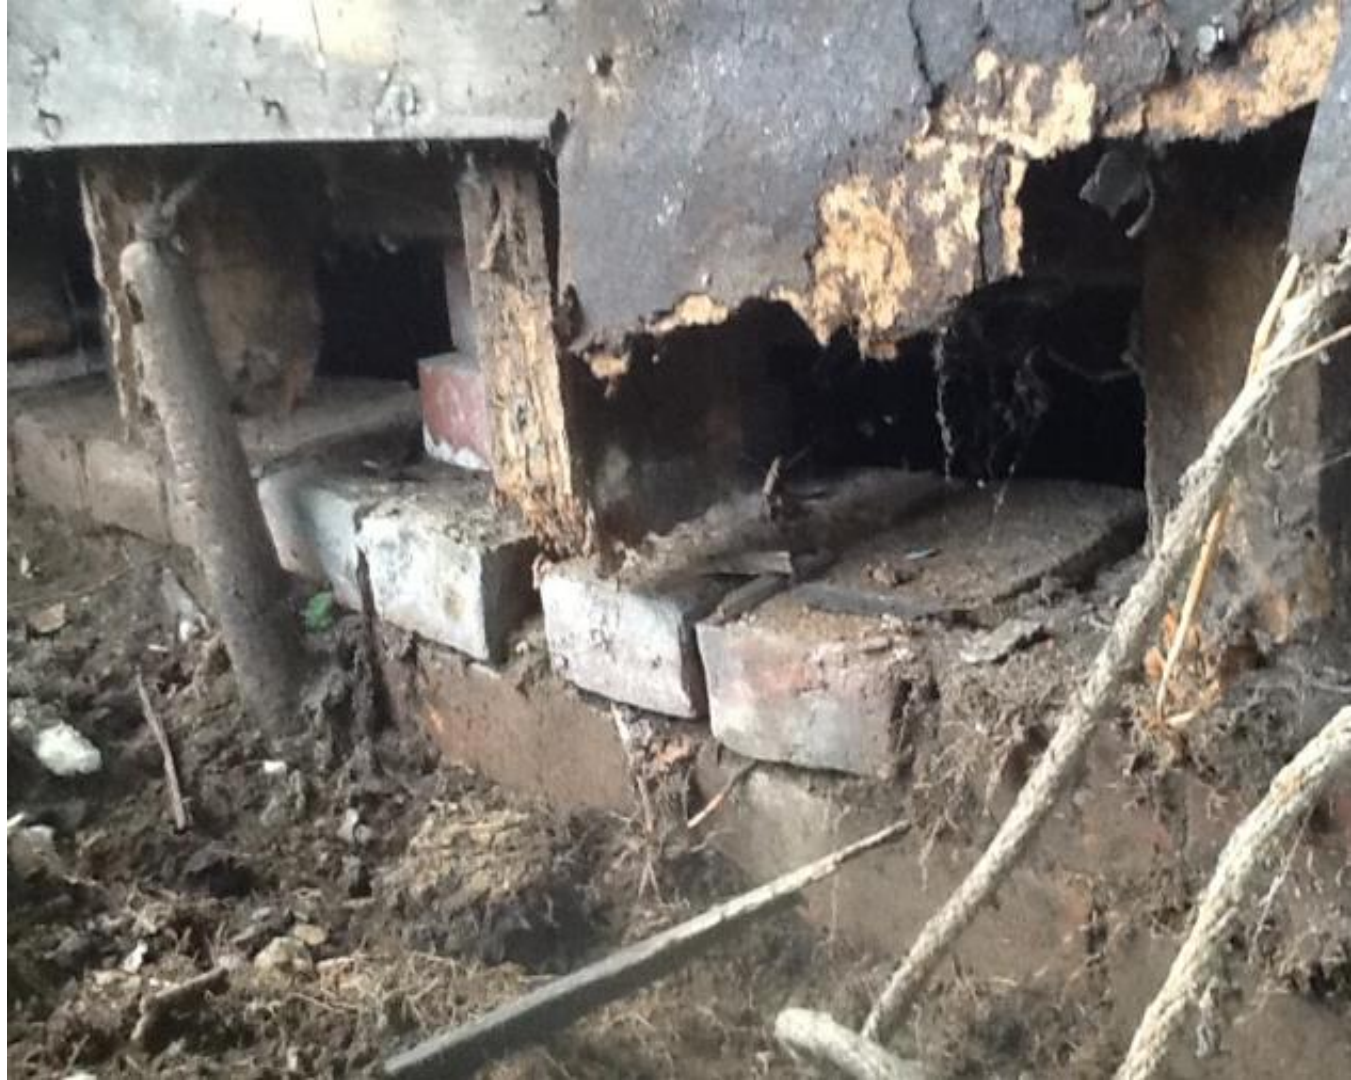
Note the  
lack of  
mortar  
between  
bricks.

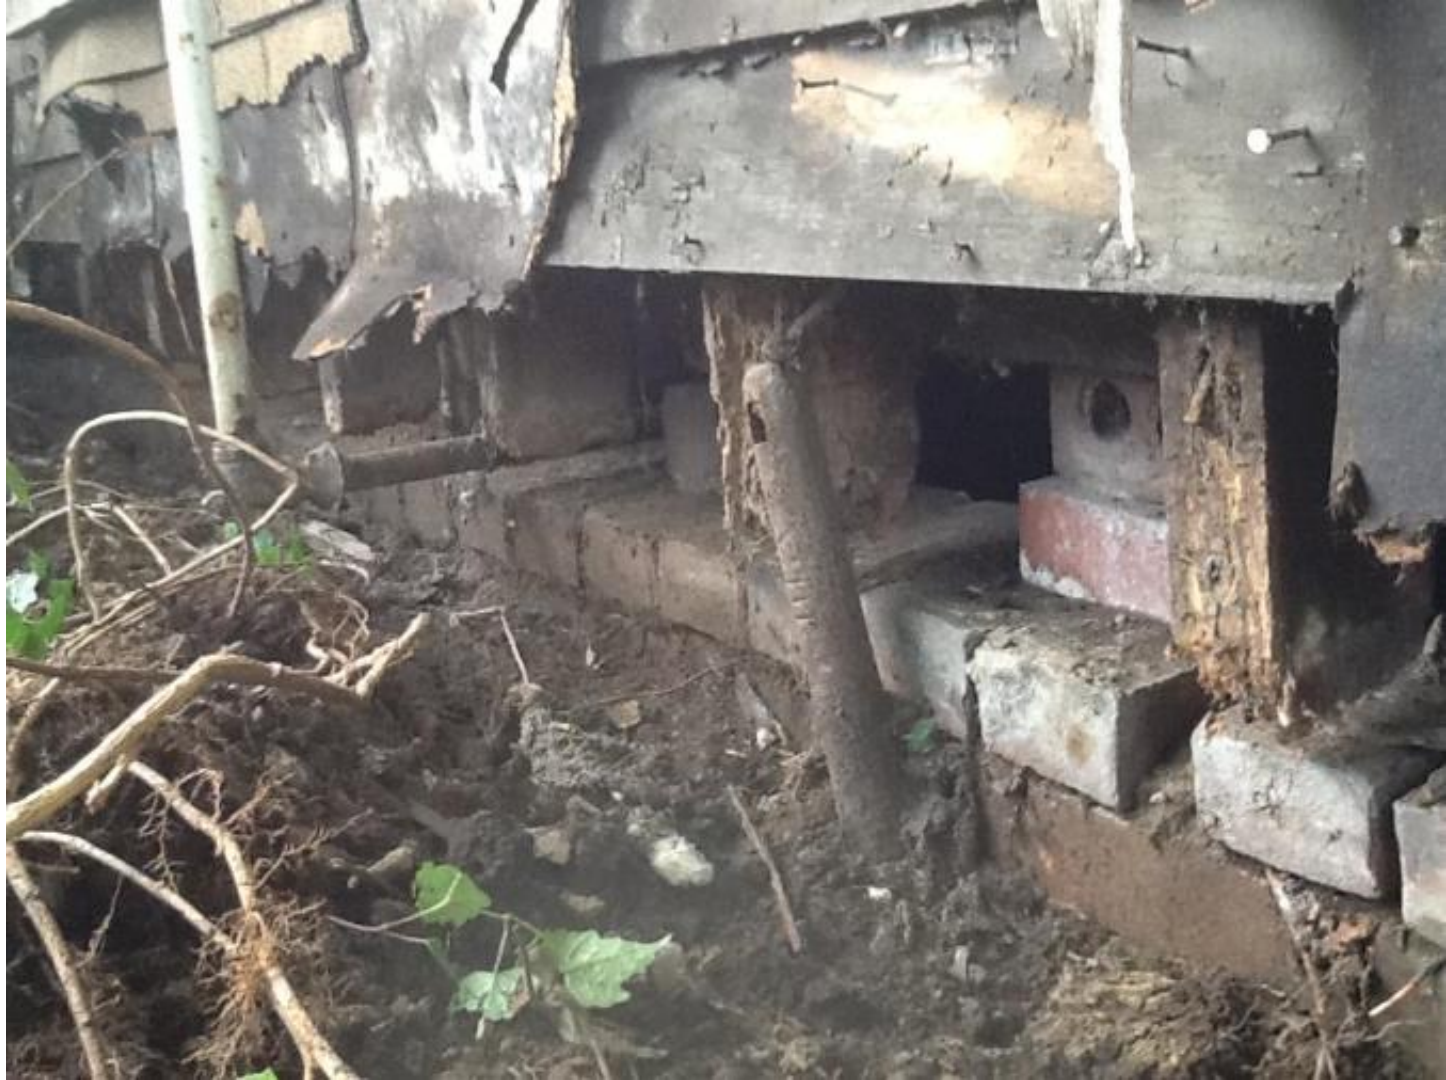
Note the  
bricks  
supporting  
the floor  
joists.

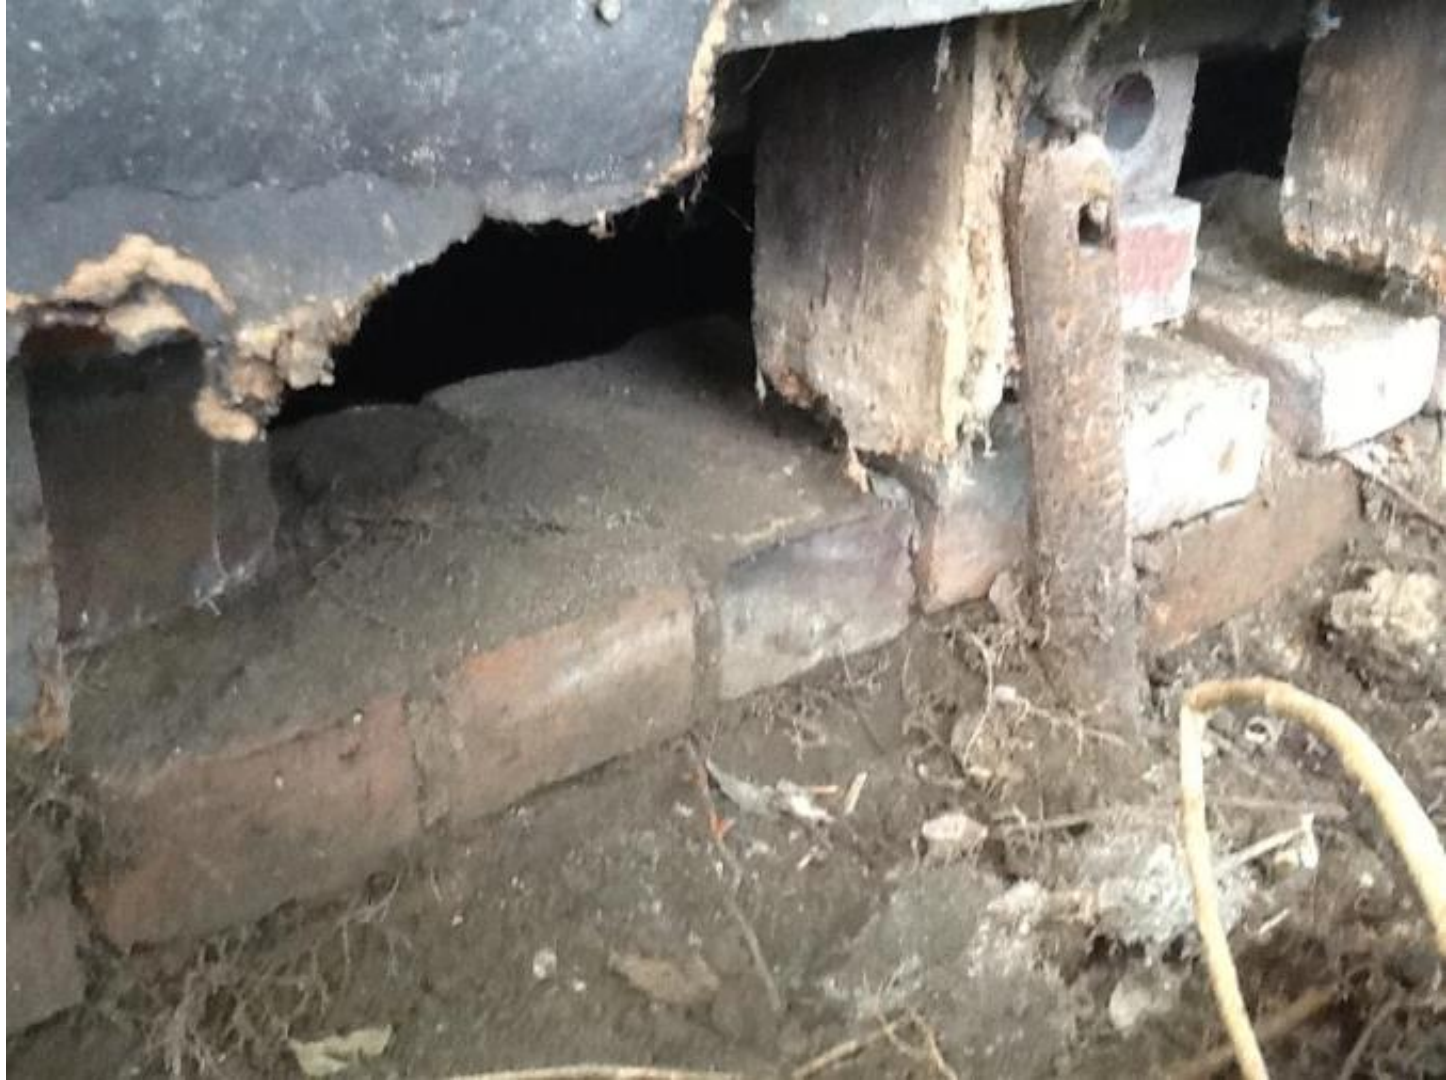
More rotted studs, no plate, and bricks supporting the floor joists.

“This wall  
hangs  
from the  
roof  
structure.”  
(p.3, #3)

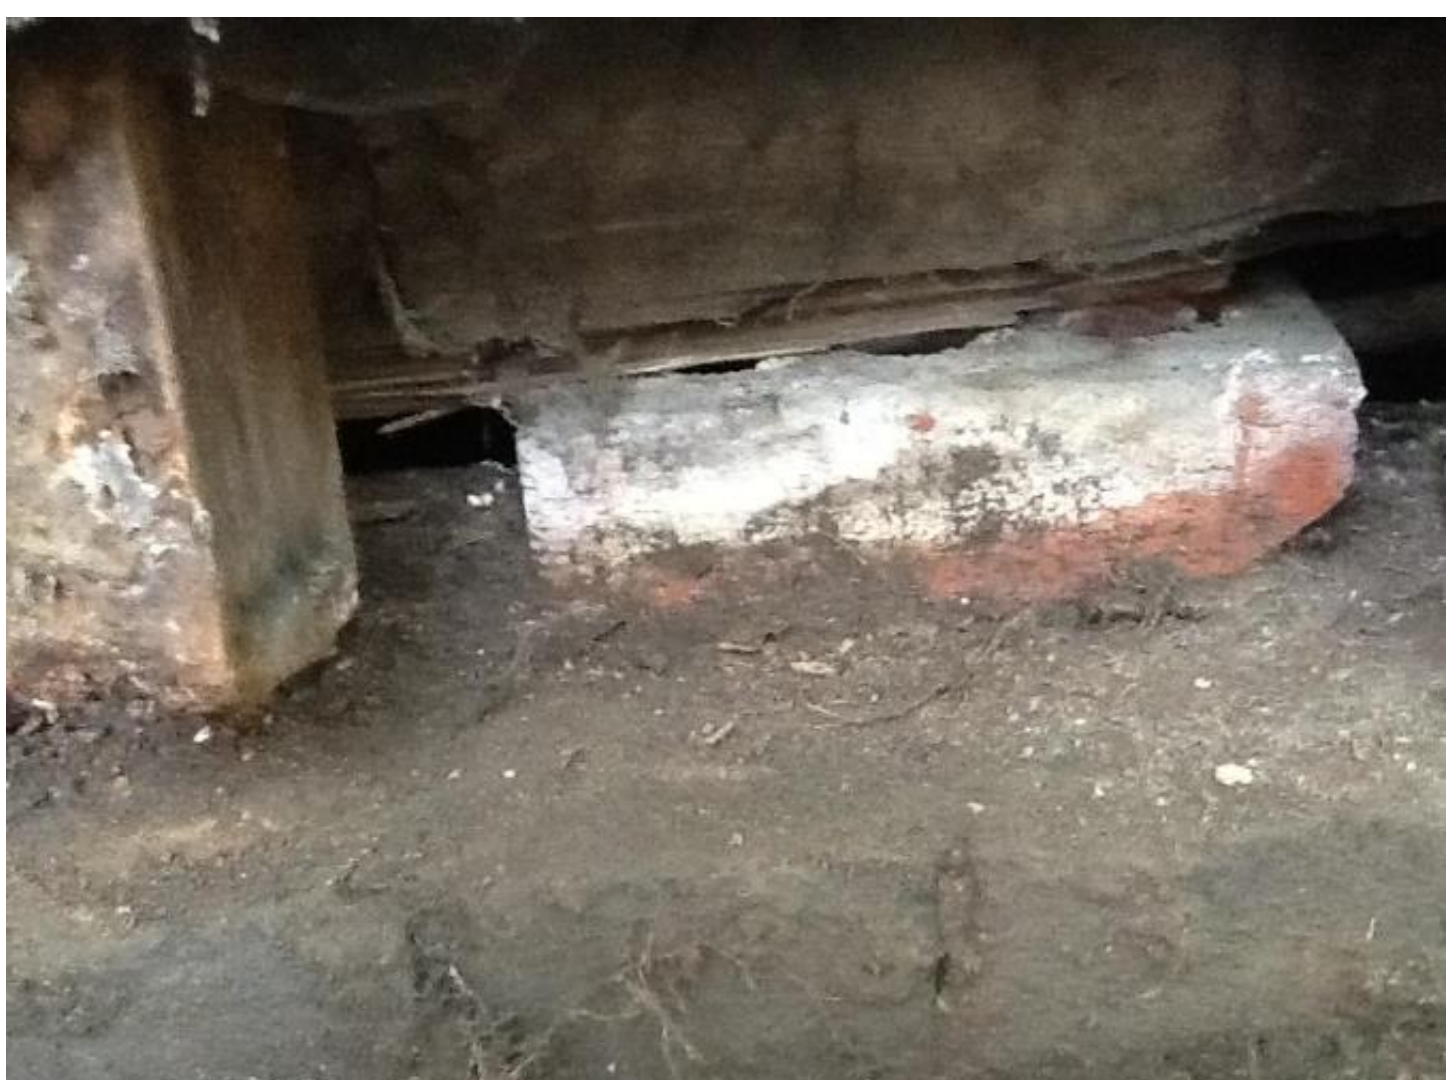
Even the floor joists are rotted away, left suspended above the well intentioned brick.

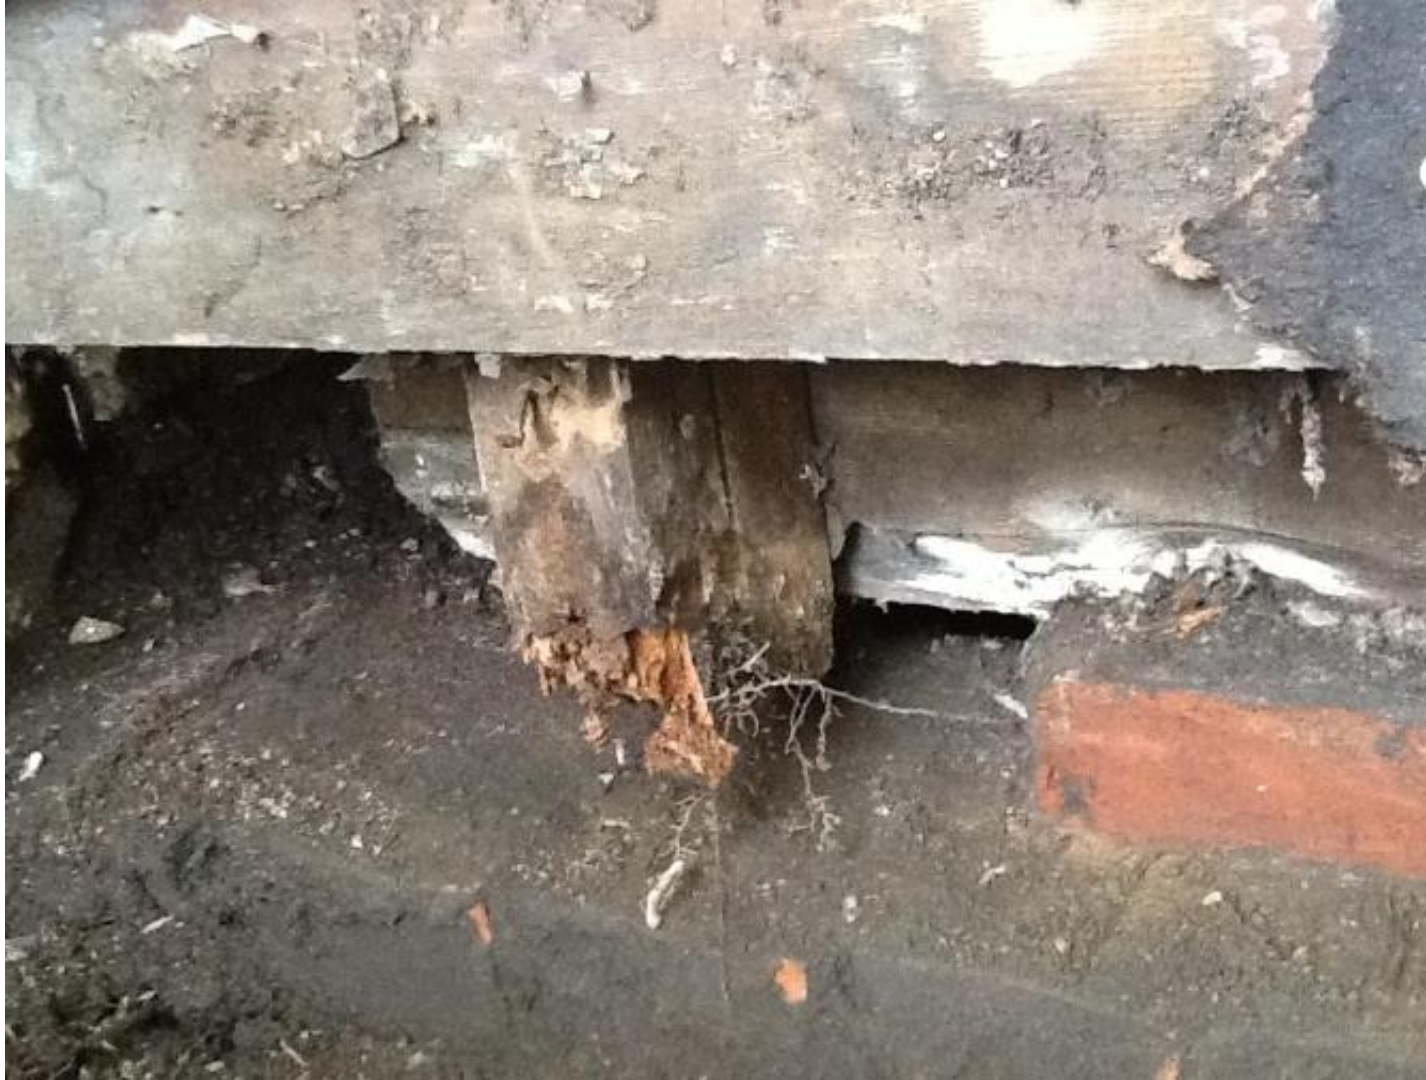
“This wall  
is not in  
contact  
with the  
existing  
foundation”  
(p.3, #3)

This  
damage  
predates  
2019 by  
several  
decades.

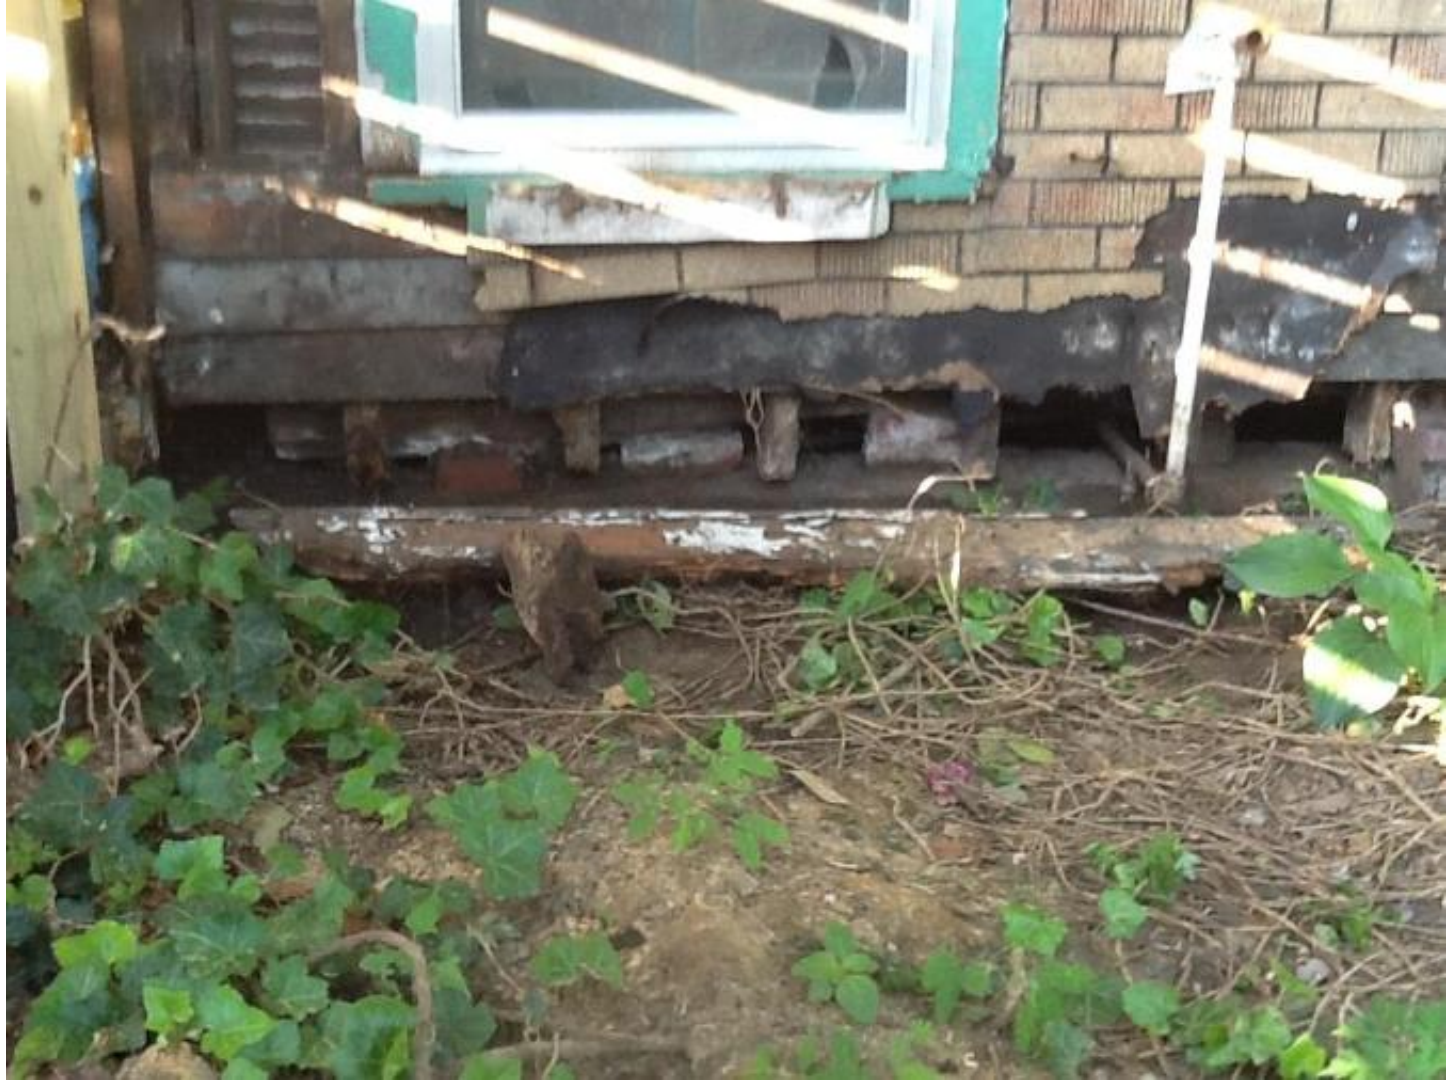
The N wall hangs, suspended in mid air. Removal of the aluminum siding to the east/left of the window revealed the interior lathing and plaster.

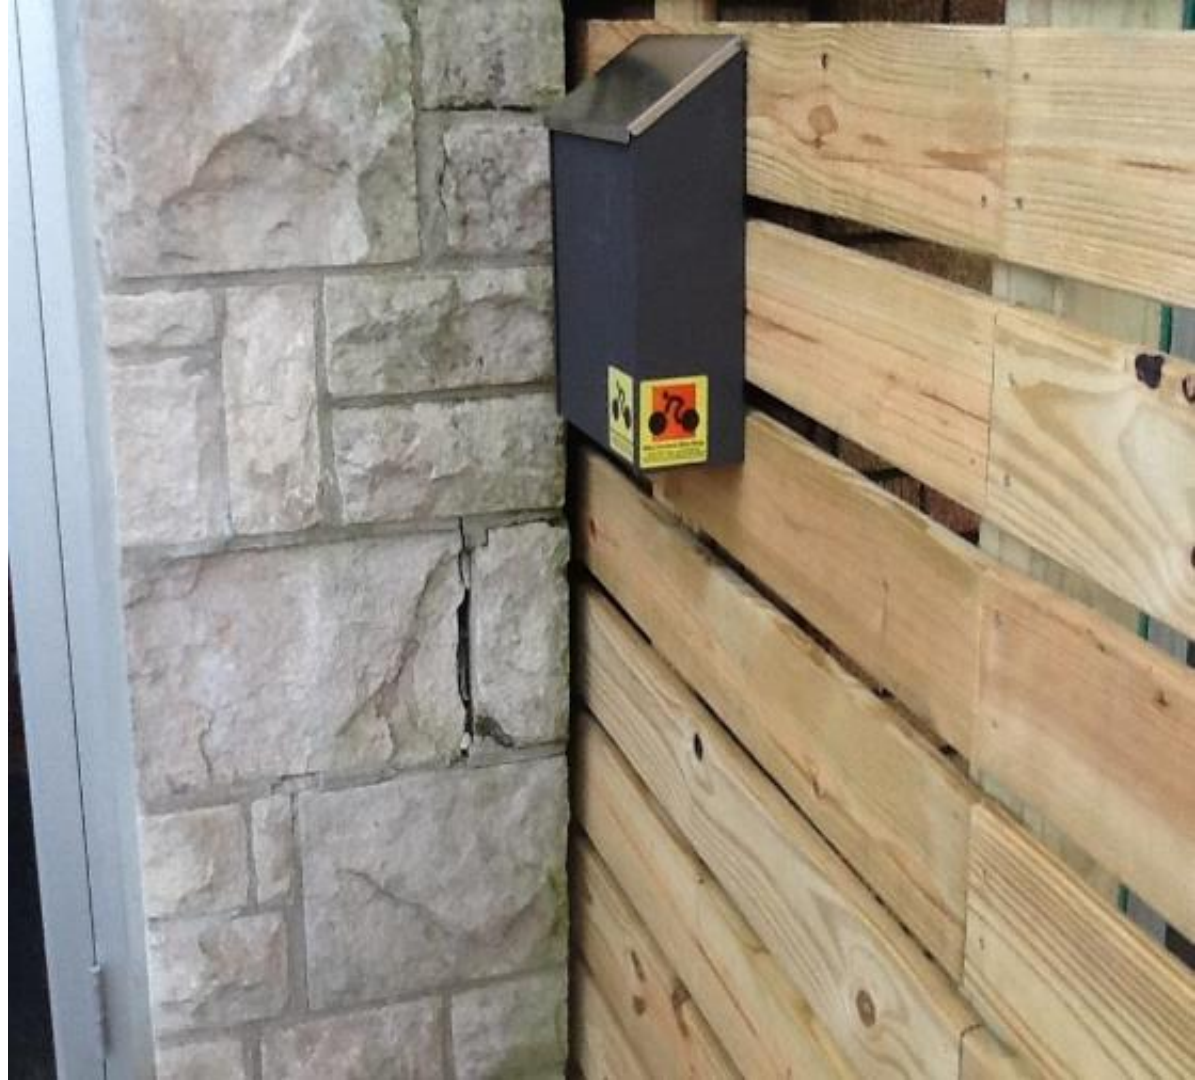
Replacing the missing mortar can be done only on the accessible north wall. The west wall damage is inaccessible.

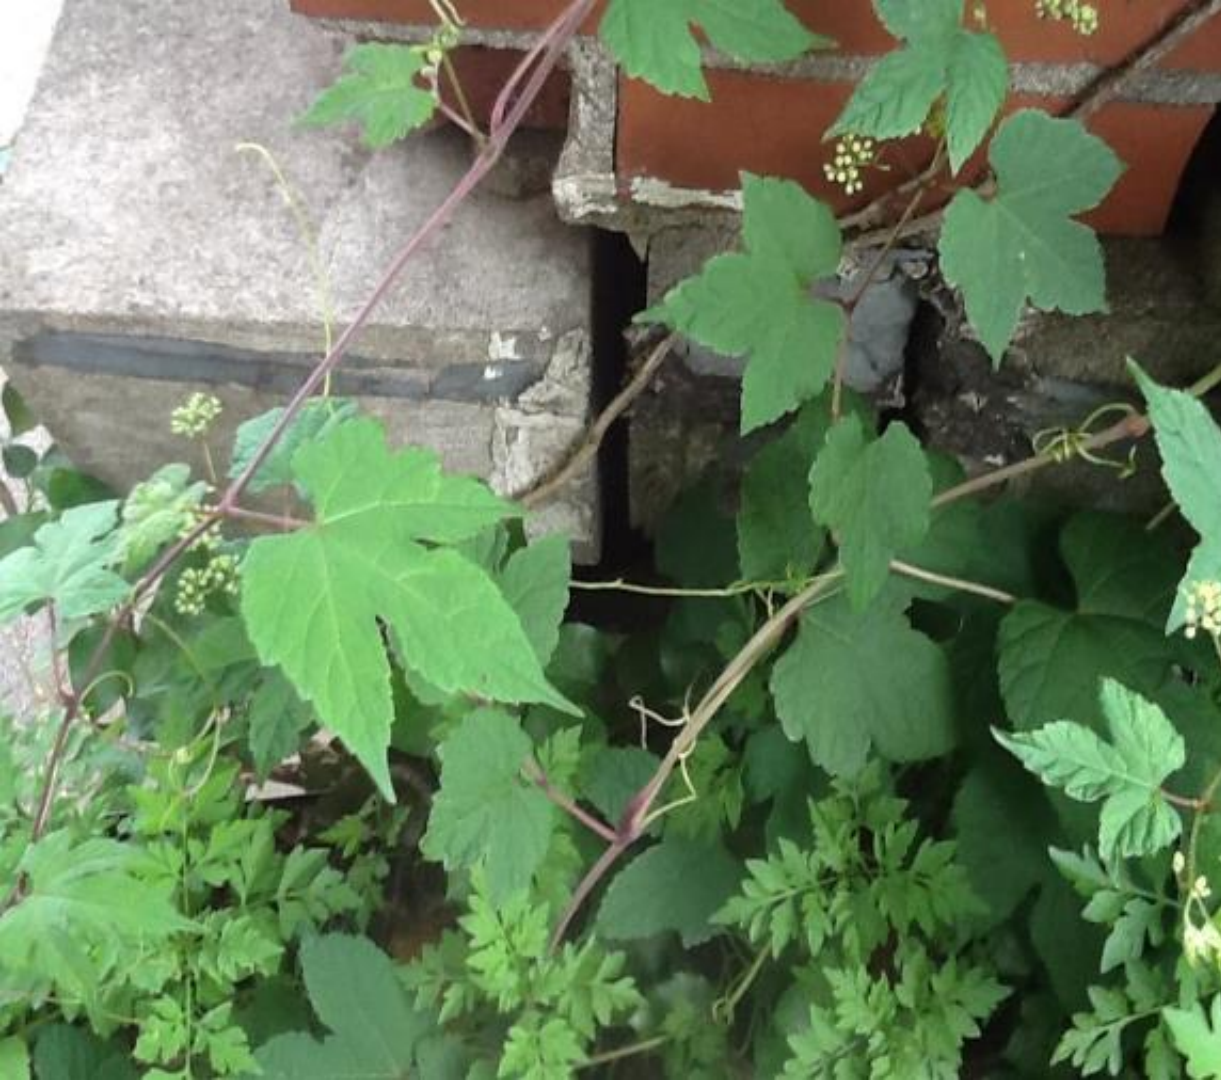
Seventy years of water between the two structures resulted in visible damage to the USPO wall and invisible damage to the walls and foundations below the 'valley'.

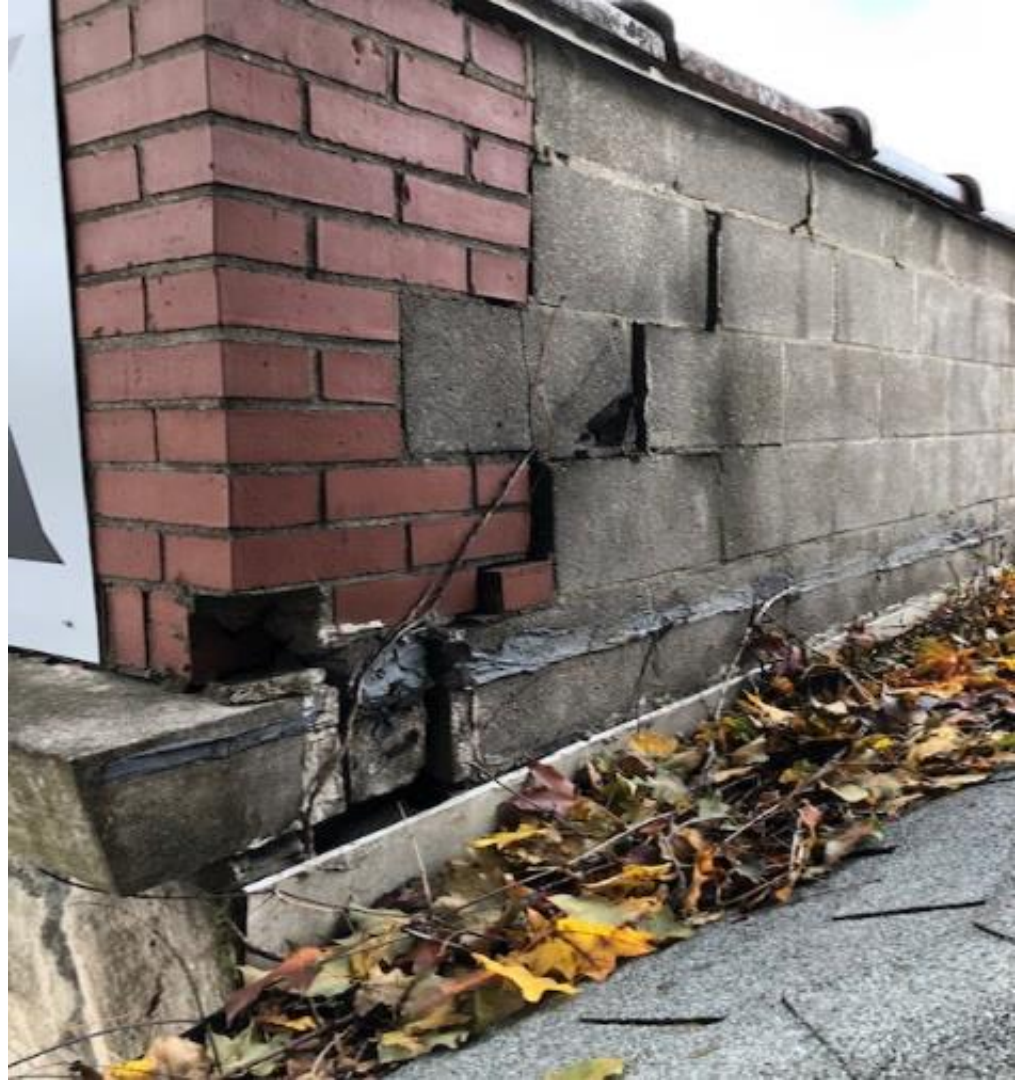
Damage  
visible  
behind  
spring  
foliage at the  
front corner  
of the USPO

This image was taken after removing accumulated debris and installing flashing. You can see a week's worth of fall maple leaves in the 'valley'. While leaf removal is a weekly contest in autumn, the bigger issue is the damage to the shifting wall, and possibly to the foundation of the USPO.

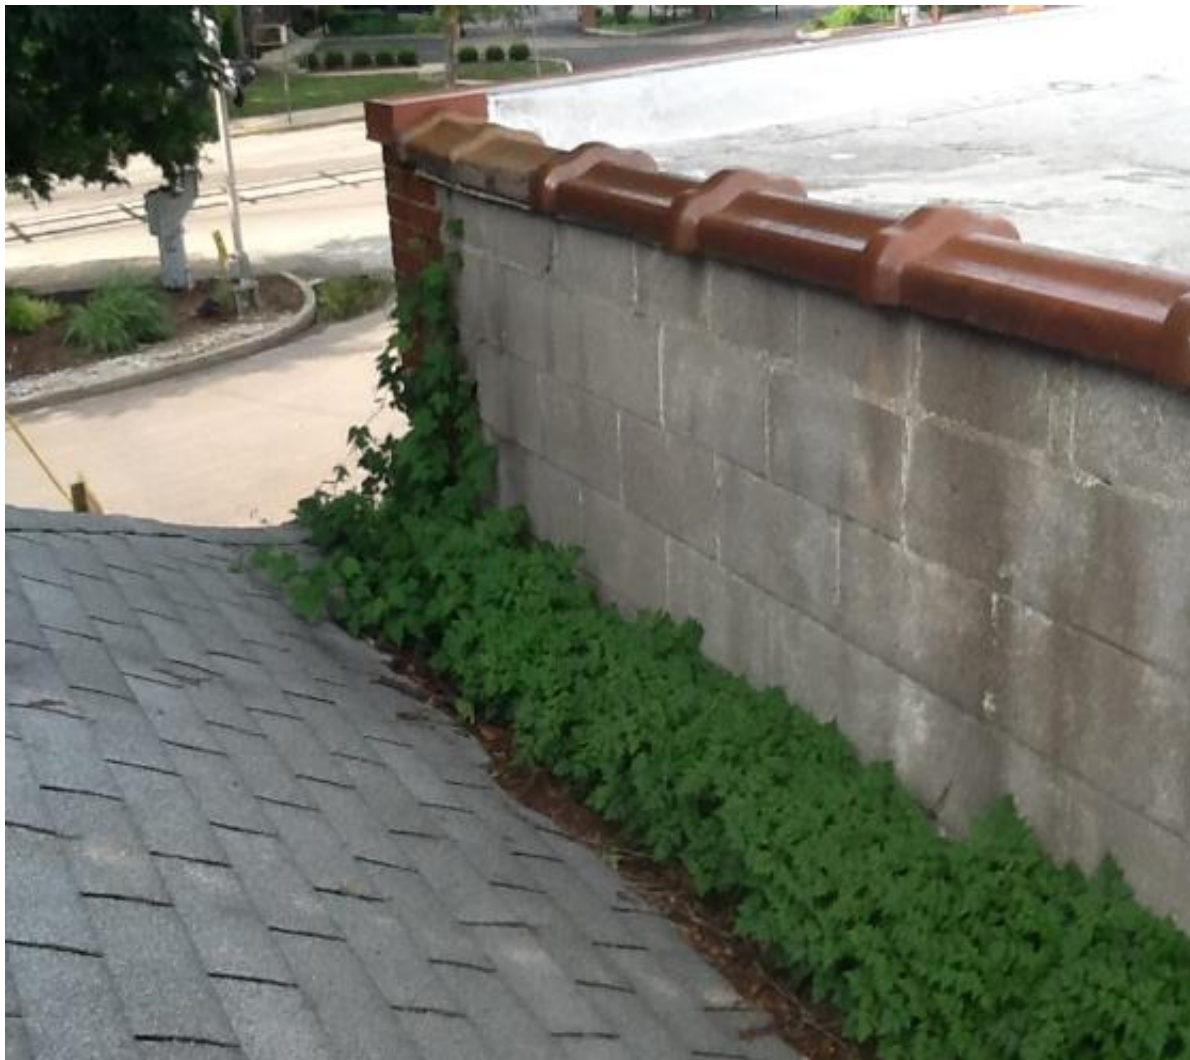
The west wall and foundation of the USPO need to be accessible below the 'valley'. The only way to gain access is by demolishing the east wall of the shotgun.

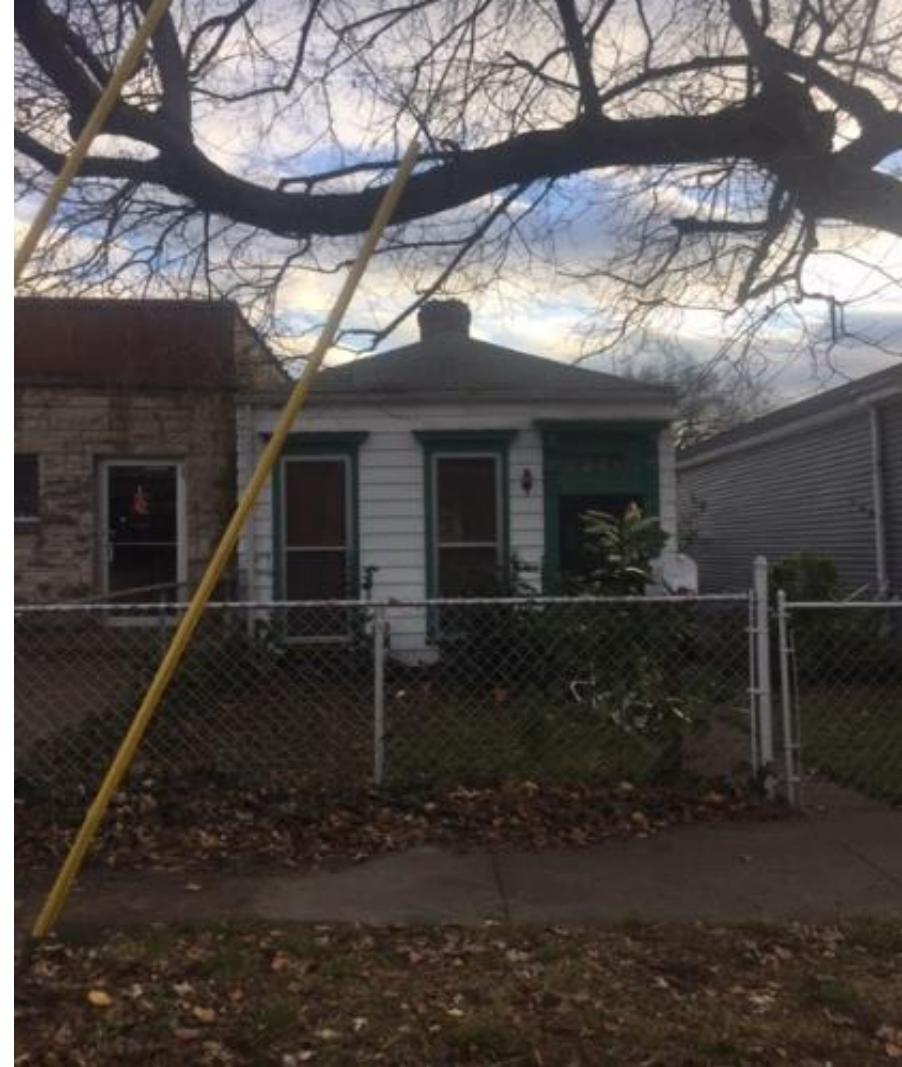
Compare the height of the window sill to the threshold of the USPO door. The parking lot of the USPO is a foot higher than the front yard of 2130. The sidewalk and the road are eight inches higher. The front yard of 2128 (to the west/right) is a bit higher. All that rain and melted snow find their way to the lowest spot - the front yard of 2130 New Main Street. Then the water begins a surface and underground migration into the shotgun's basement.

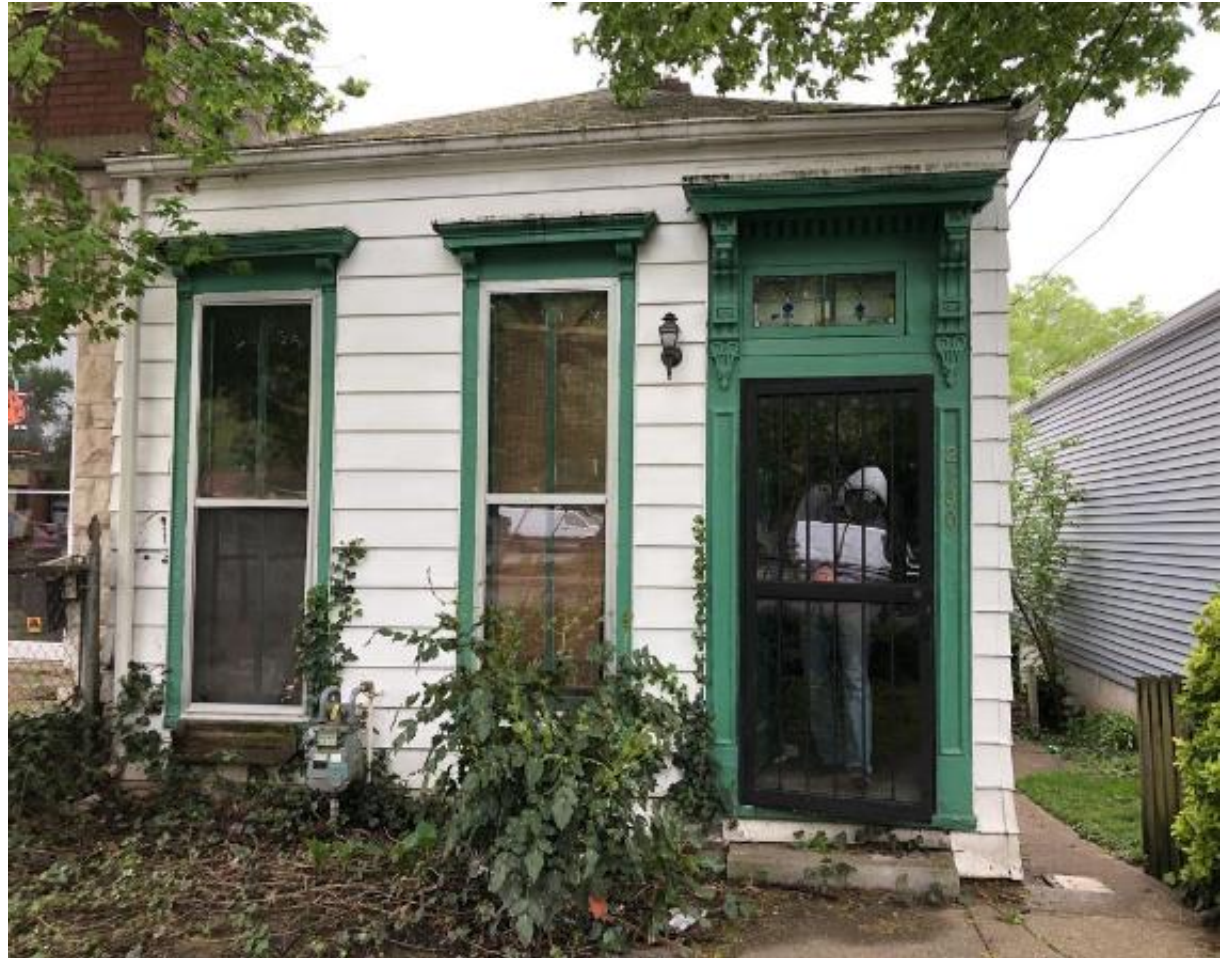
A closer view for comparison between the height of the window sill and the threshold of the USPO door. The latter is a foot higher.
