# Demolition Request

## 2130 New Main Street

# Objective: Urban Greenspace 2130 New Main Street

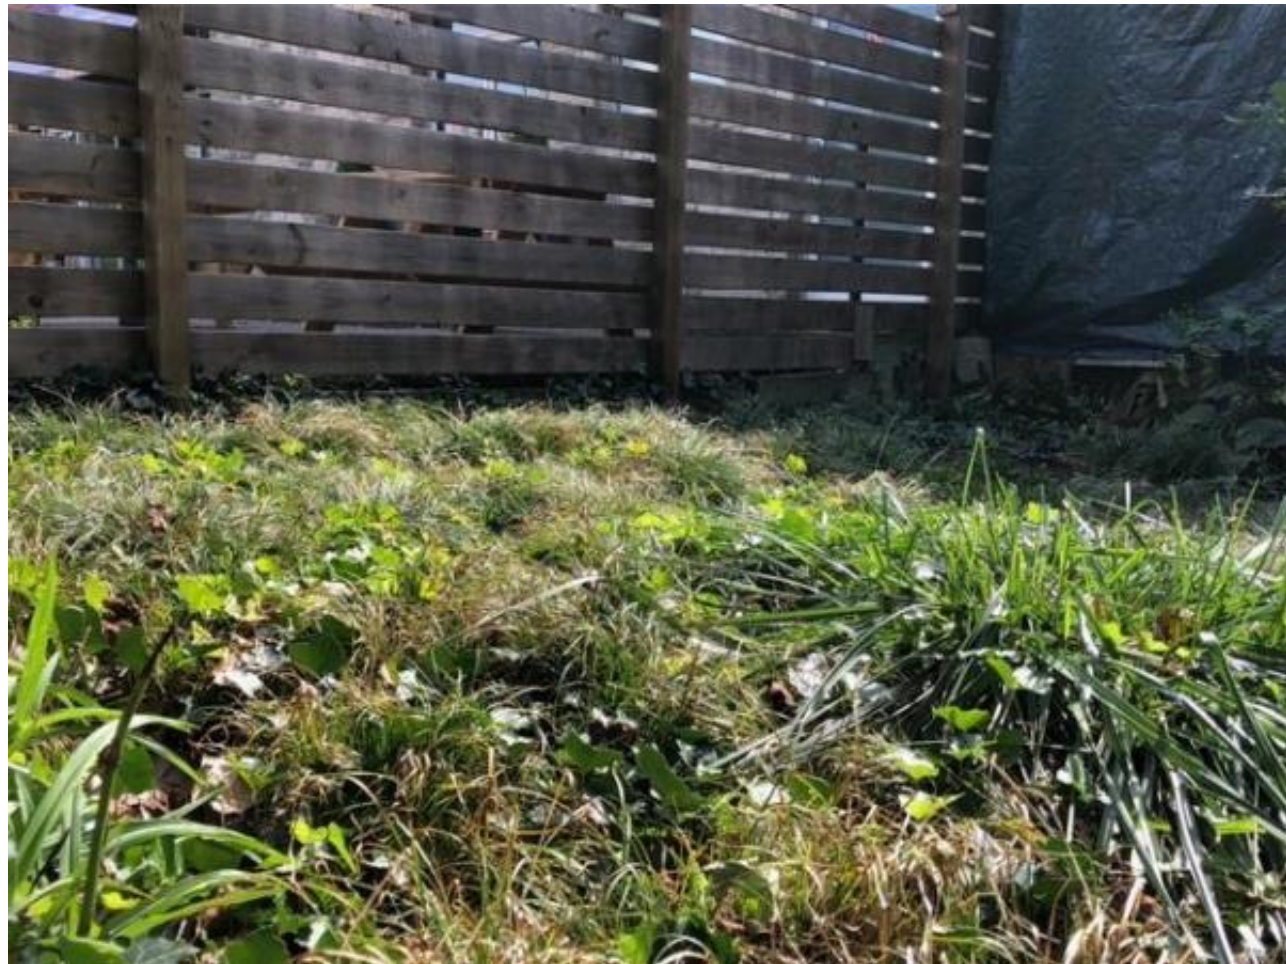
The bottom of the USPO door is the shiny horizontal line seen between the fence slats. Note how low the yard is.

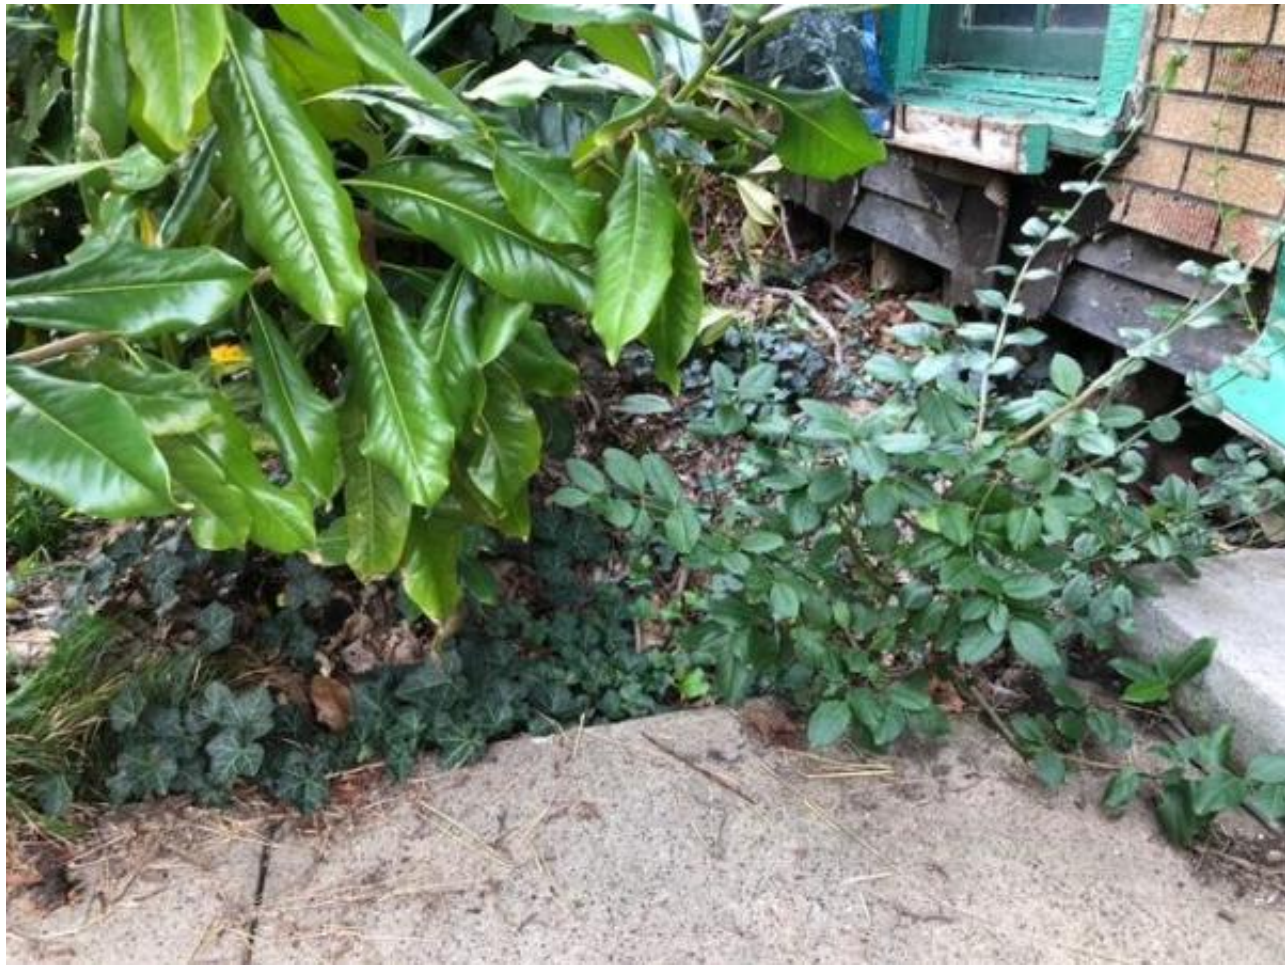
The front yard has begun to sink lower than the walk leading to the front door. Along with the rain and melted snow, the soil is infiltrating the basement.

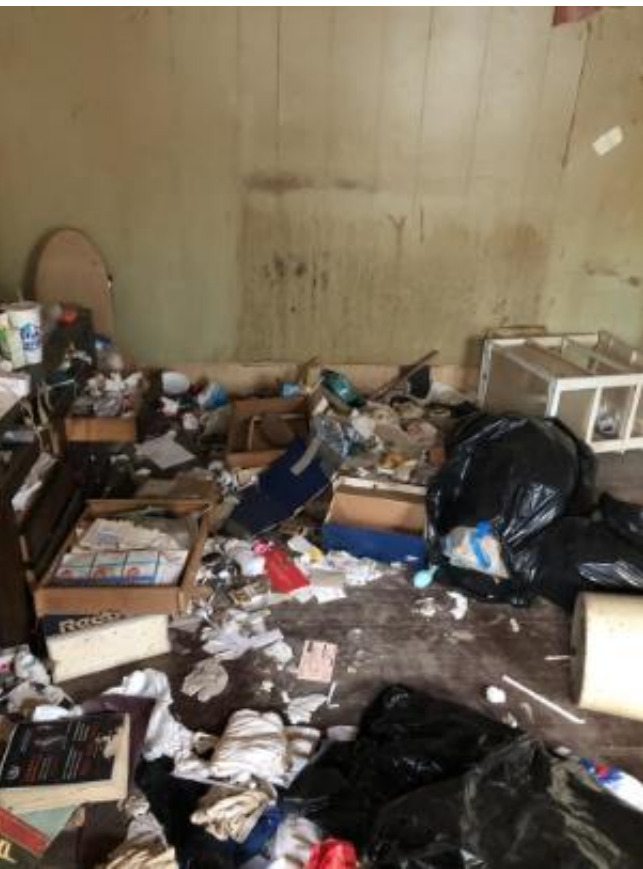
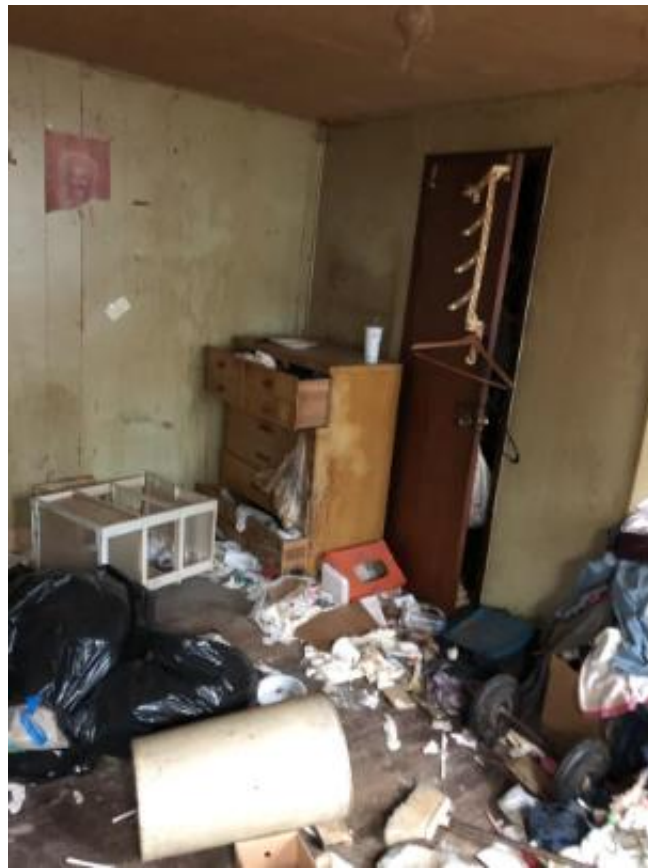
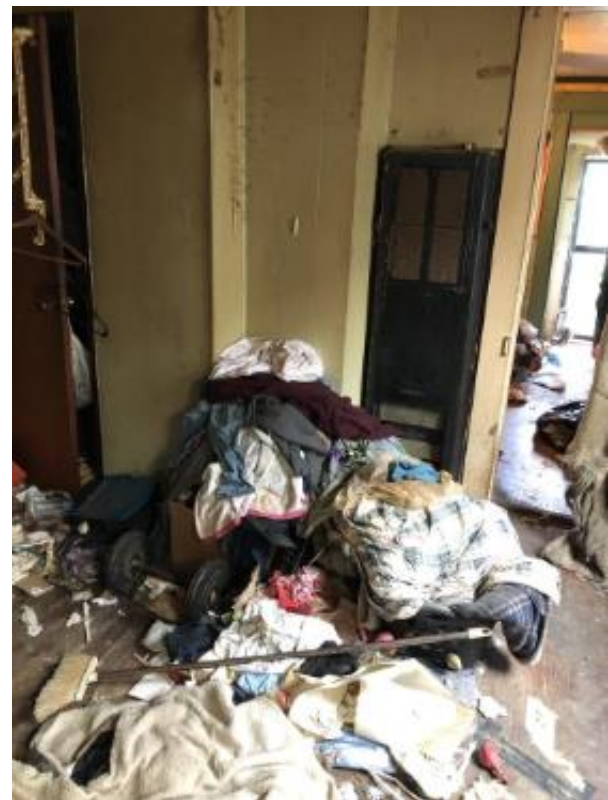
Second Bedroom

Still in the second  
bedroom.

Beyond the quilt  
nailed over the  
doorway is the  
kitchen.

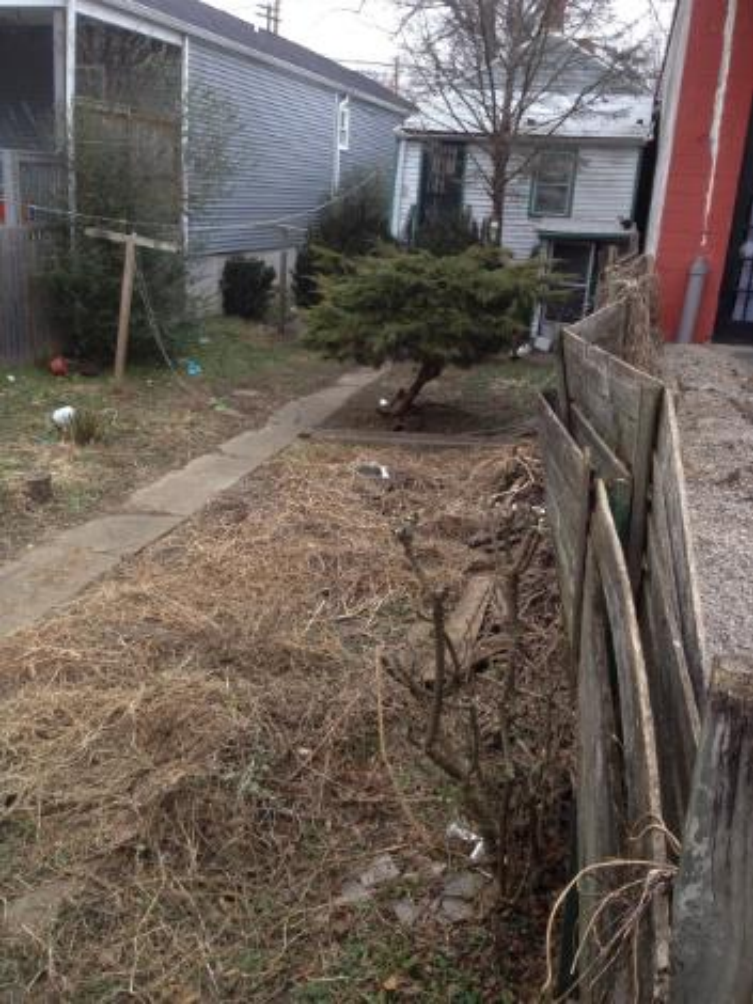
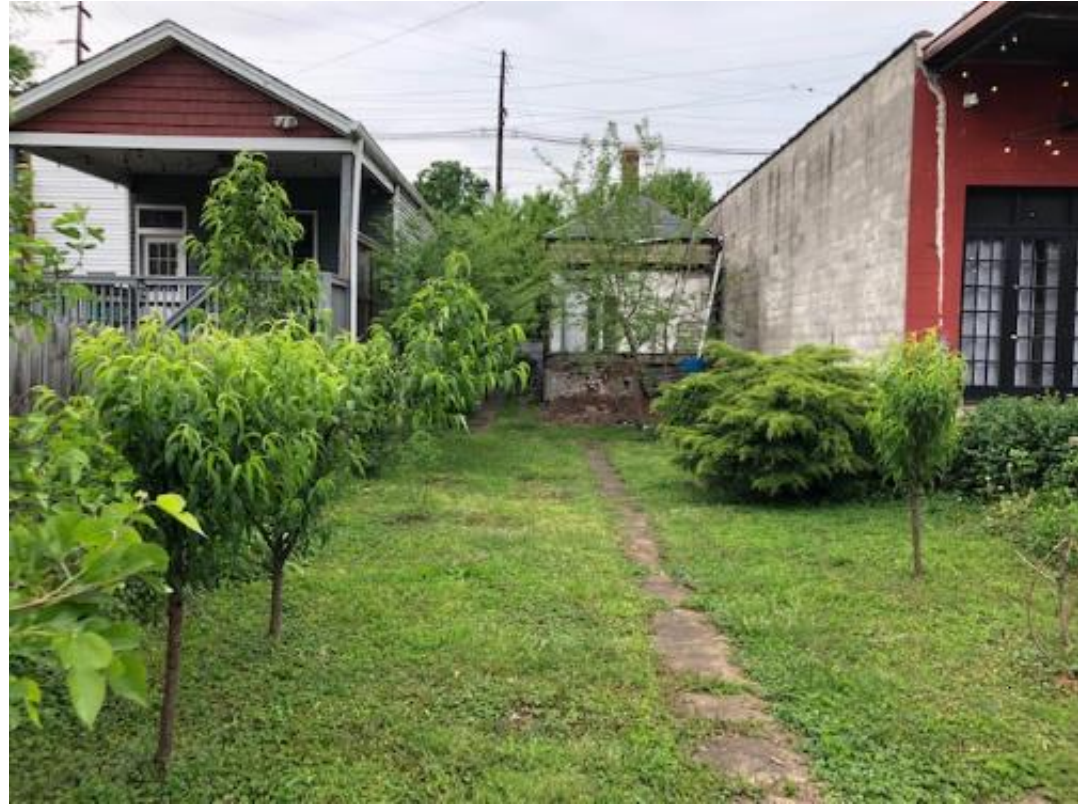
< The back yard at purchase.  
v The back yard today.
