RE: Hogan's Fountain Teepee Pavilion, Cherokee Park

## Memo

**Re.** Cherokee Park Hogan's Fountain Pavilion

**Subject:** Cherokee Park, Hogan's Fountain Teepee Pavilion Reassessment

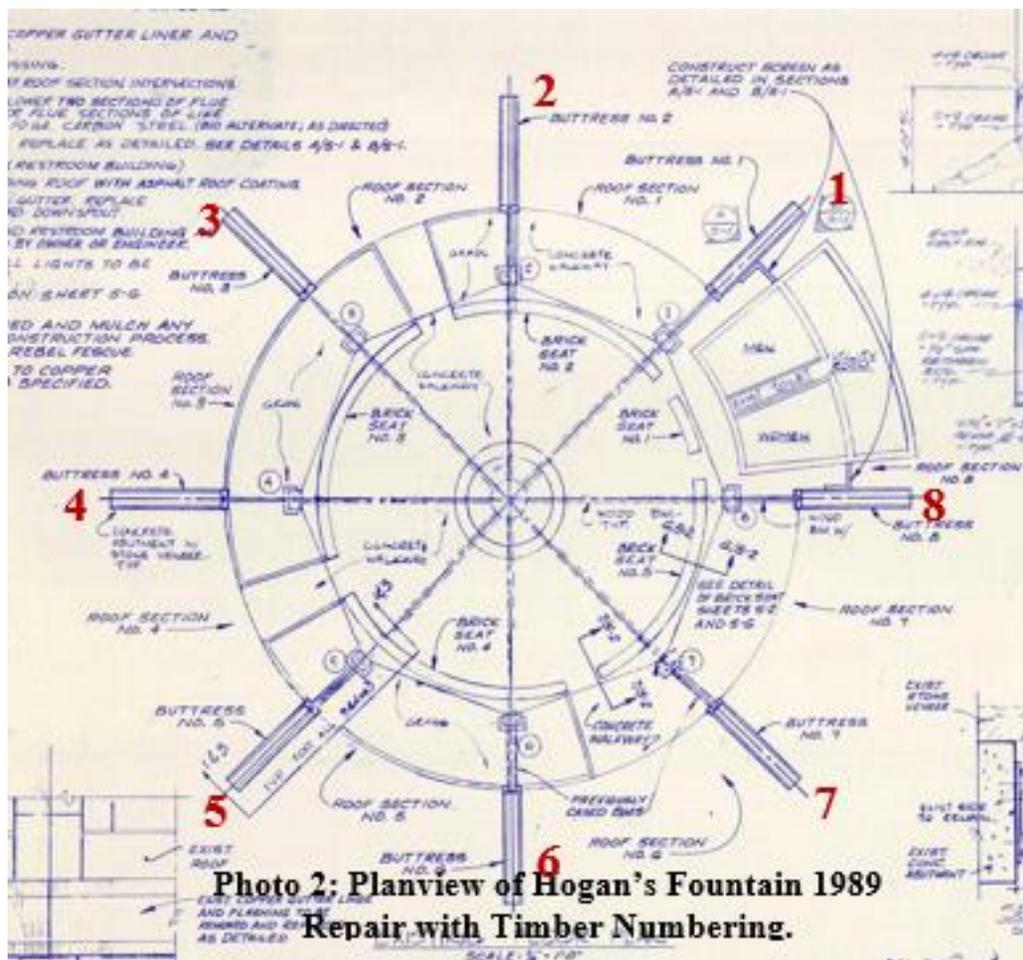
**Photo 1: Hogan's Fountain- Eight timbered legs encased in ½" steel.**

throughout. Due to the recent movement of the structural timbers, Wood was requested to evaluate the condition of the encased timbers and to determine if the timbers have experienced deterioration. Wood hired subcontractor, Concrete Coring & Cutting, to drill 2-inch diameter holes in the ½-inch steel casing to evaluate the wood condition. The following provides a brief overview of our results. For this evaluation, Wood used the same naming nomenclature used on the 1989 plans.

Based on our evaluation, the wood encased in the steel has experienced severe deterioration and therefore is not structurally sound. Repair options should not utilize this section of wood as a structural component. In addition, in several areas, the wood above the steel is showing signs of distress (delamination, darkening of the wood from possible water damage, etc.).
