Fuller
Mossbarger
Scott &
May

August 14, 1997

Re: Sinkhole Review
Lots 21, 22, 23 and 28
Blankenbaker Commerce Centre
Jefferson County, Kentucky

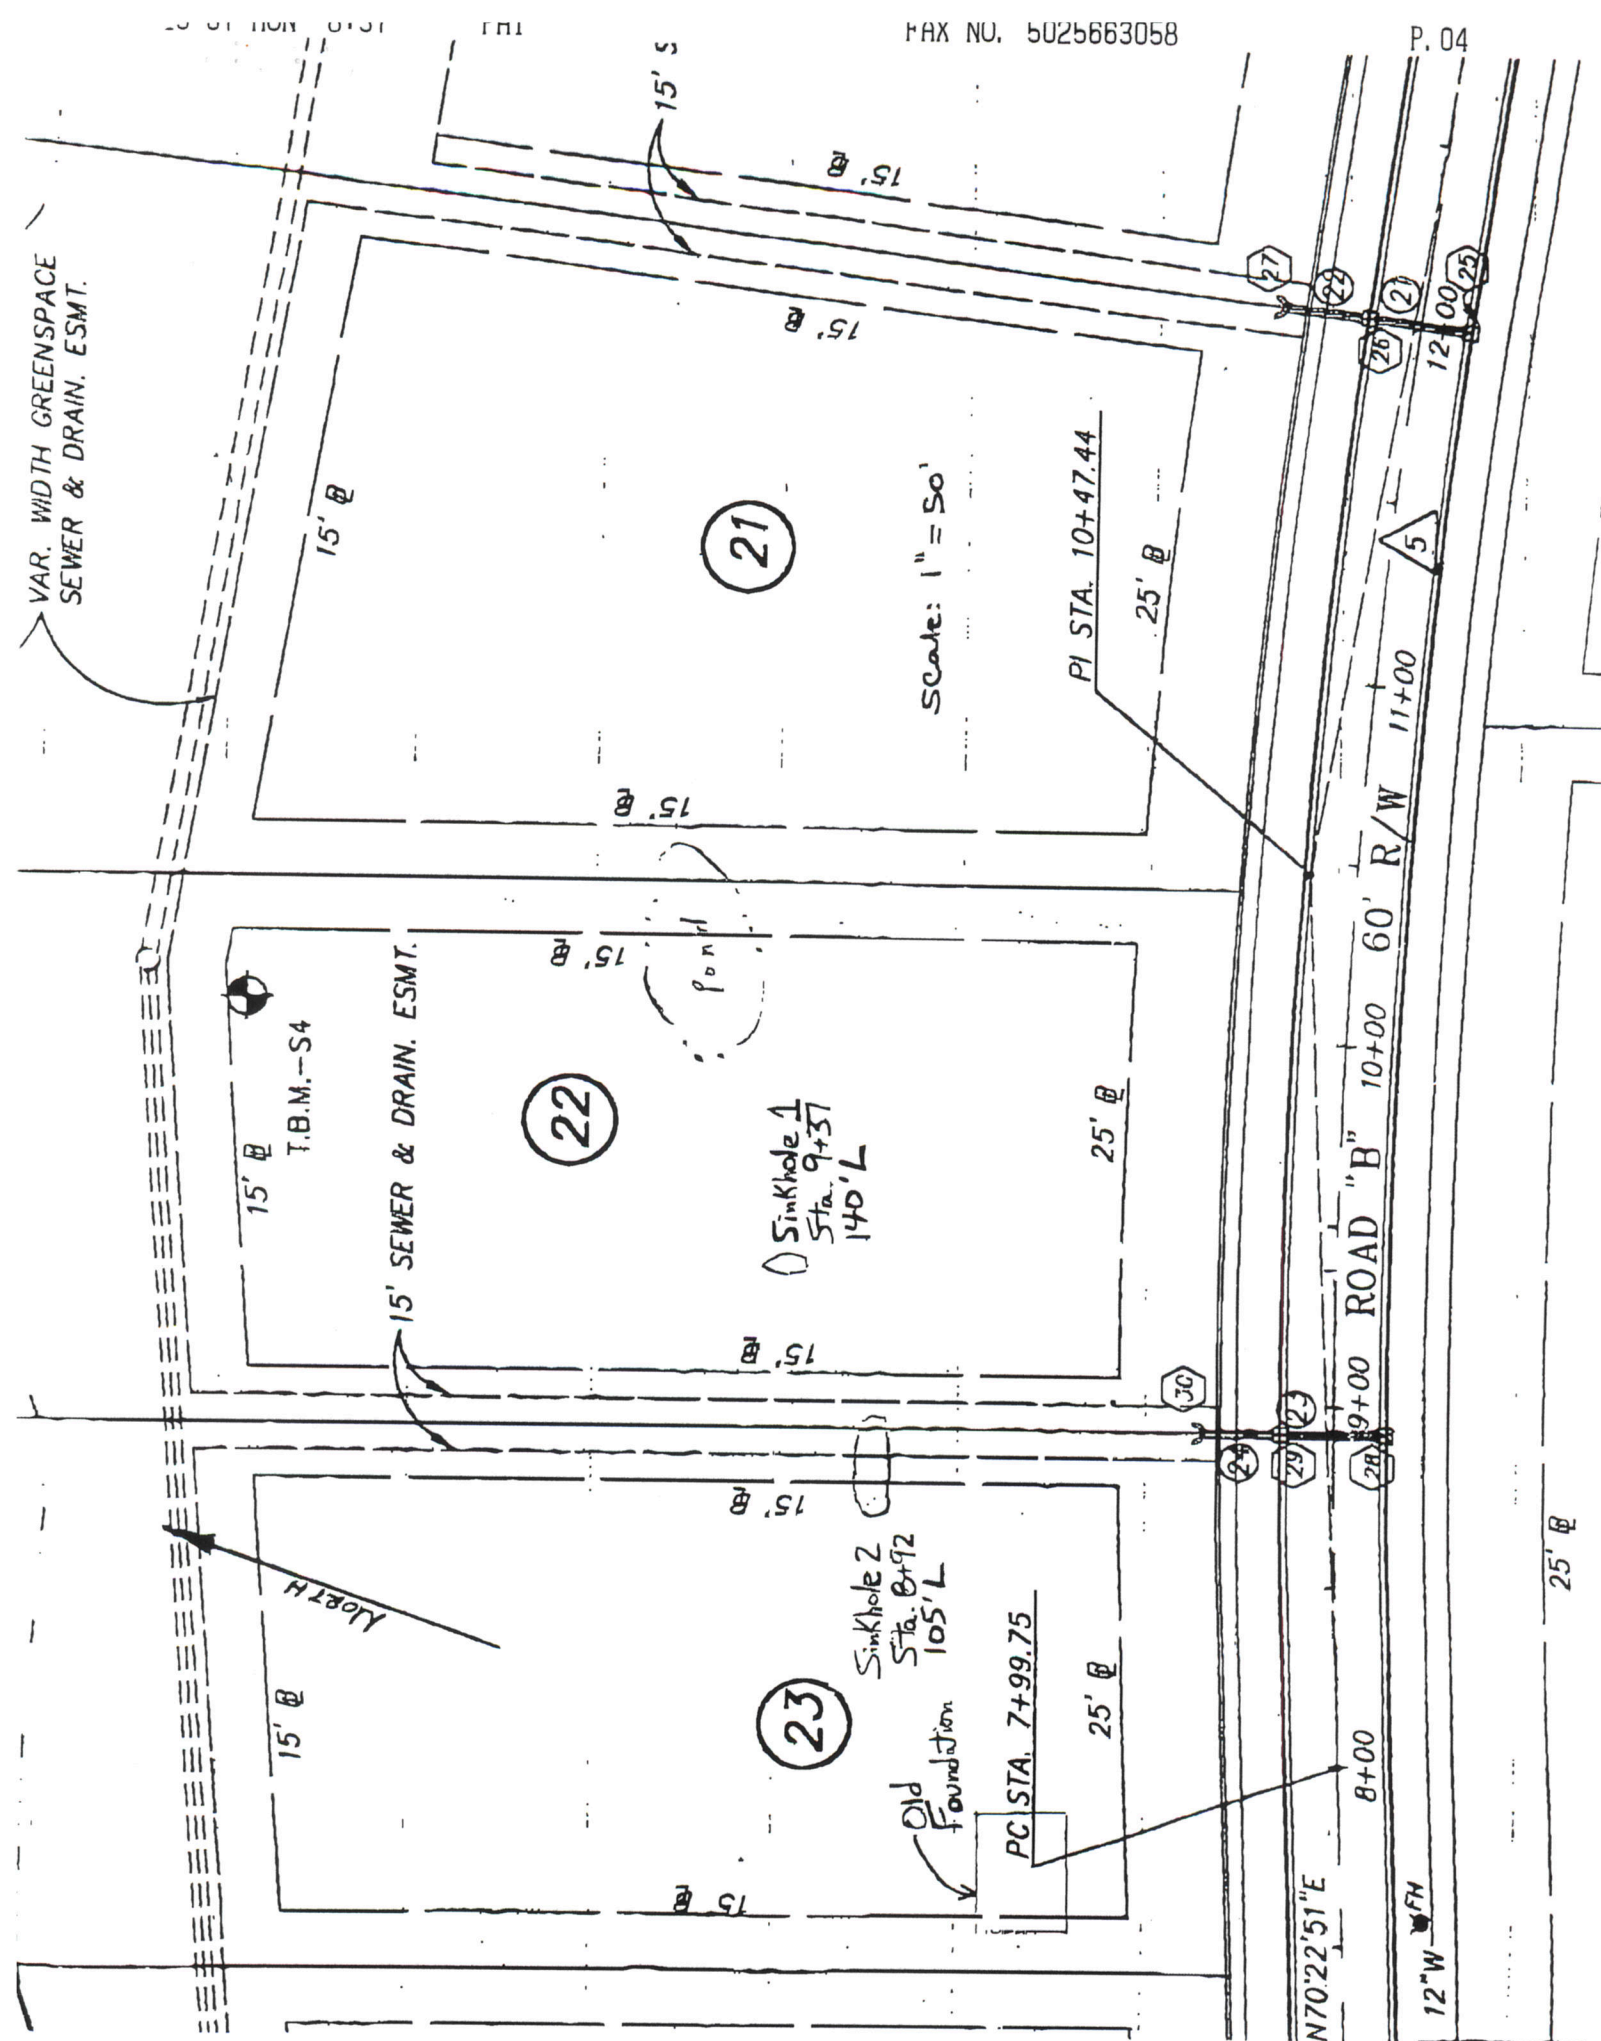
An approximate 10-foot by 10-foot by 4-foot deep excavation had been made to the rock surface. This sinkhole is labeled as Sinkhole 1 on the attached portion of the plan view drawing. It is located at the south-central area of the lot. A one to two-foot wide crevice was observed in the rock surface running in a north-south direction. On the north side of the excavation, the crevice had been cleaned to a depth of about three feet and was clay-filled below this depth. The crevice had not been cleaned on the south side of the excavation. Prior to any treatment, the excavation will need to be extended to the south to determine the limits of the crevice.

A pond was also observed on the east side of the lot and is marked on the attached layout.

An approximate 10-foot by 20-foot by 5-foot deep excavation had been made to the rock surface. This sinkhole is labeled as Sinkhole 2 on the attached portion of the plan view. It is located at the extreme east side of the lot. The eastern half of this sinkhole is located in a 15-foot wide sewer and drainage easement, and it appears to extend just into Lot 22. An approximate six-inch wide crevice is present in the sinkhole running in an east-west direction. This crevice was probed and an open throat extended to a depth of five feet below the rock surface in several locations. This excavation will need to be extended to the east and west to define the limits of the crevice prior to treatment.

An approximate 25-foot diameter sinkhole (Sinkhole 3) about 2 to 3 feet deep was observed 80 to 90 feet east of the southwest corner of the lot. A tree is present in this sinkhole. No excavation had been performed and an open throat was not visible.

From a geotechnical standpoint, sewers, pavements and buildings should be sited to avoid sinkholes because of an increased risk for damage caused by any future ground collapses. However, this will probably not be possible because Sinkhole 1 is in the central portion of Lot 22²² where pavement or a building will likely be placed, and Sinkholes 2 and 3 are in sewer and drainage easements. Therefore, these sinkholes will need to be treated to help prevent future collapse.

The method of treatment for the sinkholes will require that the rock surface be exposed to identify any voids or crevice features in the bedrock (the rock surface has already been exposed at Sinkholes 1 and 2). The voids or crevices should be cleaned and filled with No. 2 or 3 crushed stone up to the rock surface. Additional crushed stone wrapped in KDOH Type IV geotextile fabric would then be placed to provide a cap or a seal over the void or crevice. Normal fill placement can then take place to reach final grades. A Geotechnical Engineer should be present to review treatment of the sinkholes in conjunction with the proposed construction and grades so that any changes or adjustments can be made.
