# “THE **WRONG** HOUSE!”

BENJAMIN ROBBINS, AIA

TRADITIONAL ARCHITECTURE SPECIALIST

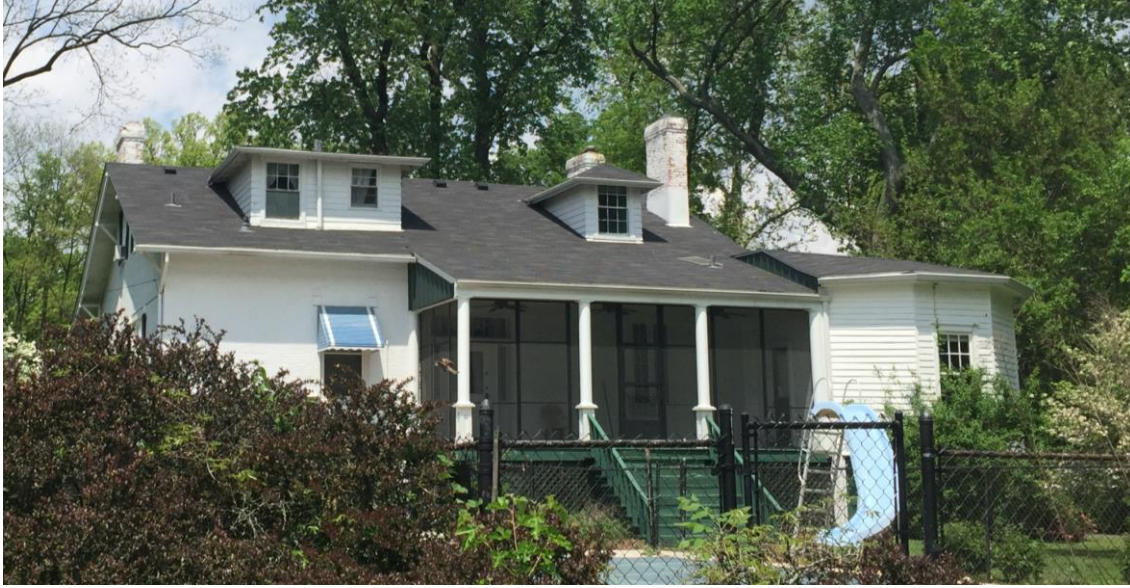
CURRENT HOUSE

- **GREEN** - CURRENT OPENINGS (3)
- **WHITE** - FILSON PICTURE OPENINGS (5)
- THERE IS NO EVIDENCE OF WINDOW OPENING RELOCATION IN BRICK
- **NO EVIDENCE OF THE LOWER WINDOWS EXISTING**

THE WINDOWS ARE NOT THE SAME IN NUMBER, (3) VS (5), OR IN THE CORRECT LOCATION. WHERE DID LOWER WINDOWS GO?

CURRENT HOUSE: ***BIG OVERHANG***

THE LARGE OVERHANG, IF ADDED, WOULD HAVE CLIPPED CEILINGS ON FIRST FLOOR. THEY ARE NOT CLIPPED.

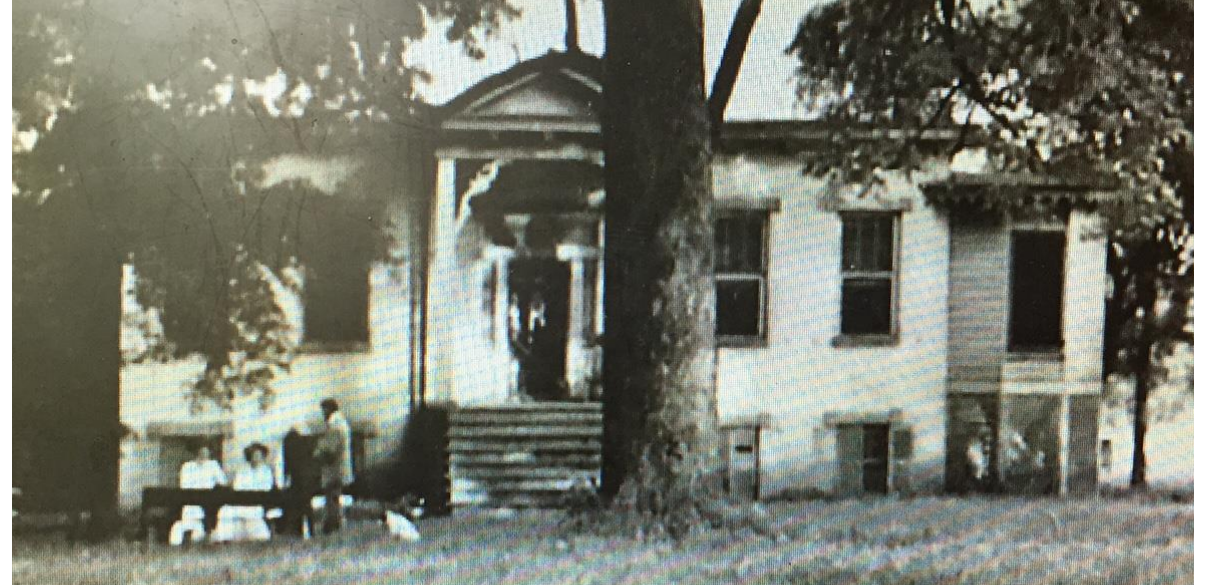
FILSON HOUSE

FILSON PICTURE: ***NO OVERHANG***
