21-COA-0054
104 N. Keats Ave.

Clifton Architectural Review Committee
Public Hearing

Kat Groskreutz, Historic Preservation Specialist
April 28, 2021

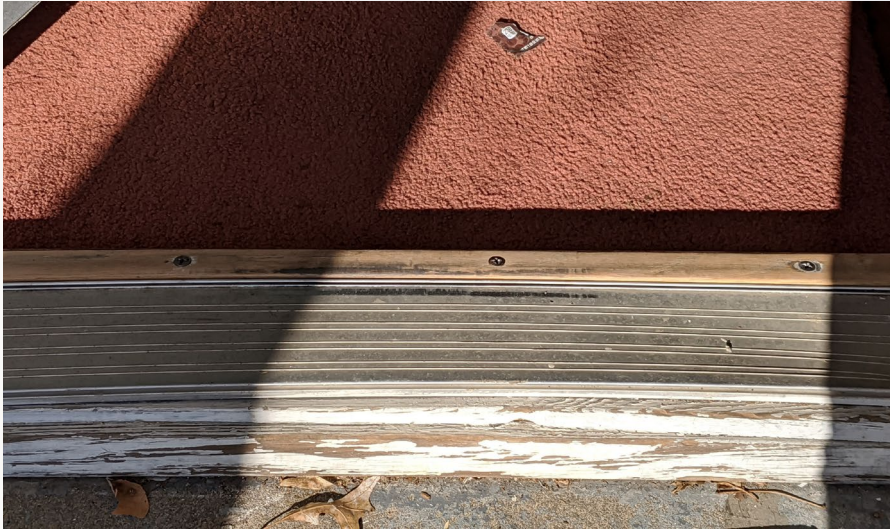
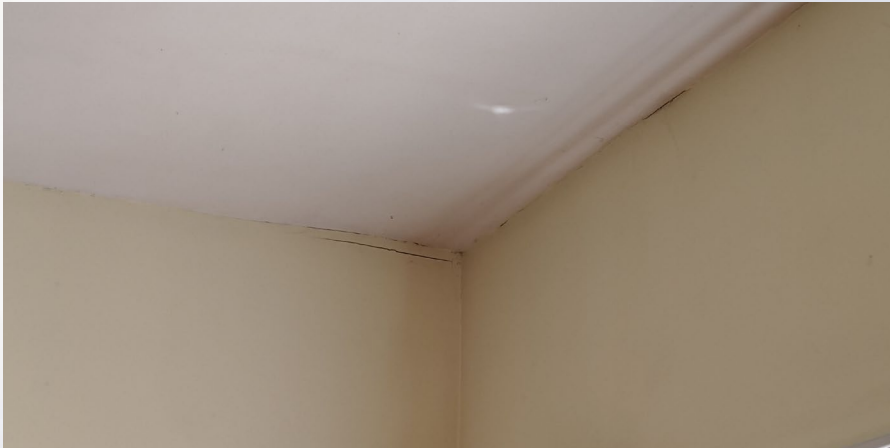
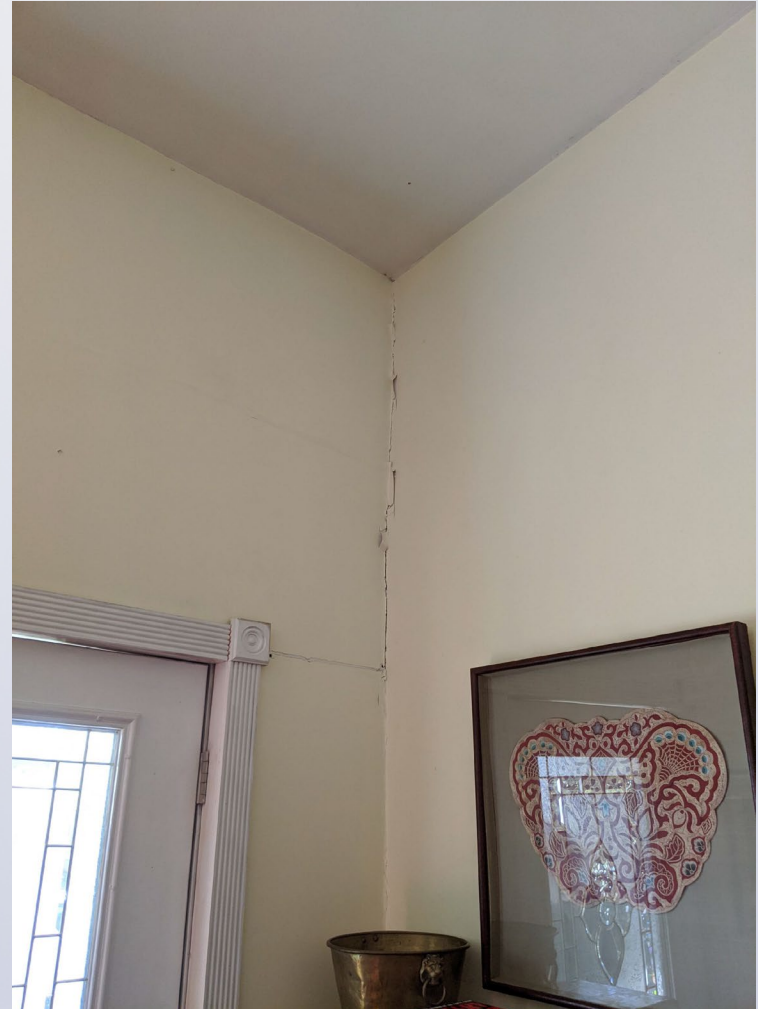
- The proposed demolition somewhat meets the Clifton design guidelines for **Demolition**:
 - Guidelines stipulate, “Any structure in part or in whole 50 years old or older within the Clifton boundary should be preserved.”
 - Staff made a site visit and clearly saw the deteriorating foundation posts, some which were completely gone and no longer making contact with the floor joists
 - Temporary foundation fixes were no longer working
 - Interior floor was steeply unlevel; the front door has sunk below the threshold
 - Cracking of interior walls and buckling of aluminum siding where the foundation was failing were observed

- Staff recommends the application for a Certificate of Appropriateness be **approved with the following conditions:**
 1. The existing building and addition shall not be demolished in a manner that will threaten the structural integrity of the front portion of the historic structure.
 2. The applicant shall take steps to insure the structural integrity of any newly exposed walls.
 3. The applicant shall remove the interior finishes and make the wall suitable to be an exterior wall.
