# Landmarks Certificate of Appropriateness & Overlay District Permit

Project Name: Historic Rehabilitation 843 East Market Street

Project Address / Parcel ID: 843 East Market Street / 017E01350000

A Historic Rehabilitation of the ca. 1875 building is being planned for the purpose of State and Federal Historic Preservation Tax Credits. Significant additions and alterations to the existing building include: 1) addition of an elevator and elevator tower structure that allows accessibility to each of the three stories, 2) addition of a second story to the existing one-story concrete block section of the building, 3) rehabilitation of the existing corner storefront, 4) reconstruction of the wood storefronts, 5) repair and maintenance of the existing steel fire-escape, 6) repainting of the building exterior, and 7) general repair and maintenance of building exterior.

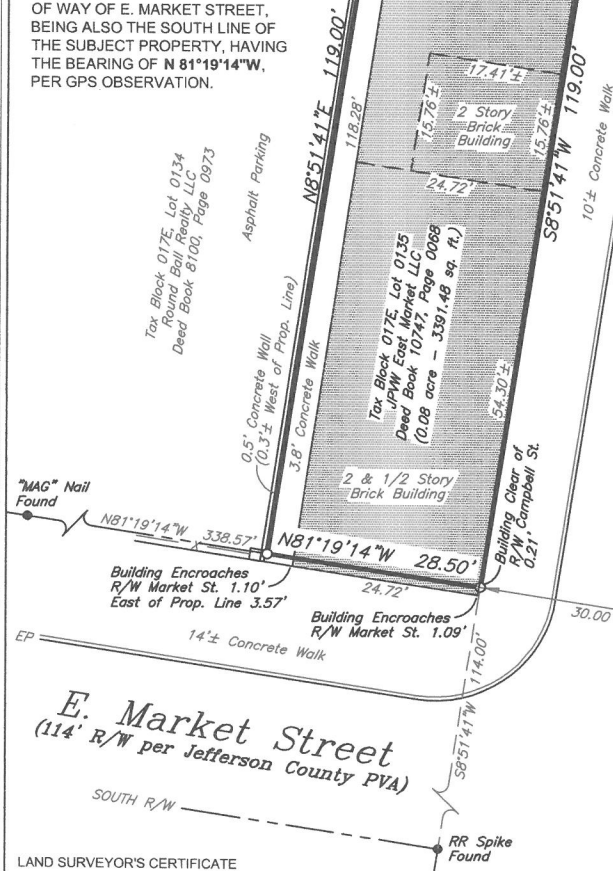
#### SURVEYOR'S NOTES

THIS PLAT IS SUBJECT TO ALL DEFECTS, LIENS, ENCUMBRANCES, ADVERSE CLAIMS, COVENANTS, RESTRICTIONS, ALL LEGAL EASEMENTS, RIGHT-OF-WAYS, ETC. WHICH MAY BE REVEALED BY A TITLE SEARCH WHETHER SHOWN ON THIS PLAT OR NOT.

#### MERIDIAN NOTES

THE REFERENCE MERIDIAN USED FOR THIS PLAT TO DETERMINE THE DIRECTION OF SURVEY LINES IS BASED ON THE NORTH RIGHT OF WAY OF E. MARKET STREET, BEING ALSO THE SOUTH LINE OF THE SUBJECT PROPERTY, HAVING THE BEARING OF  $N 81^{\circ}19'14''W$ , PER GPS OBSERVATION.

#### LAND SURVEYOR'S CERTIFICATE

I HEREBY CERTIFY THAT THE SURVEY DEPICTED HERE WAS MADE UNDER MY SUPERVISION, AND THAT THE ANGULAR AND LINEAR MEASUREMENTS AS WITNESSED BY MONUMENTS SHOWN HEREON, ARE TRUE AND CORRECT TO THE BEST OF MY KNOWLEDGE AND BELIEF. ALL MEASUREMENTS WERE MADE BY REAL TIME KINEMATIC (RTK) GPS OBSERVATION, USING A TOPCON PG-A1 DUAL-FREQUENCY RECEIVER. THE RELATIVE POSITIONAL ACCURACY IS WITHIN  $\pm 0.05' + 100$  PPM. THE SURVEY AS SHOWN HEREON IS CLASS "URBAN" AND THE ACCURACY AND PRECISION OF SAID SURVEY MEETS OR EXCEEDS THE SPECIFICATION OF THIS CLASS.
