# Landmarks Certificate of Appropriateness & Overlay District Permit

Project Name: Historic Rehabilitation 843 East Market Street

Project Address / Parcel ID: 843 East Market Street / 017E01350000

A Historic Rehabilitation of the ca. 1875 building is being planned for the purpose of State and Federal Historic Preservation Tax Credits. Significant additions and alterations to the existing building include: 1) addition of an elevator and elevator tower structure that allows accessibility to each of the three stories, 2) addition of a second story to the existing one-story concrete block section of the building, 3) rehabilitation of the existing corner storefront, 4) reconstruction of the wood storefronts, 5) repair and maintenance of the existing steel fire-escape, 6) repainting of the building exterior, and 7) general repair and maintenance of building exterior.

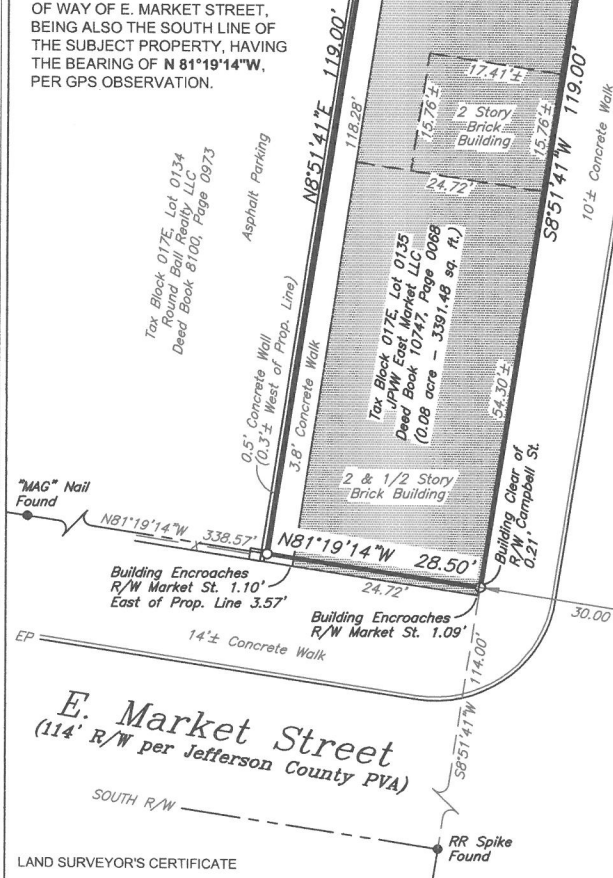
THE REFERENCE MERIDIAN USED FOR THIS PLAT TO DETERMINE THE DIRECTION OF SURVEY LINES IS BASED ON THE NORTH RIGHT OF WAY OF E. MARKET STREET, BEING ALSO THE SOUTH LINE OF THE SUBJECT PROPERTY, HAVING THE BEARING OF  $N 81^{\circ}19'14''W$ , PER GPS OBSERVATION.
