## Historic Landmarks and Preservation Districts Commission

### Report to the Committee

**Case No:** 23-COA-0232  
**Classification:** Committee Review

**Property Address:** 918 S. 6<sup>th</sup> St.

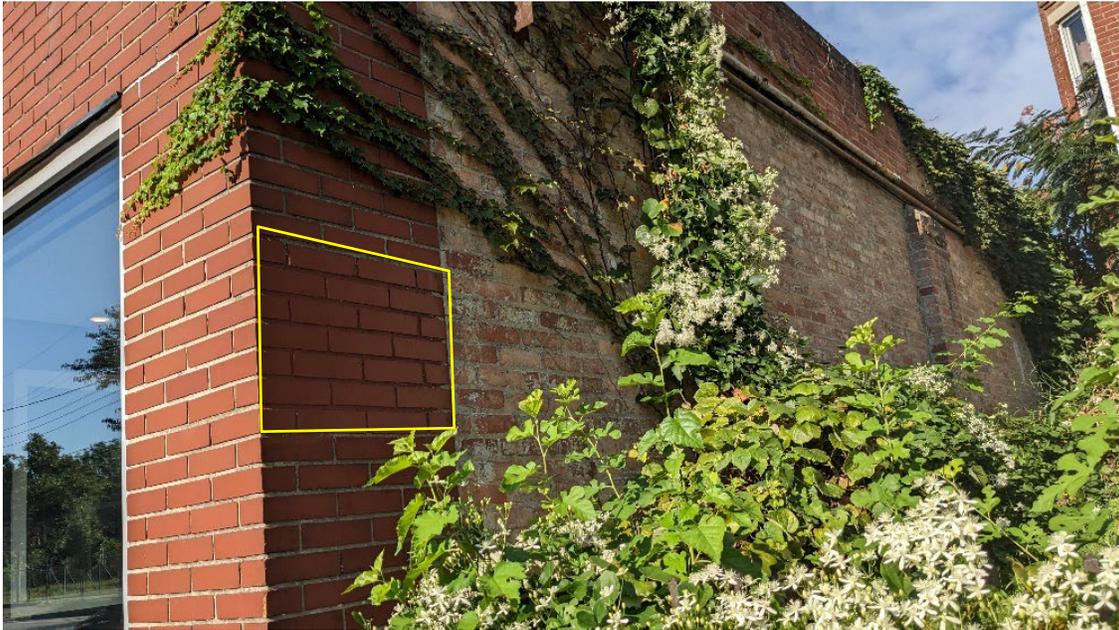
### **Conclusions**

**Figure 1: North side façade, painted area marked in yellow, staff photo.**

1. Only the red smooth brick on the east front and south side façades and a small area of the same brick that wraps around the north façade and the west rear facade shall be painted. The brick with a rough texture on the west rear and north façades shall remain unpainted.
2. The concrete storefront and window sills and the concrete trim on top of the front façade wall shall remain unpainted.
3. A breathable masonry paint that is compatible with and can create a strong bond with existing paint shall be used.
4. If the design or materials change, the applicant shall contact staff for review and approval.

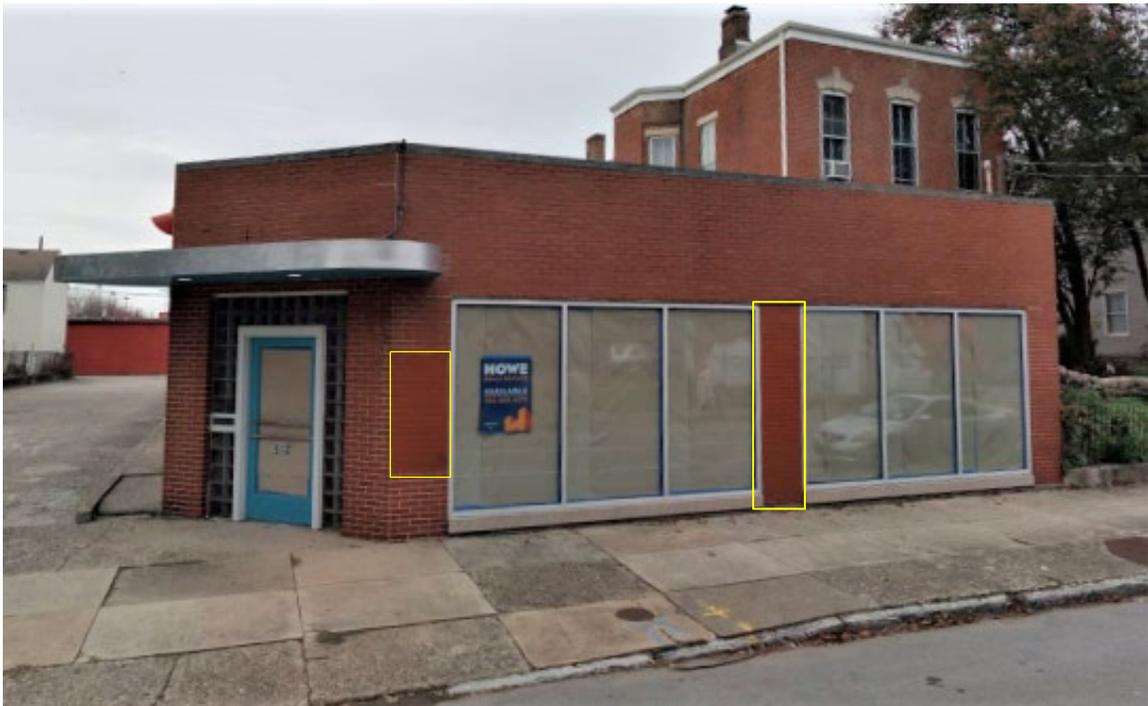
**Figure 2: East front façade, painted areas marked in yellow, PVA photo Nov. 2021.**

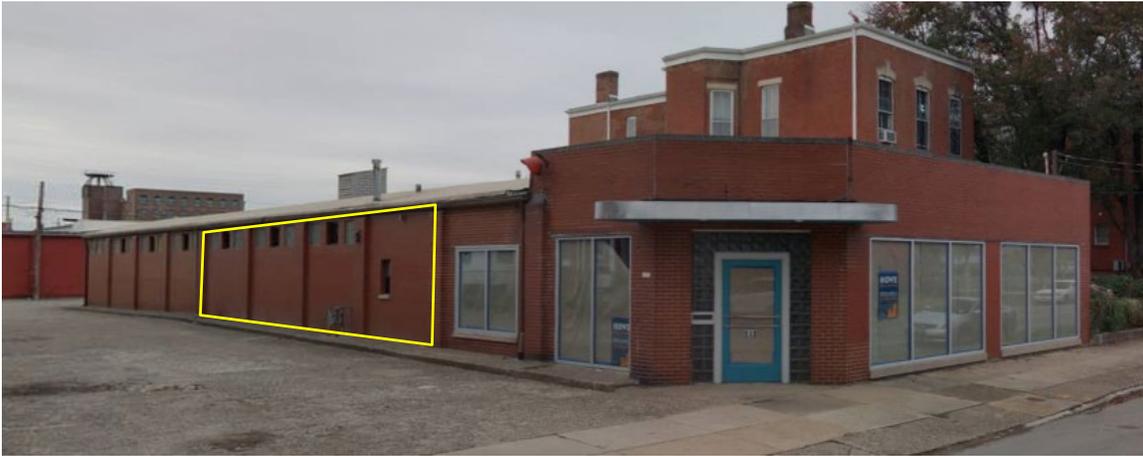
**Figure 3: South side façade, painted area marked in yellow, PVA photo Nov. 2021.**

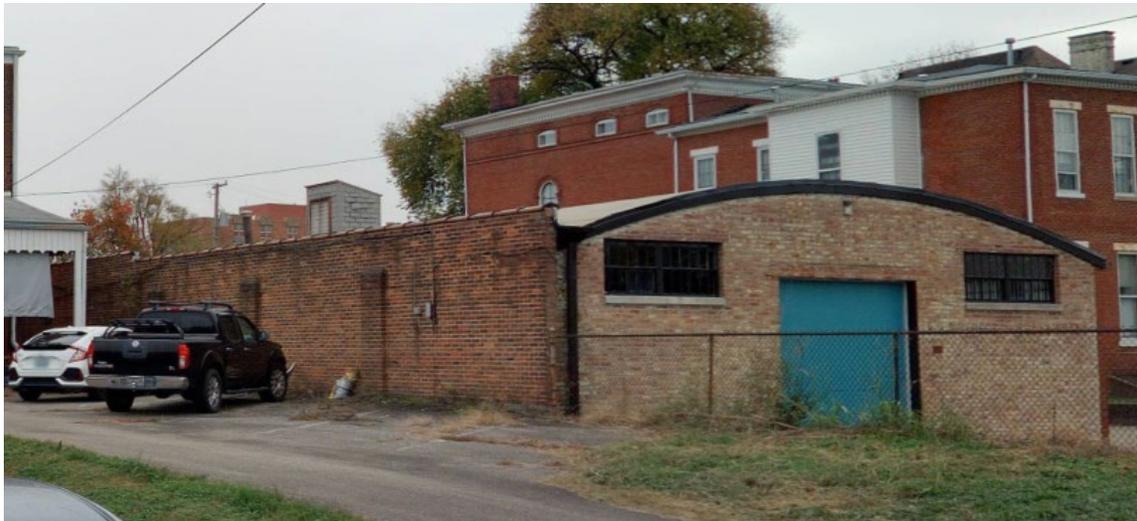
**Figure 4: West rear and north side façade, PVA photo, Nov. 2021.**

Since more than 80% of the brick has never been painted, the proposed painting does not conform with guidelines **P1** and **M24**. Furthermore, the unpainted brick on the west rear and north side façades has a rough texture and soft consistency, thus it is more likely to be damaged with paint. For this reason, staff finds that this brick should remain unpainted.
