Historic Landmarks and Preservation Districts
Commission

Report to the Committee

Case No: 26-COA-0069
Classification: Committee Review

Address: 2544 Glenmary Avenue

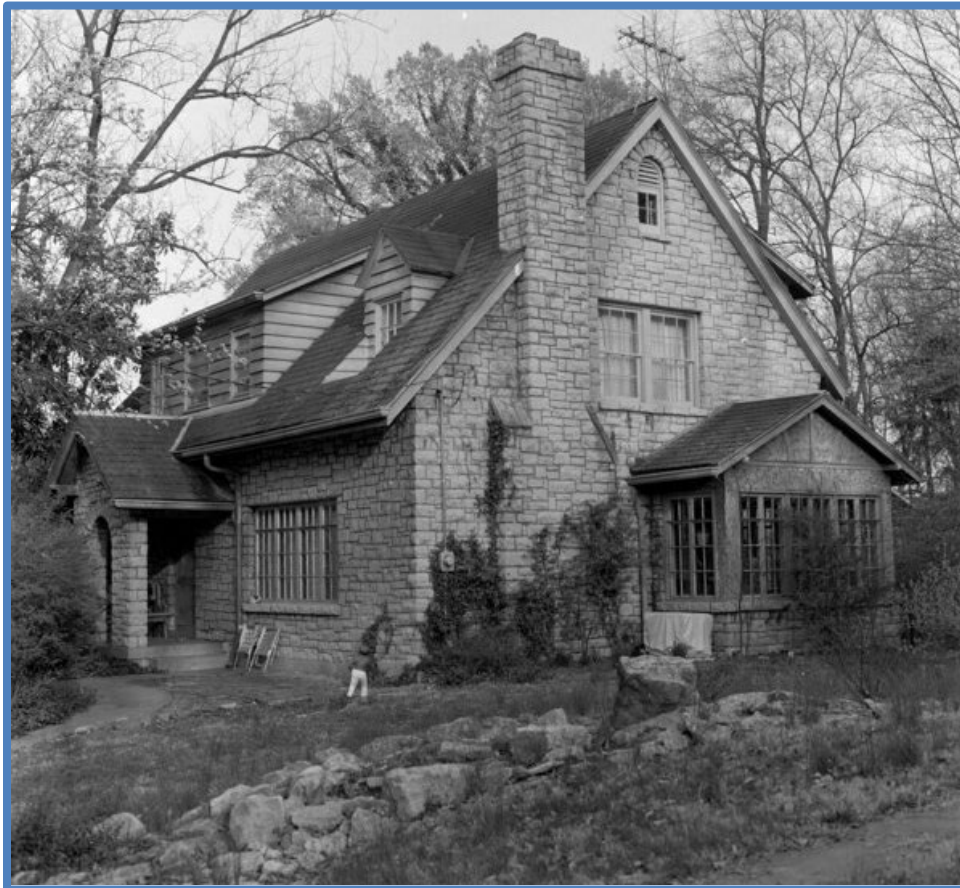
Figure 1: 1975 designation photo.

As the application does not meet the applicable guidelines, Staff must recommend denial. However, Staff recommends that the applicant consider working with staff to change the arc of the character defining concrete walk to restore it to the 1975 designation photo (**Figure 1**). This would create space to add a flagstone patio where one was previously removed.

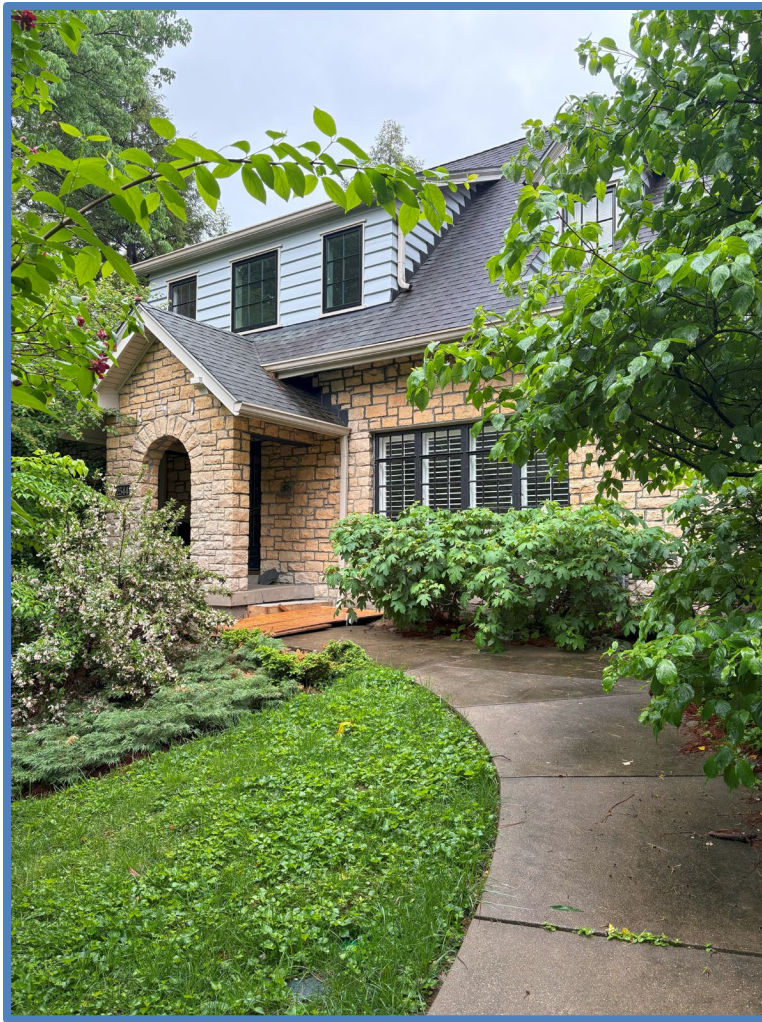
Figure 2: Staff photo, April 2026
