As we discussed previously, in our investigation for the design of the new columns at 811-819 W. Main St. it became necessary to uncover the existing foundation locations. Attached you will find our findings of the existing condition. In general, it can be said that the existing foundations are immediately beneath the existing basement slab. Except one wall, the foundations are a single limestone block perpendicular to the basement wall immediately below the basement slab. The one wall that varies is a brick wall with a corbelled brick foundation. This is not consistent with other buildings immediately adjacent to yours on Main St. In those buildings the foundations were 3-4ft below the basement slab.

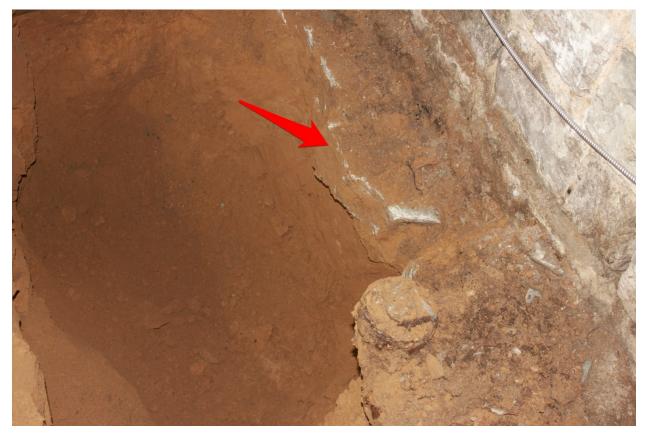
Figure 1 817 West

- A) Corbeled brick foundation
- B) Bottom of existing brick or stone foundation
- C) Undisturbed earth.

Through this investigation we have determined that in order to get the columns as close to the brick walls as possible it would require two piers (25 feet deep each) per column to provide additional support for the existing masonry walls. This will allow us to remove the cantilevered portion of the footing and locate the new column as close to the wall as possible. This investigation also further substantiated that these masonry walls are not adequate to support the code required dead and live loads for any new occupation of the buildings.
