# **GEOTECHNICAL EVALUATION REPORT**

HURSTBOURNE APARTMENTS DEVELOPMENT LOUISVILLE, KENTUCKY

SME Project Number: 088601.00 April 25, 2022

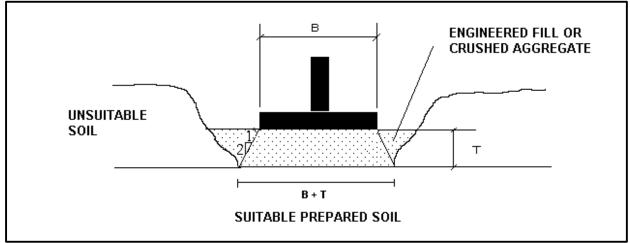
**IMAGE 1: TYPICAL FOUNDATION UNDERCUTTING DIAGRAM**

Where undercutting is necessary, foundations can be constructed at the bottom of the undercut, or the design foundation bearing elevation can be re-established by placing compacted engineered fill or crushed aggregate. The foundation undercuts should be oversized laterally and backfilled with granular engineered fill or crushed aggregate (KYTC DGA) as shown on Image 1 (*Typical Foundation Undercutting Diagram*) below.

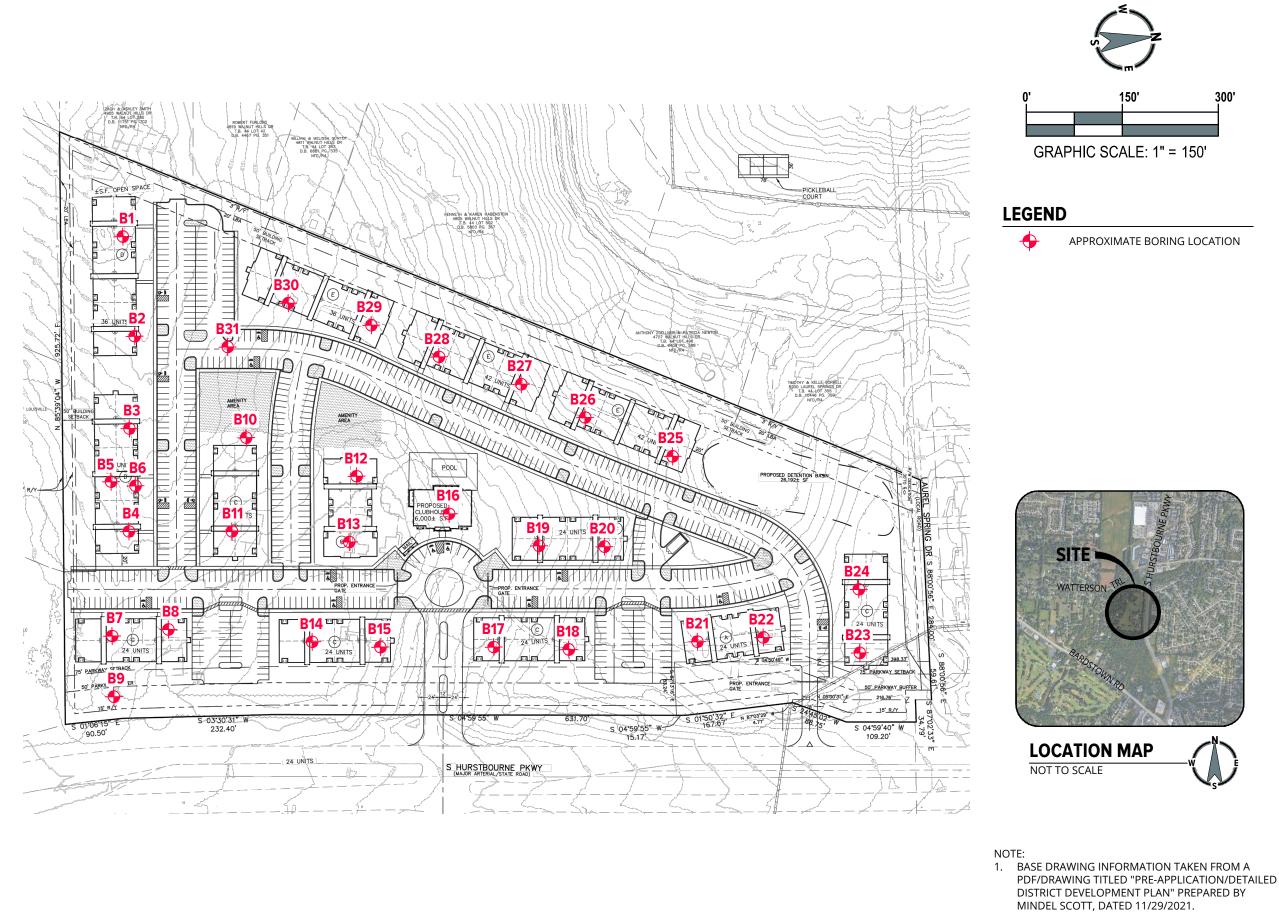
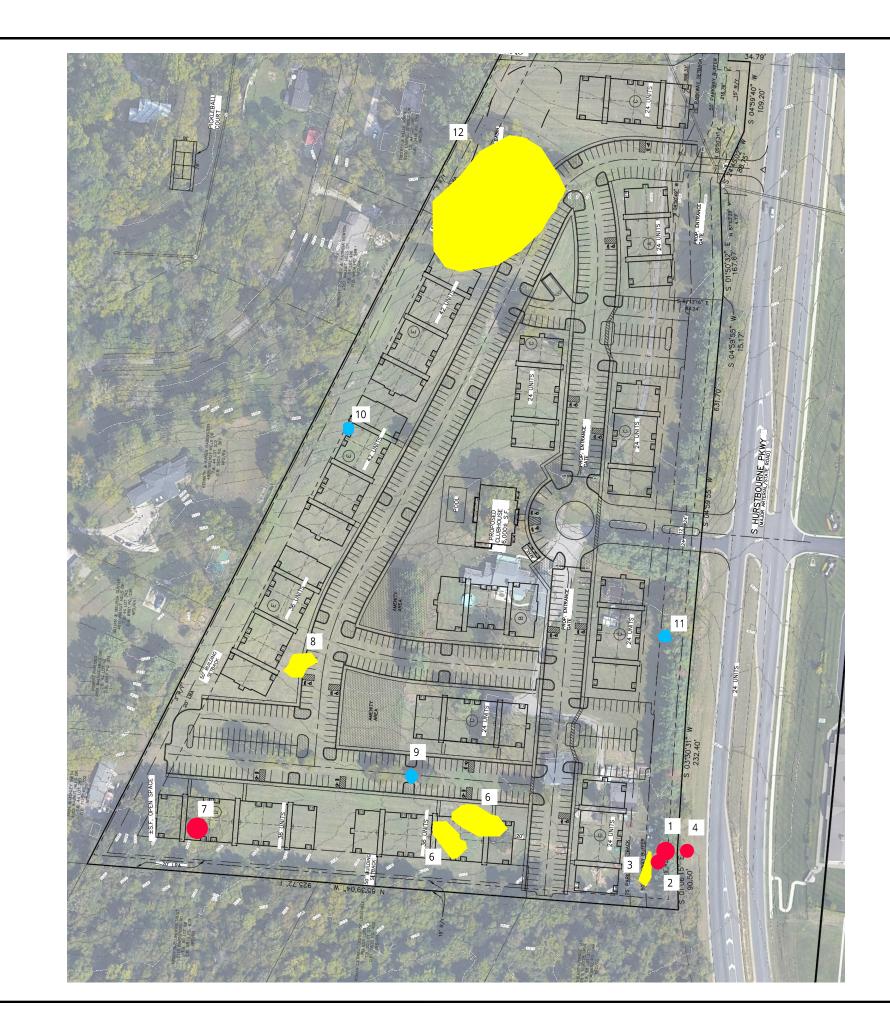
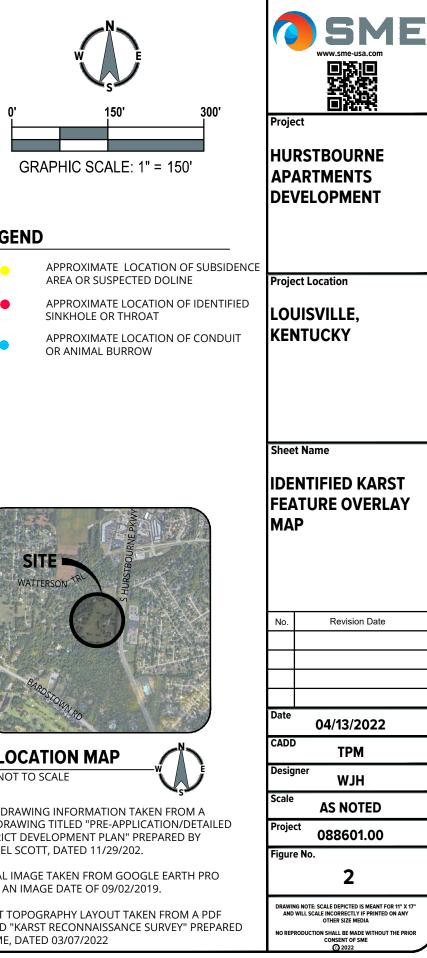
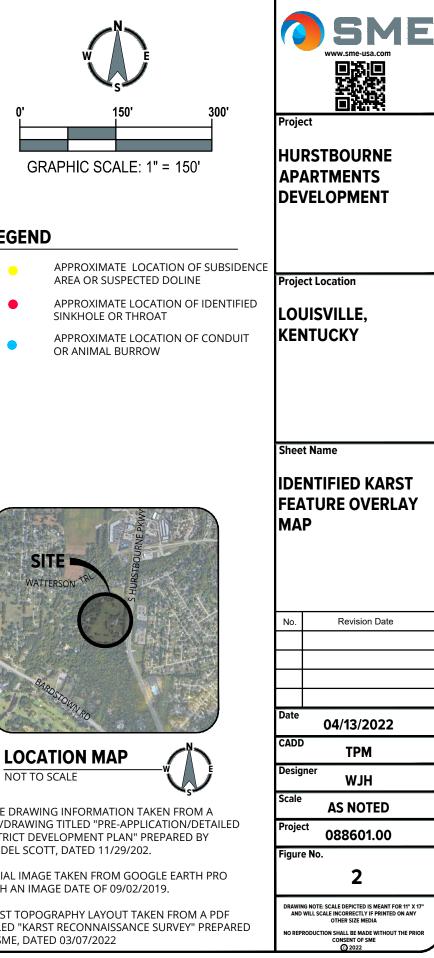
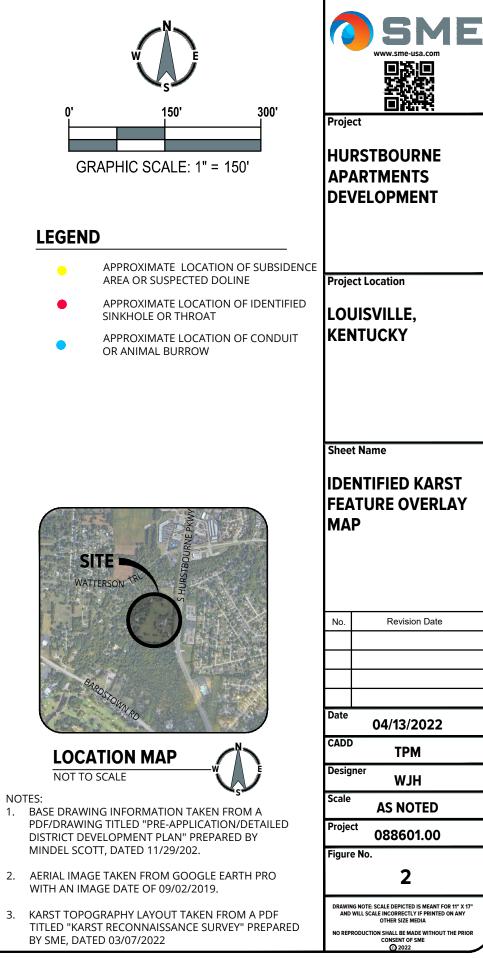
BORING LOCATION DIAGRAM (FIGURE NO. 1) IDENTIFIED KARST FEATURE OVERLAY MAP (FIGURE NO. 2) BORING LOG TERMINOLOGY BORING LOGS (B1 THROUGH B31)

SME performed thirty-two (32) borings (B1 through B31, plus B12A) at the project site between March 14 to March 17, 2022. The approximate as-drilled locations of the borings are depicted on Figure No. 1. ARCO Senior Living Multi-Family requested the number of borings. SME determined the planned depths and locations of the borings based on the project information provided to us. SME staked the borings in the field using a hand-held GPS unit with sub-meter accuracy.
