Historic Landmarks and Preservation Districts Commission

MEMORANDUM

Case No: 22-COA-0251

Property Address: 2354, 2356, 2358 Grinstead Drive
2421, 2423 Glenmary Avenue

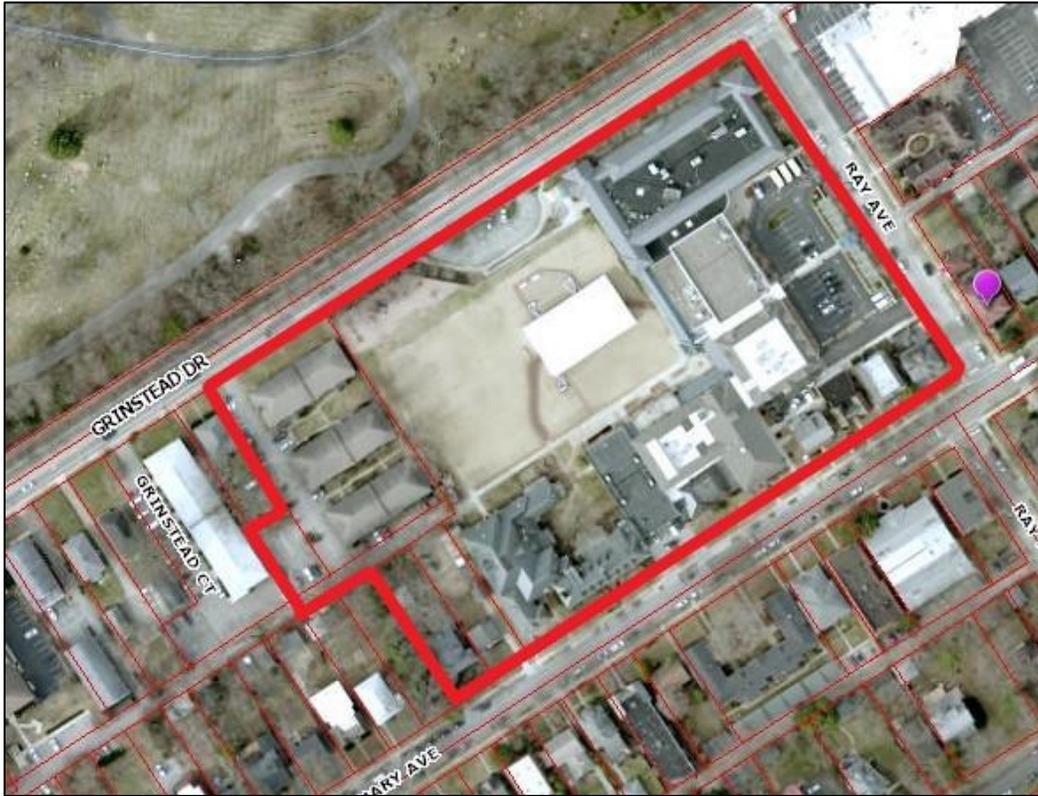
Figure 1. As reference, this LOJIC aerial shows the extent of Louisville Collegiate School's ownership (red).

Louisville Collegiate School owns several buildings on Grinstead Drive and Glenmary Avenue. **Figure 1** shows the current extent of ownership with a red outline. This outline was also placed on other historic maps and aerial photographs to provide a boundary of review. It does not infer that the school owned these buildings at the time of the map or photograph's creation. The 1928 Sanborn Fire Insurance Map (**Figure 2**) is the earliest map found of this area with building footprints. The map shows the historic school building on Glenmary Avenue surrounded by a variety of residential structures. The 1951 Sanborn Fire Insurance Map (**Figure 3**) shows the same buildings except for one demolition on Grinstead Drive (2402 Grinstead Drive) and the addition of the school's athletic fields located off the alley where outbuildings once stood. Additionally, an apartment building was constructed on Ray Avenue (1108 Ray Avenue).

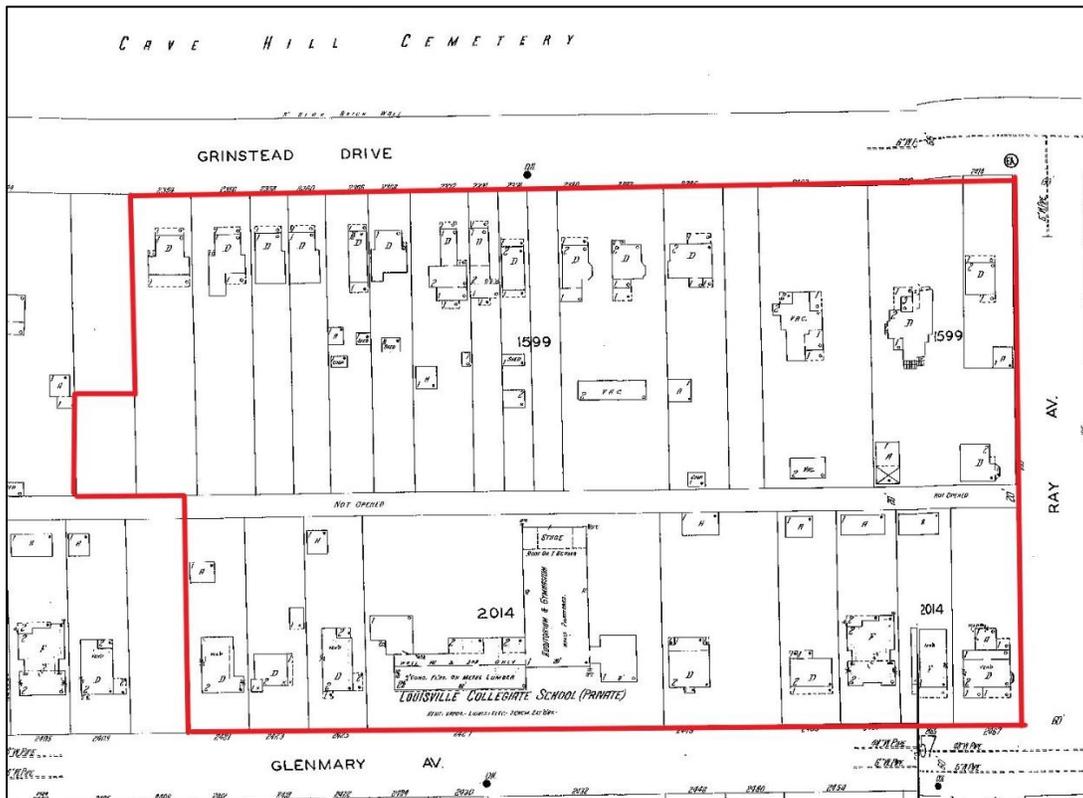
Figure 2. 1928 Sanborn Fire Insurance Map (Vol. 6, Sheet 657-658) with red outline of current school ownership. **This does not infer that the school owned all of the properties within this boundary in 1928.*

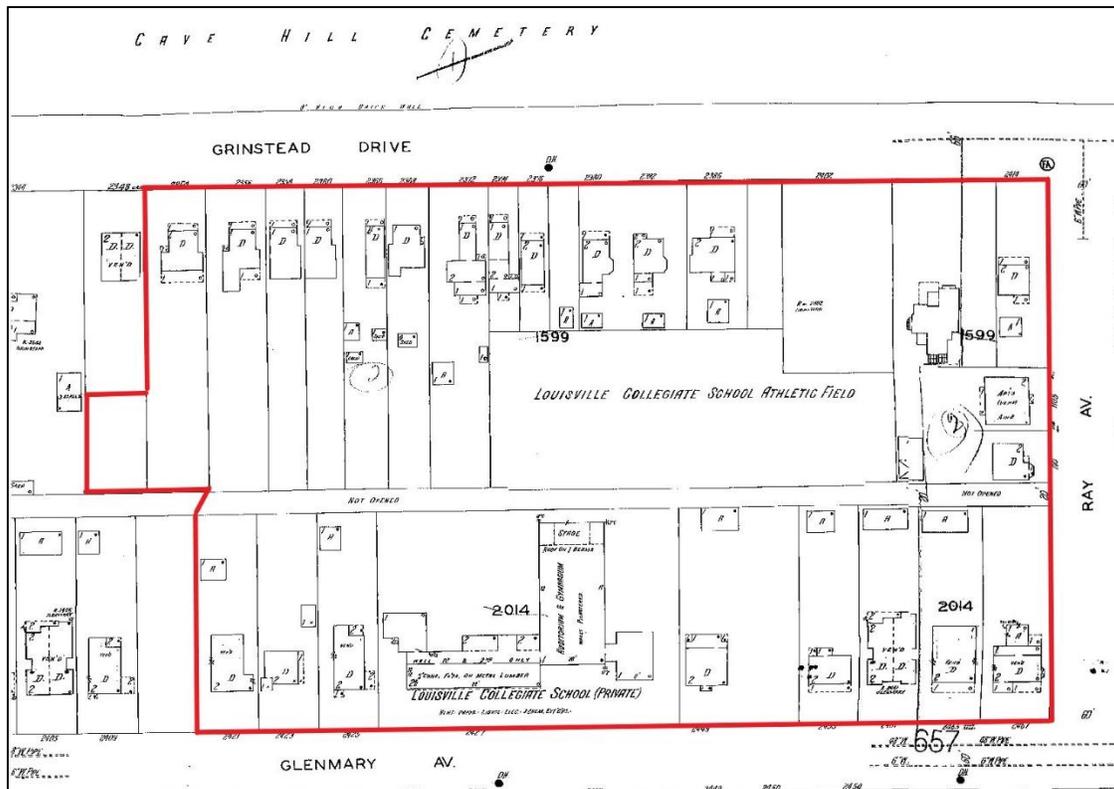
Figure 3. 1951 Sanborn Fire Insurance Map (Vol. 6, Sheet 67-658) with red outline of current school ownership. **This does not infer that the school owned all of the properties within this boundary in 1951.*

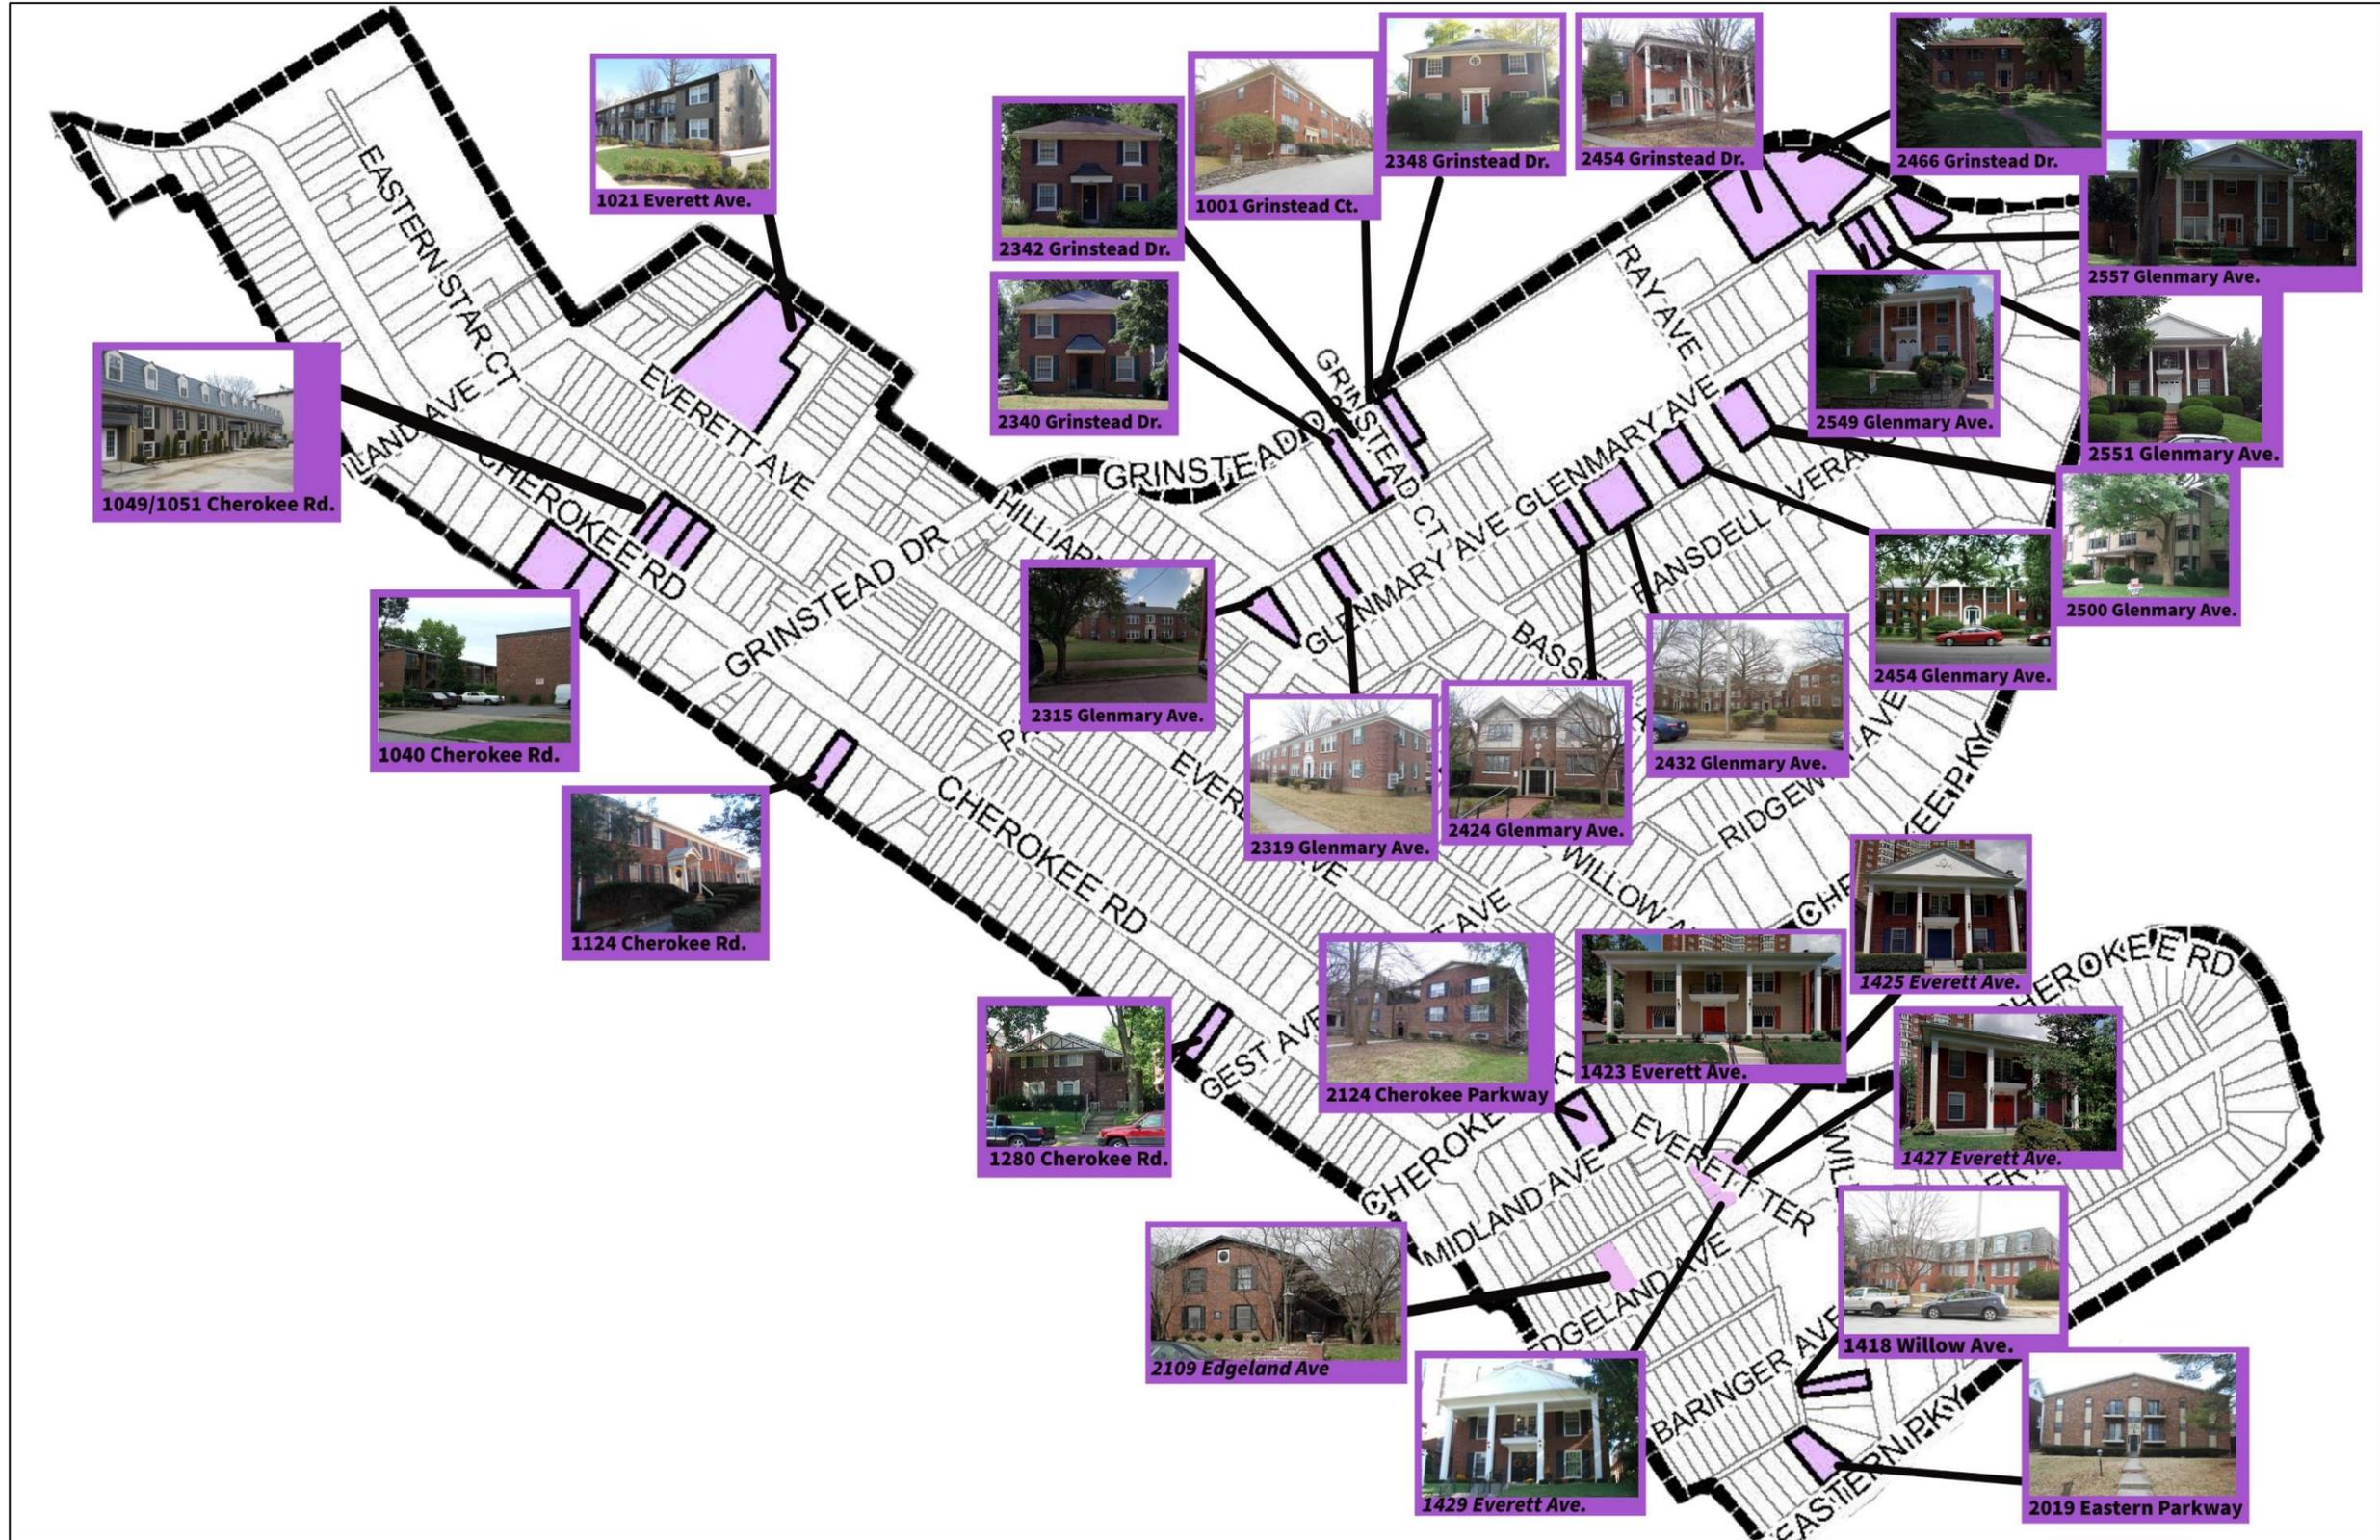
Figure 6. LOJIC map showing the location of the 1960-1979 Multifamily Buildings Extant in Cherokee Triangle.

Staff conducted a search of all multi-family buildings constructed in the Cherokee Triangle District between 1960 and 1979. Twenty-seven total number of buildings were discovered. The attached map (**Figure 6**) shows the location of each building along with a thumbnail photograph for reference. **Table 1** below contains a list of these buildings as well.
