# 2130 New Main Street Urban Greenspace

2130 New Main Street

Clifton, Louisville KY

Seeking permission to demolish shotgun & salvage material due to excessive cost of rehab

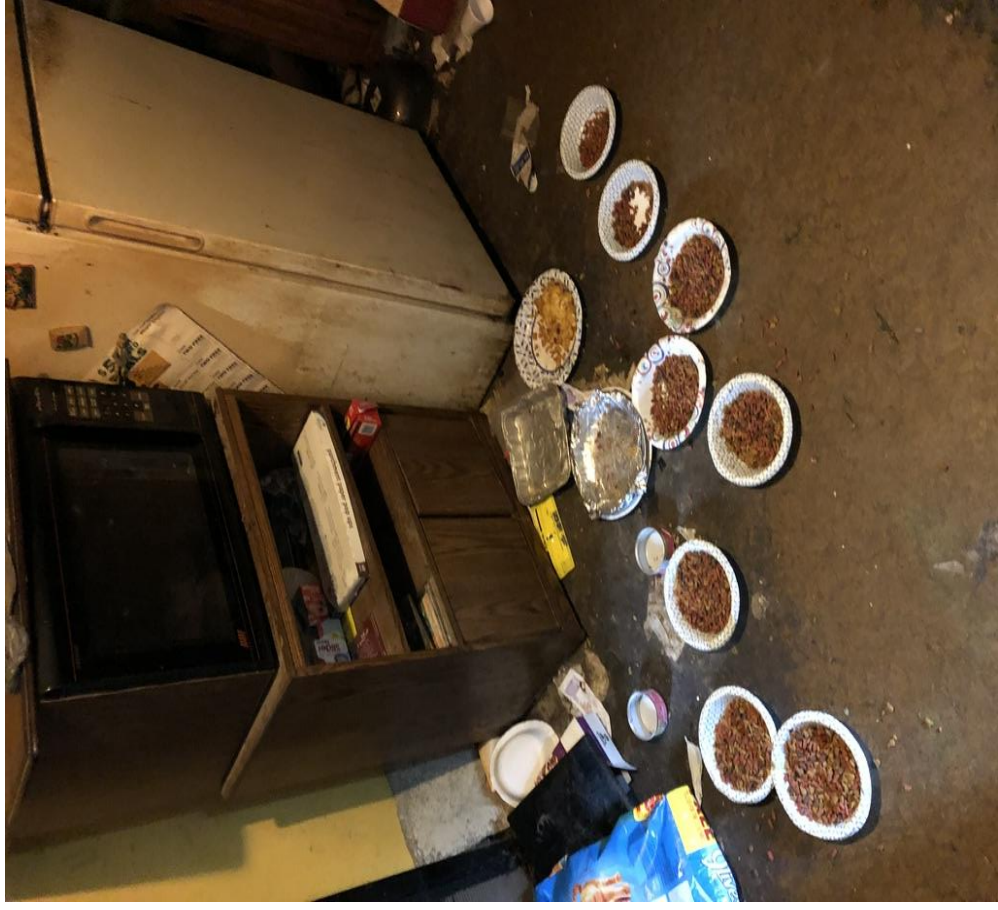
Bowls of cat  
food left on  
the kitchen  
floor

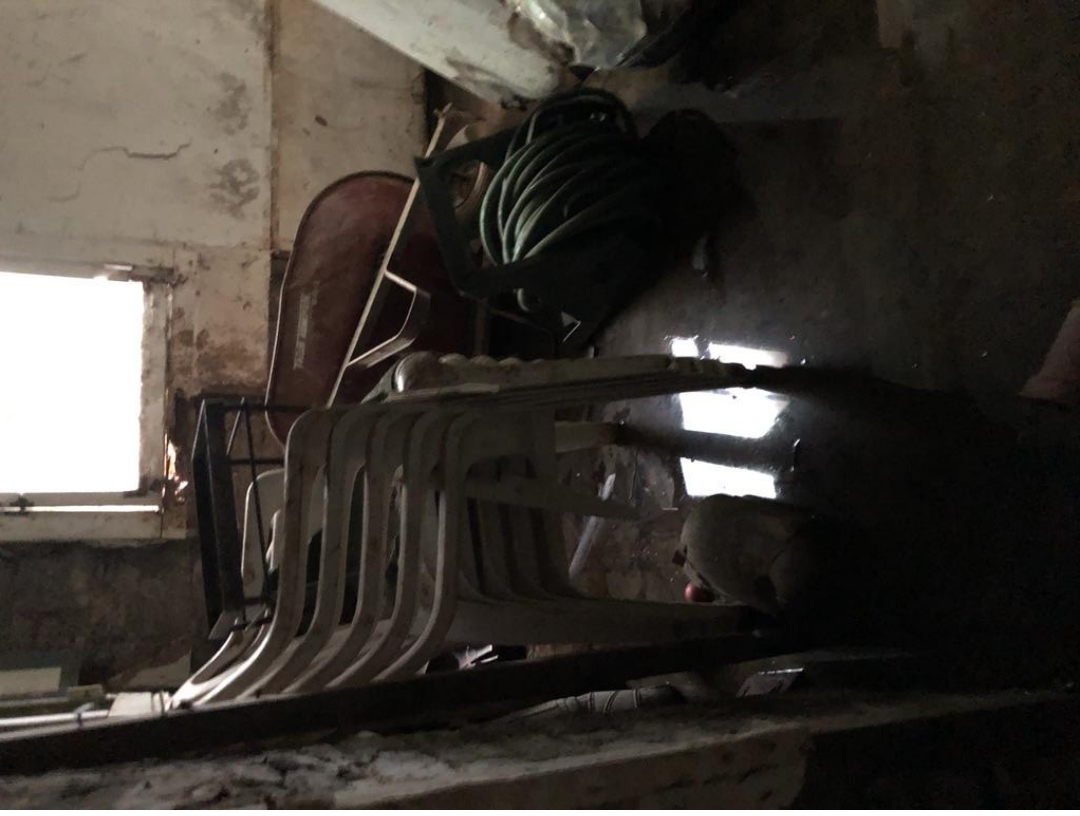
That water pools at  
about  $\frac{1}{2}$  to 1 inch in  
depth.

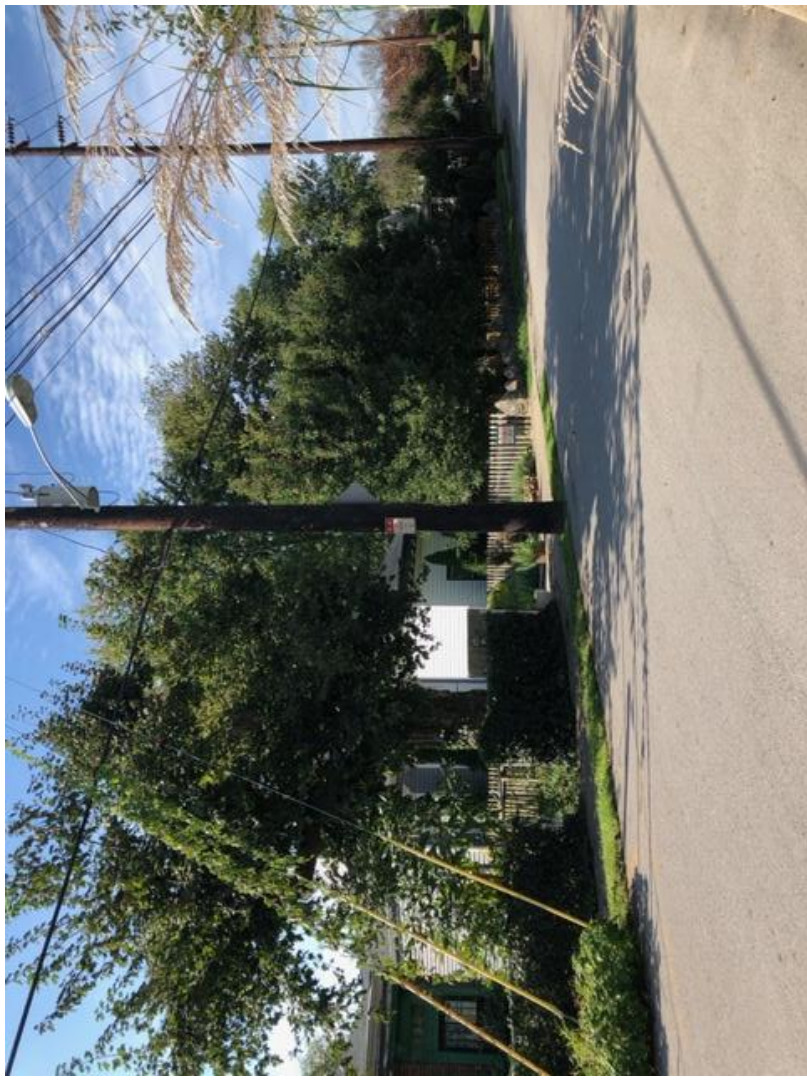
The two side  
yards between  
2126 and 2120  
New Main  
Street

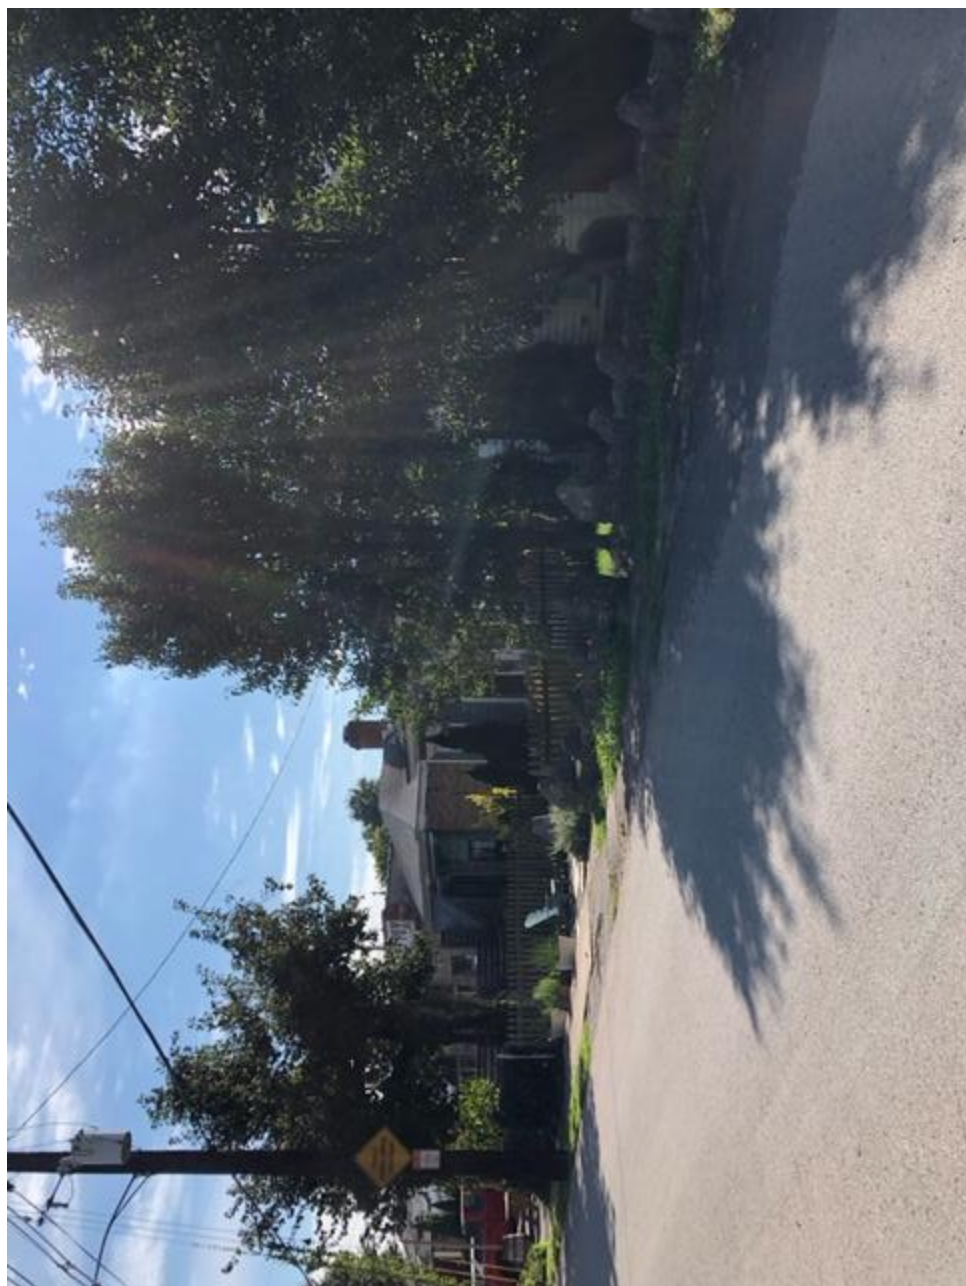
**The proximity to the USPO requires that the shotgun be moved at least two feet westward to allow maintenance of both structures. Moving the shotgun and the width of the lot results in narrowing the west walkway and crowds the neighbor to the west.**

**Due to the condition of the shotgun's foundation, rehabbing the shotgun in place requires removing the foundation and everything above the foundation in order to rebuild the foundation. This alternative still perpetuates the denial of maintenance access to the 2132 & 2130 adjacent walls.**
