# 2130 New Main Street Urban Greenspace

2130 New Main Street

Clifton, Louisville KY

Seeking permission to demolish shotgun & salvage material due to excessive cost of rehab

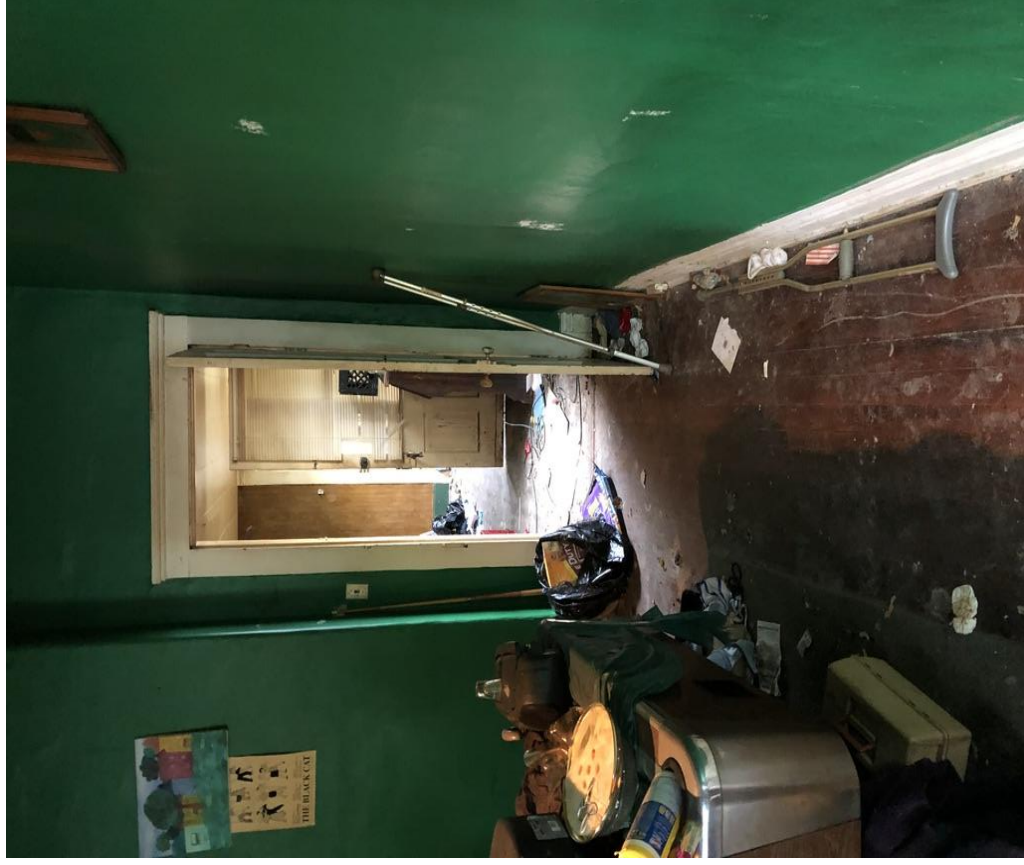
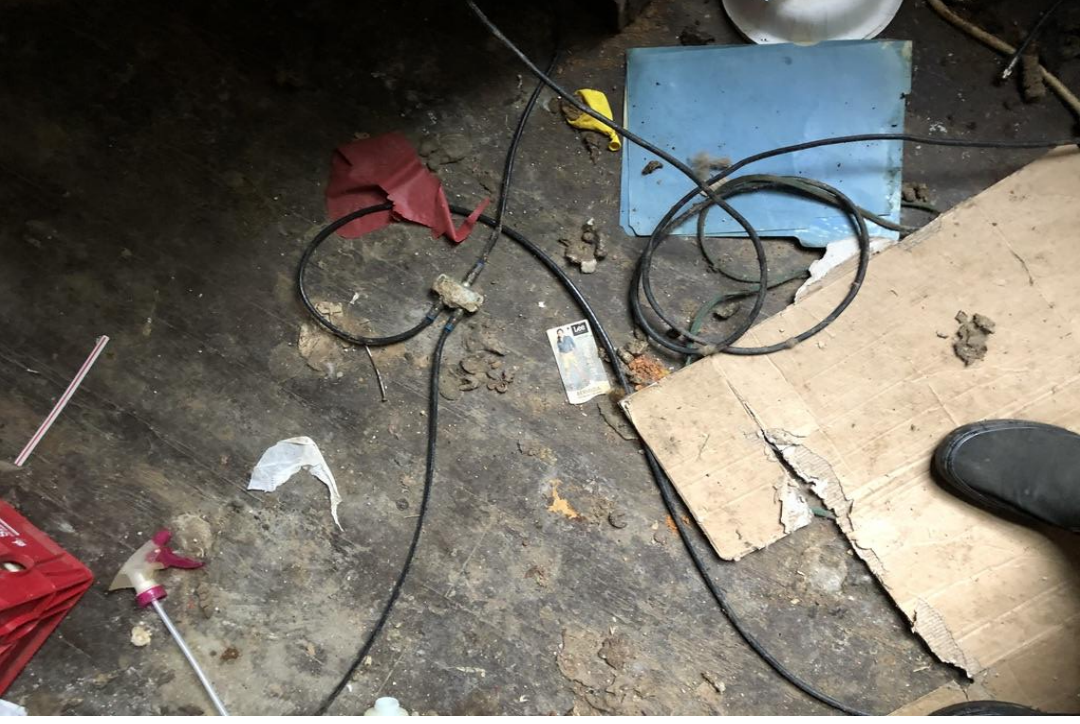
From inside the front door looking straight back the hallway. The hallway view is blocked by the open sidedoor. The house has a front room, two bedrooms, kitchen and bath - all in linear sequence. Every room serves as hallway. The brown splotches on the floor of the front room are cat feces. Cat feces is in every room and in the hall from the front door to the back door.

The left image is of the front room. The right image is in the doorway of the first bedroom. . The floor, cardboard and items are covered with cat feces. The reek of cat feces, some of it fresh, some months or years old, permeates the house. Still.

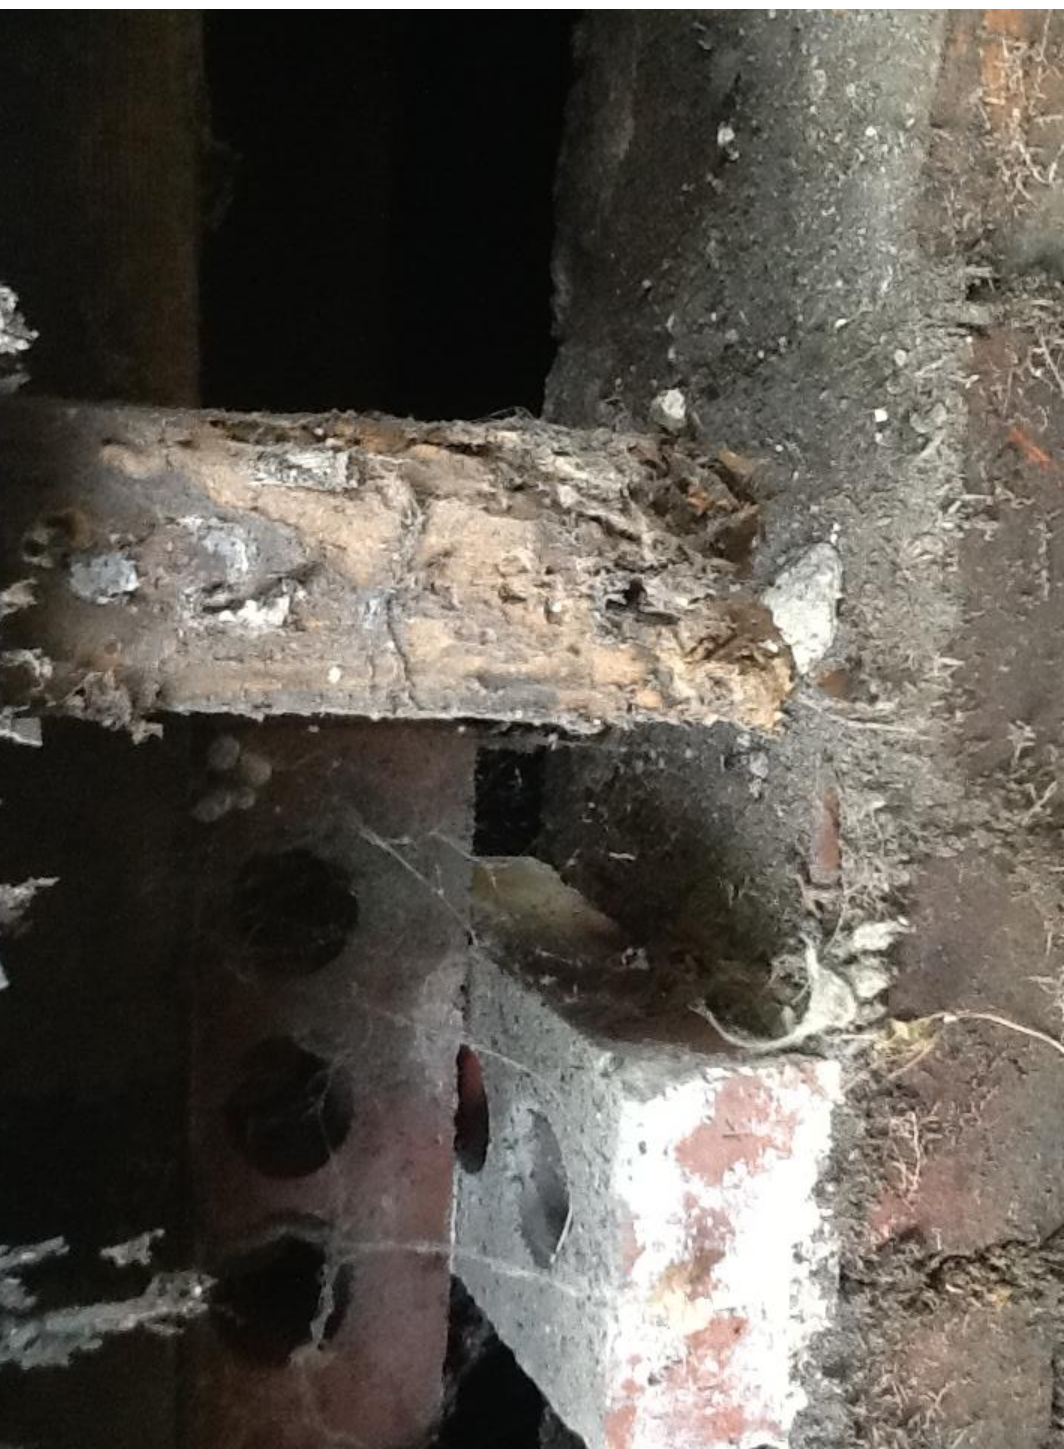
Note the  
lack of  
mortar  
between  
bricks.

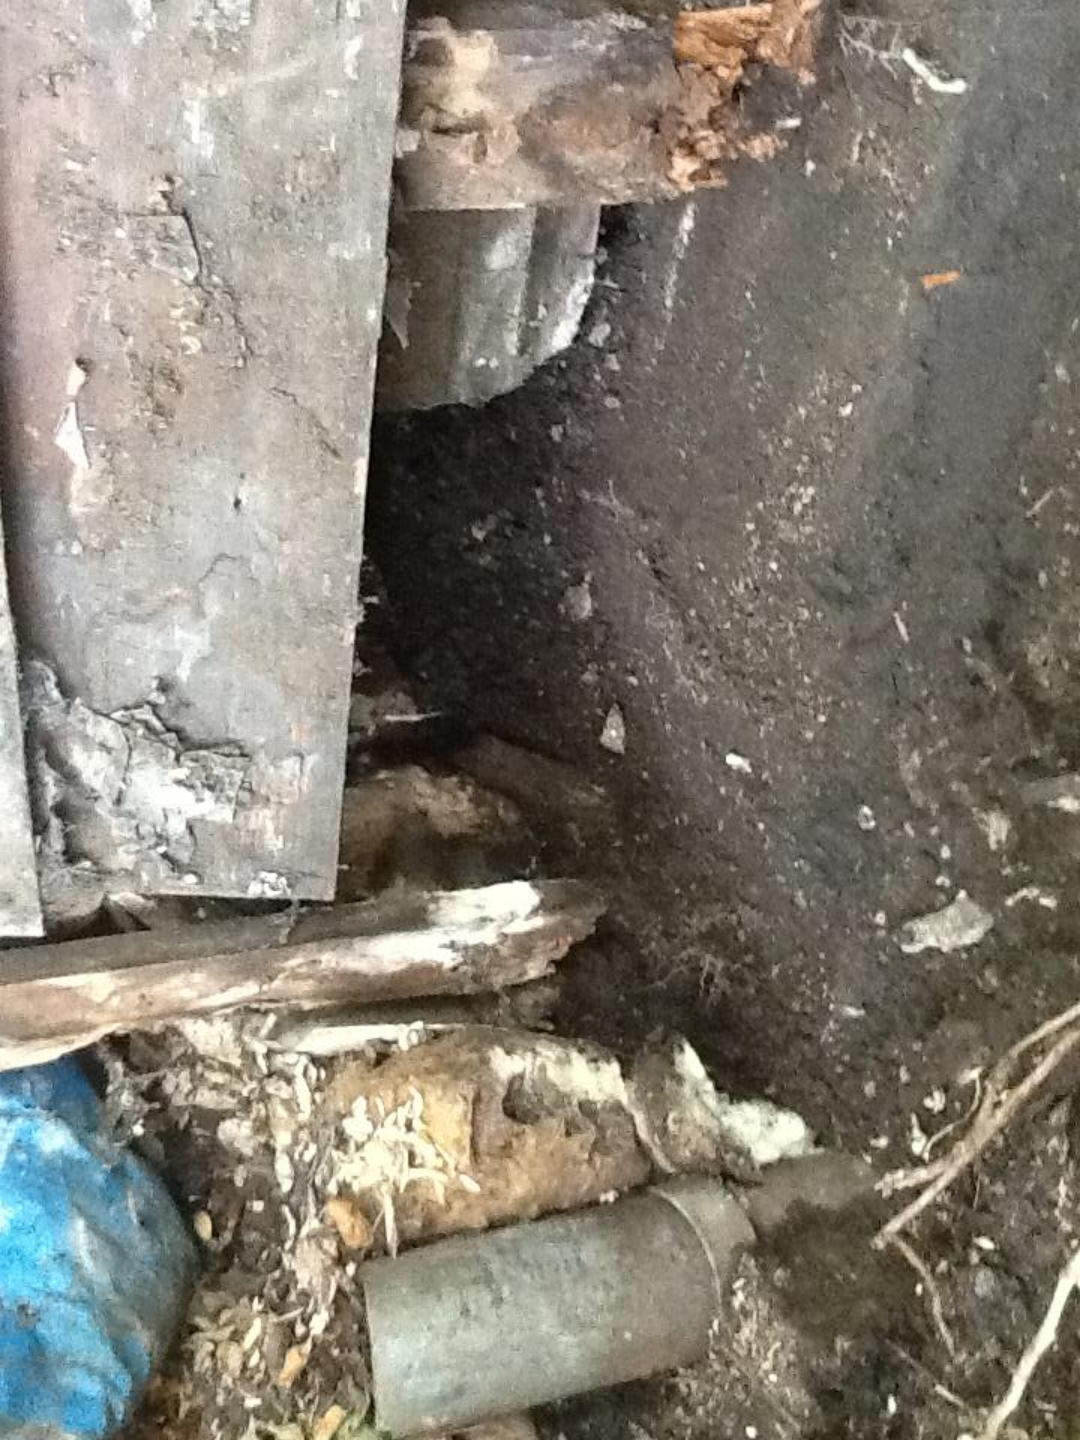
The N wall hangs, suspended in mid air. Removal of the aluminum siding to the E/left of the window revealed the interior lathing and plaster.

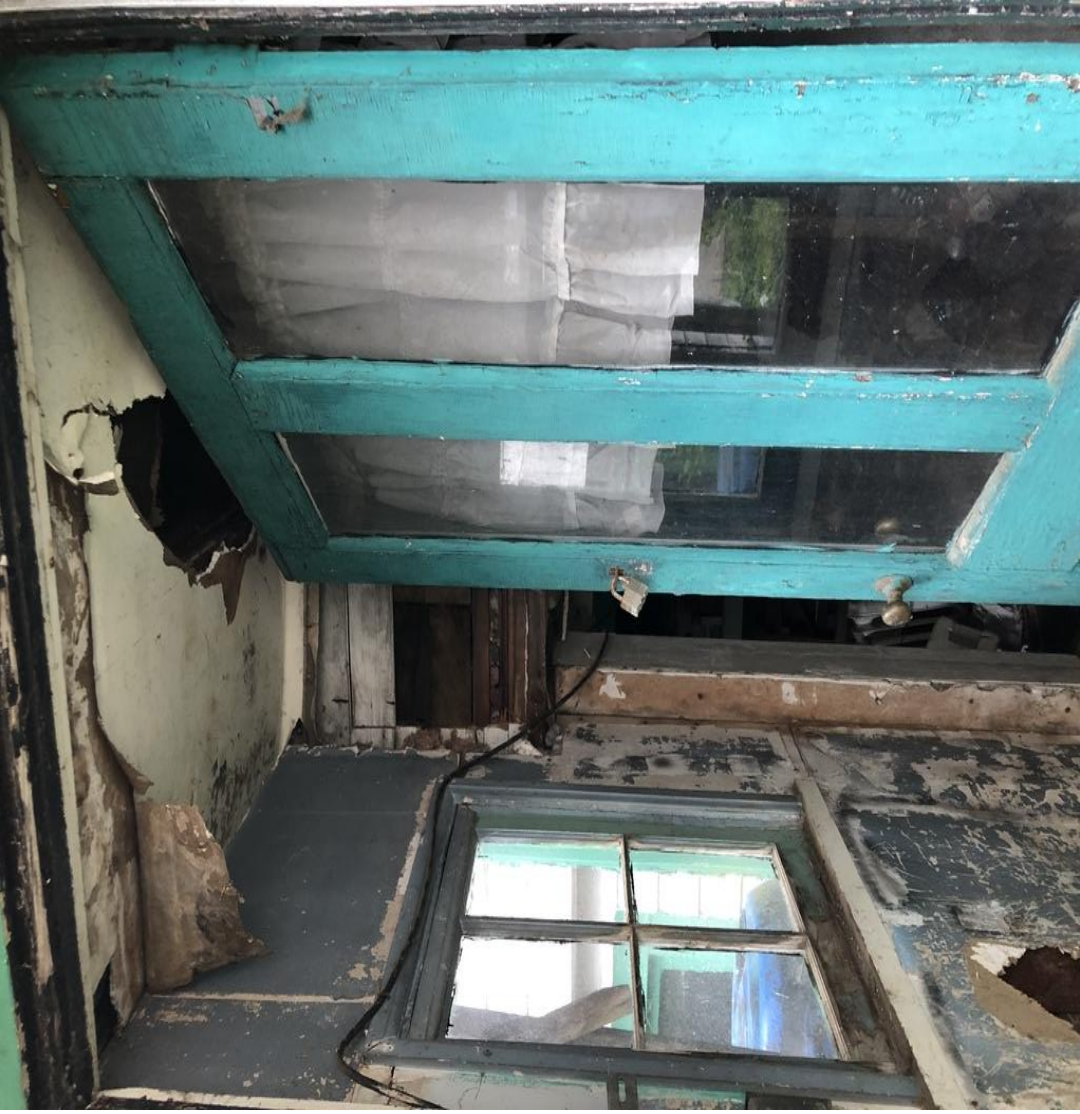
To the left, just  
inside the  
basement door.  
More humidity  
issues

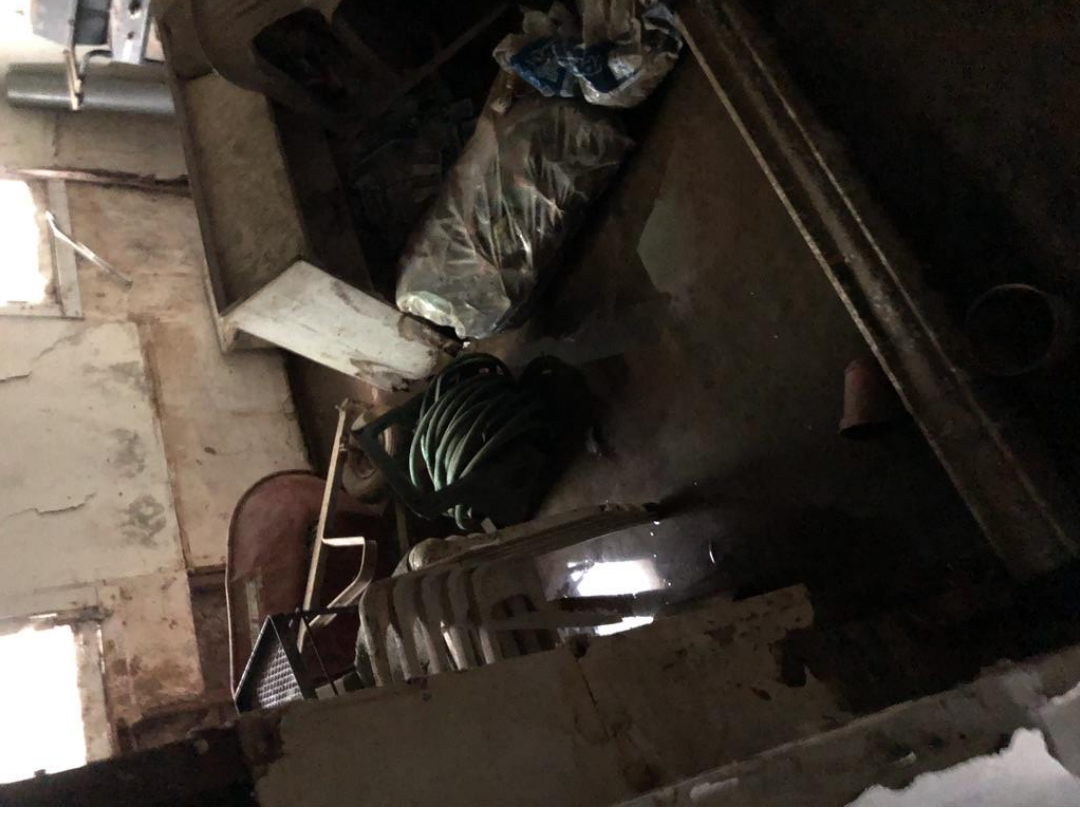
That water pools at  
about  $\frac{1}{2}$  to 1 inch in  
depth.

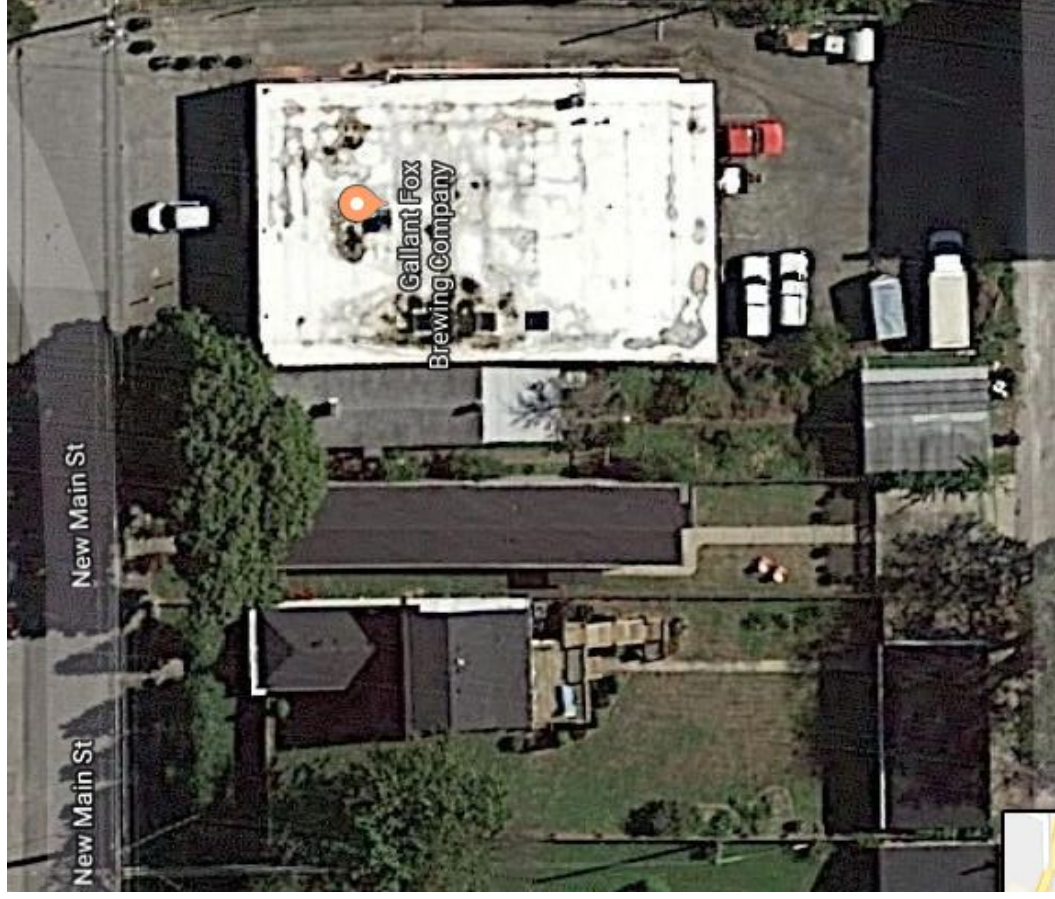
Compare the height of the window sill to the threshold of the USPO door. The parking lot of the USPO is a foot higher than the front yard of 2130. The sidewalk and the road are eight inches higher. The front yard of 2128 (to the west/right) is a bit higher. All that rain and melted snow find their way to the lowest spot - the front yard of 2130 New Main Street and then it begins a surface and underground migration into the shotgun's basement.

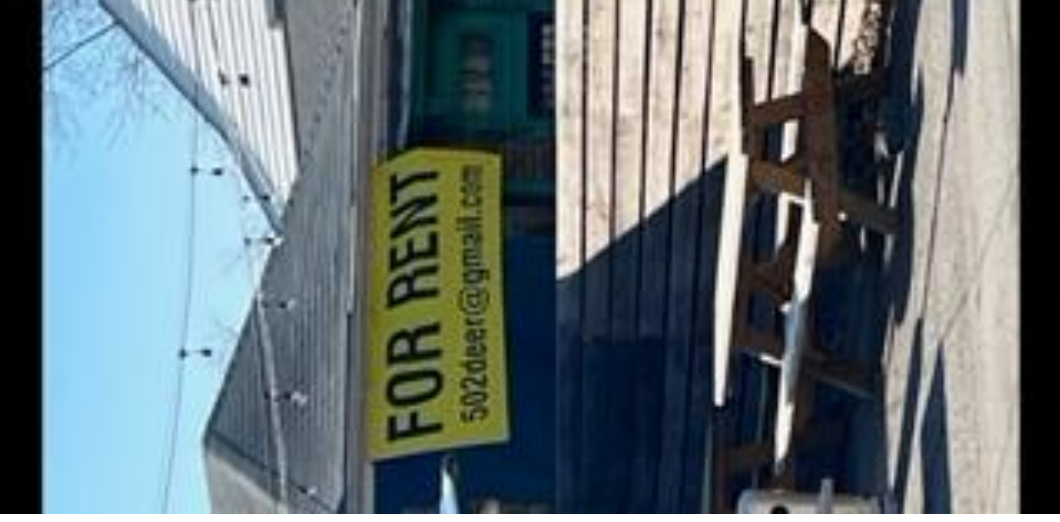
There is currently no gentle transition between the commercial 1950s strip mall USPO architecture and the residences. The incompatibility of the two is abrasive.

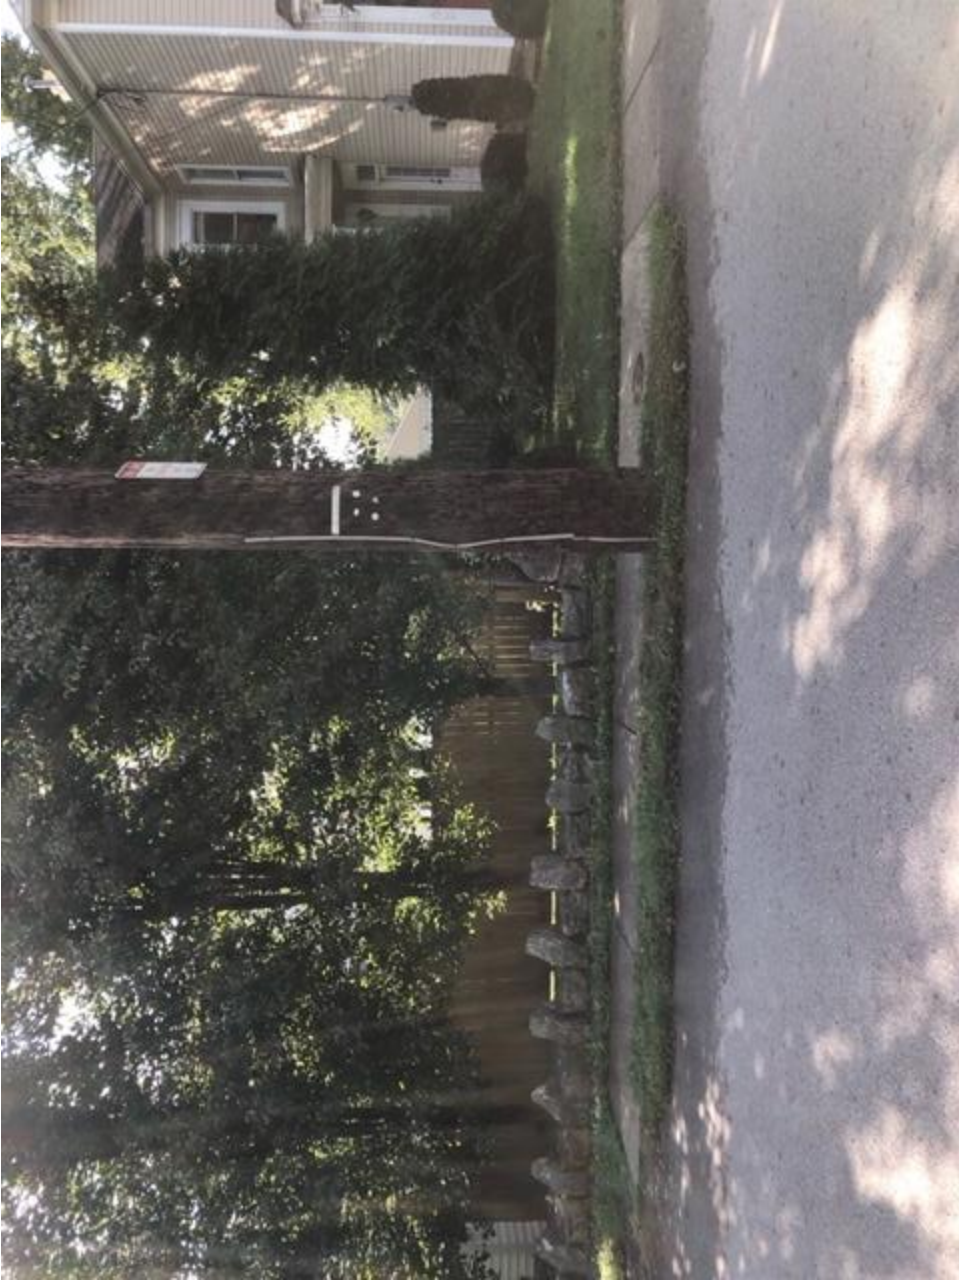
The two side  
yards between  
2126 and 2120  
New Main  
Street

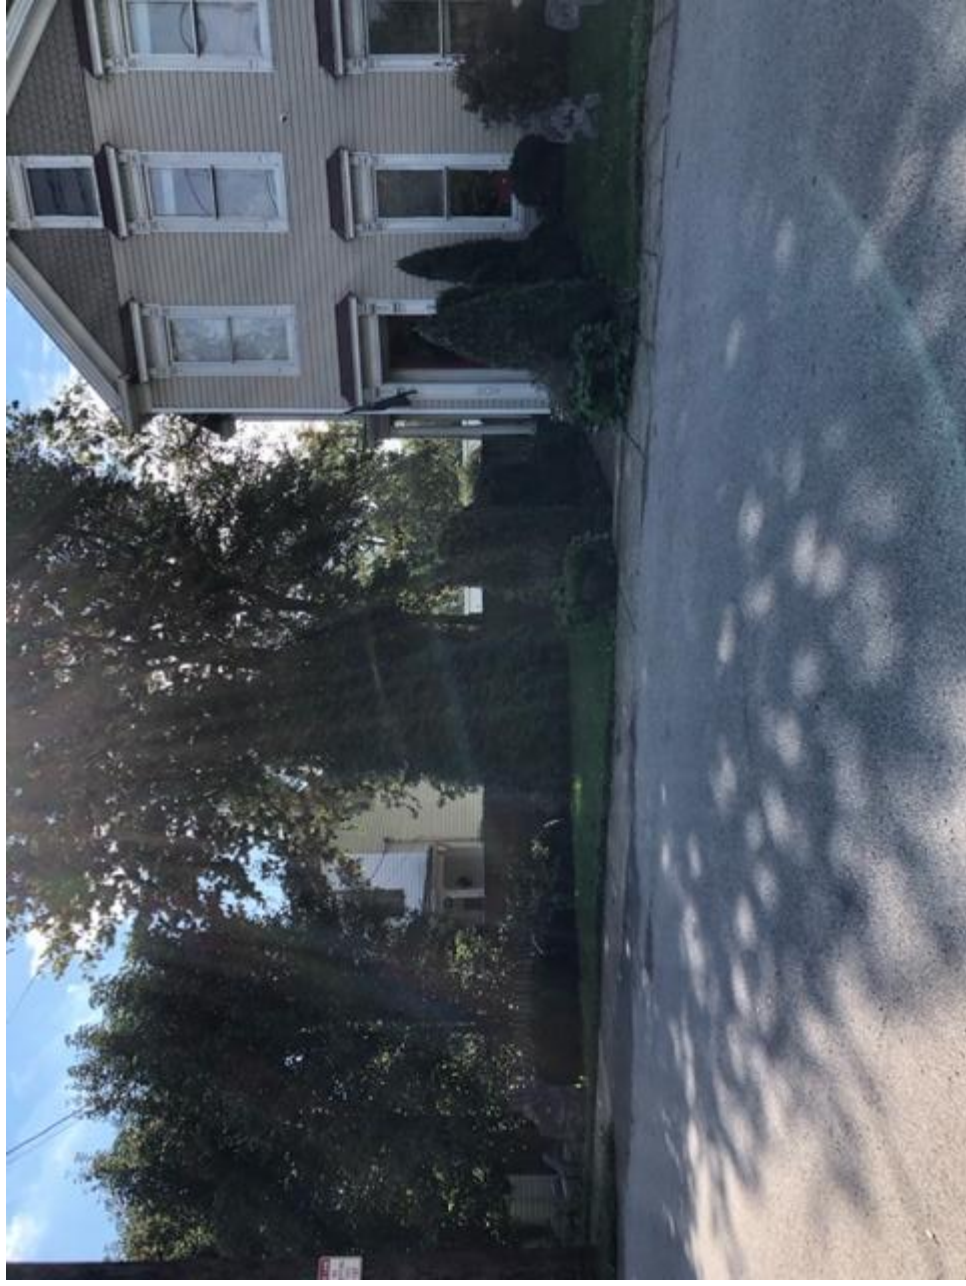
The two side  
yards between  
2126 and 2120  
New Main  
Street

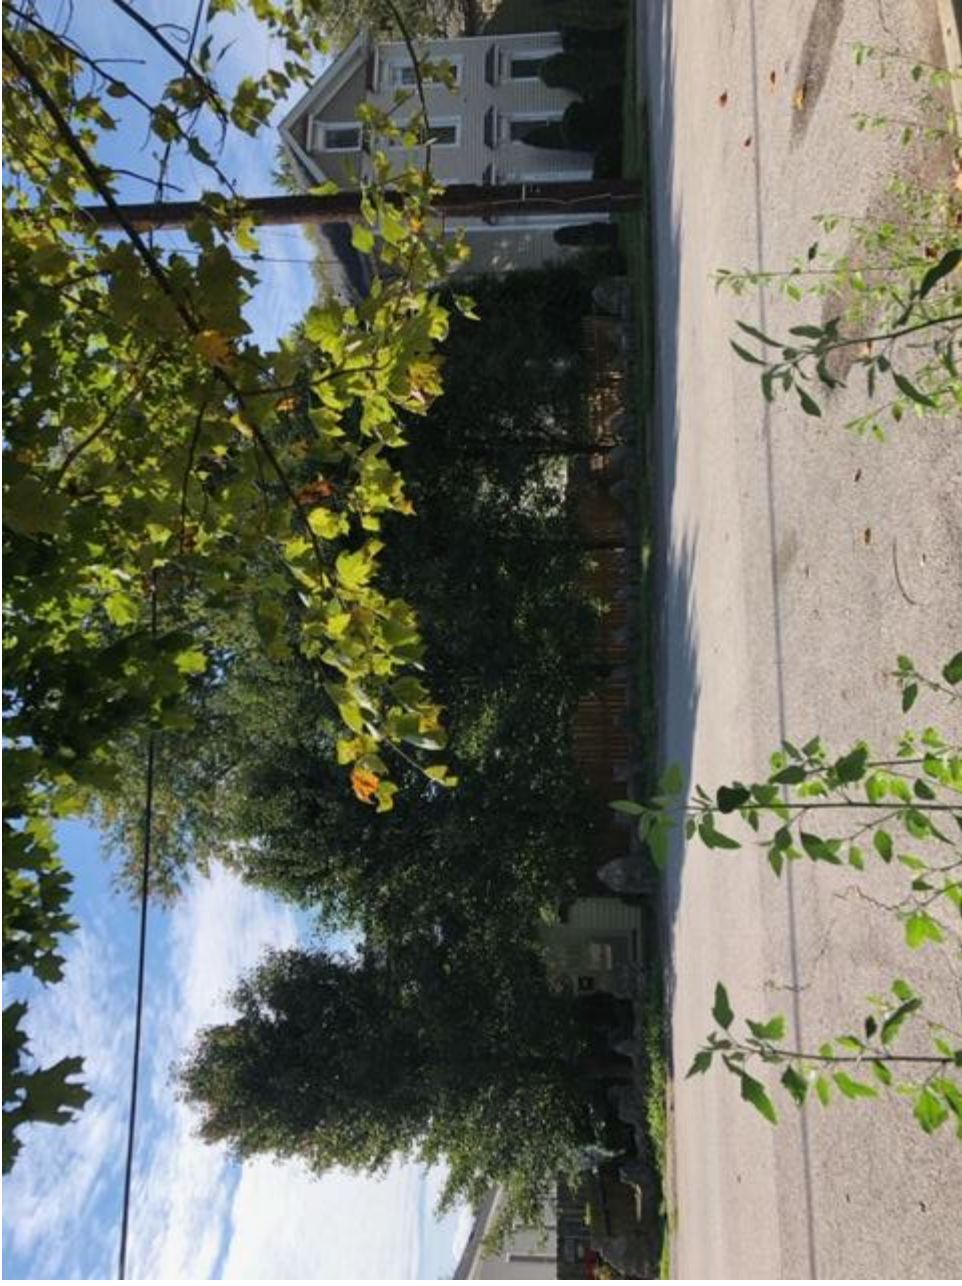
The two side  
yards between  
2126 and 2120  
New Main  
Street
